RENESAS TECHNICAL UPDATE

Product Category	MPU & MCU	Document No.	TN-16C-A219A/E	Rev.	1.00
Title	Errata to R32C/161 Group Hardware Manual		Information Category	Technical Notification	
Applicable Product	R32C/161 Group	Lot No.	Reference Document	R32C/161 Group Hardware Manual Rev. 1.02 (REJ09B0517-0102)

This document describes corrections to the R32C/161 Group Hardware Manual, Rev. 1.02.
The corrections are indicated in red in the list below.

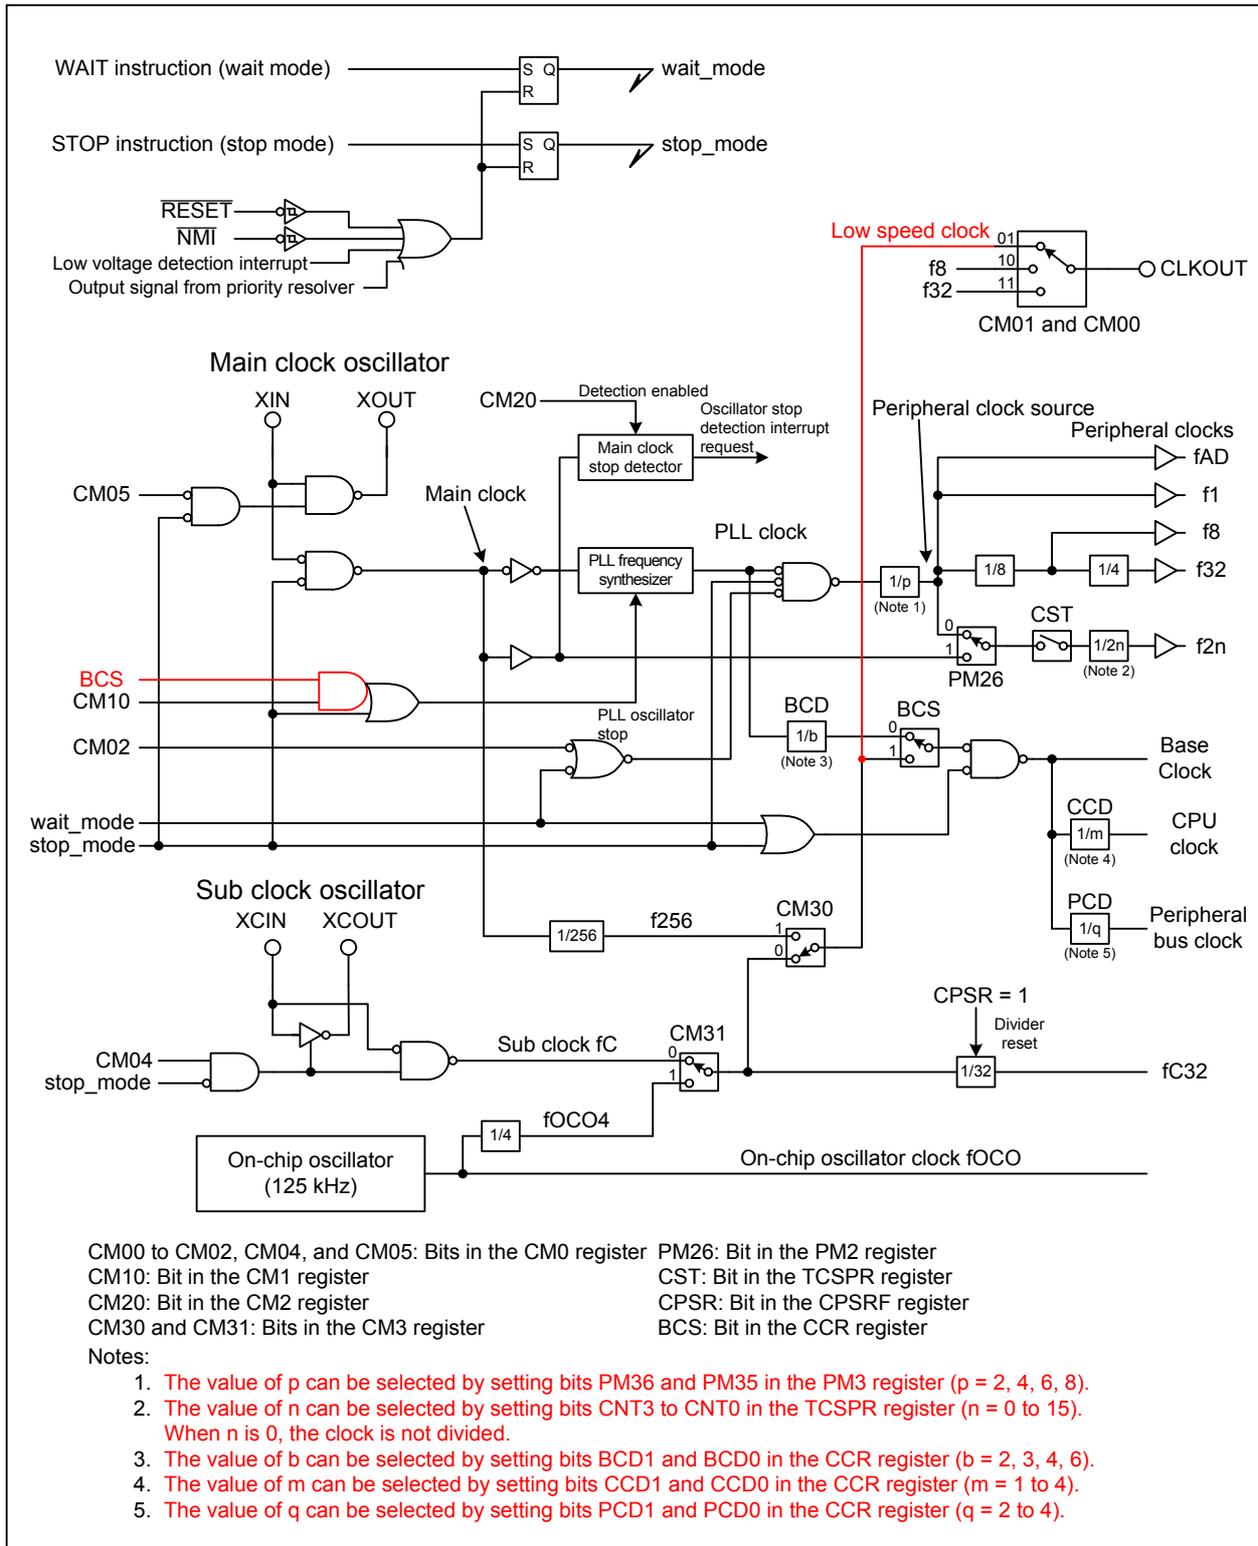
Figure 7.1 Clock Generation Circuitry

•Page 82 of 586, Figure 7.1 is corrected as follows:

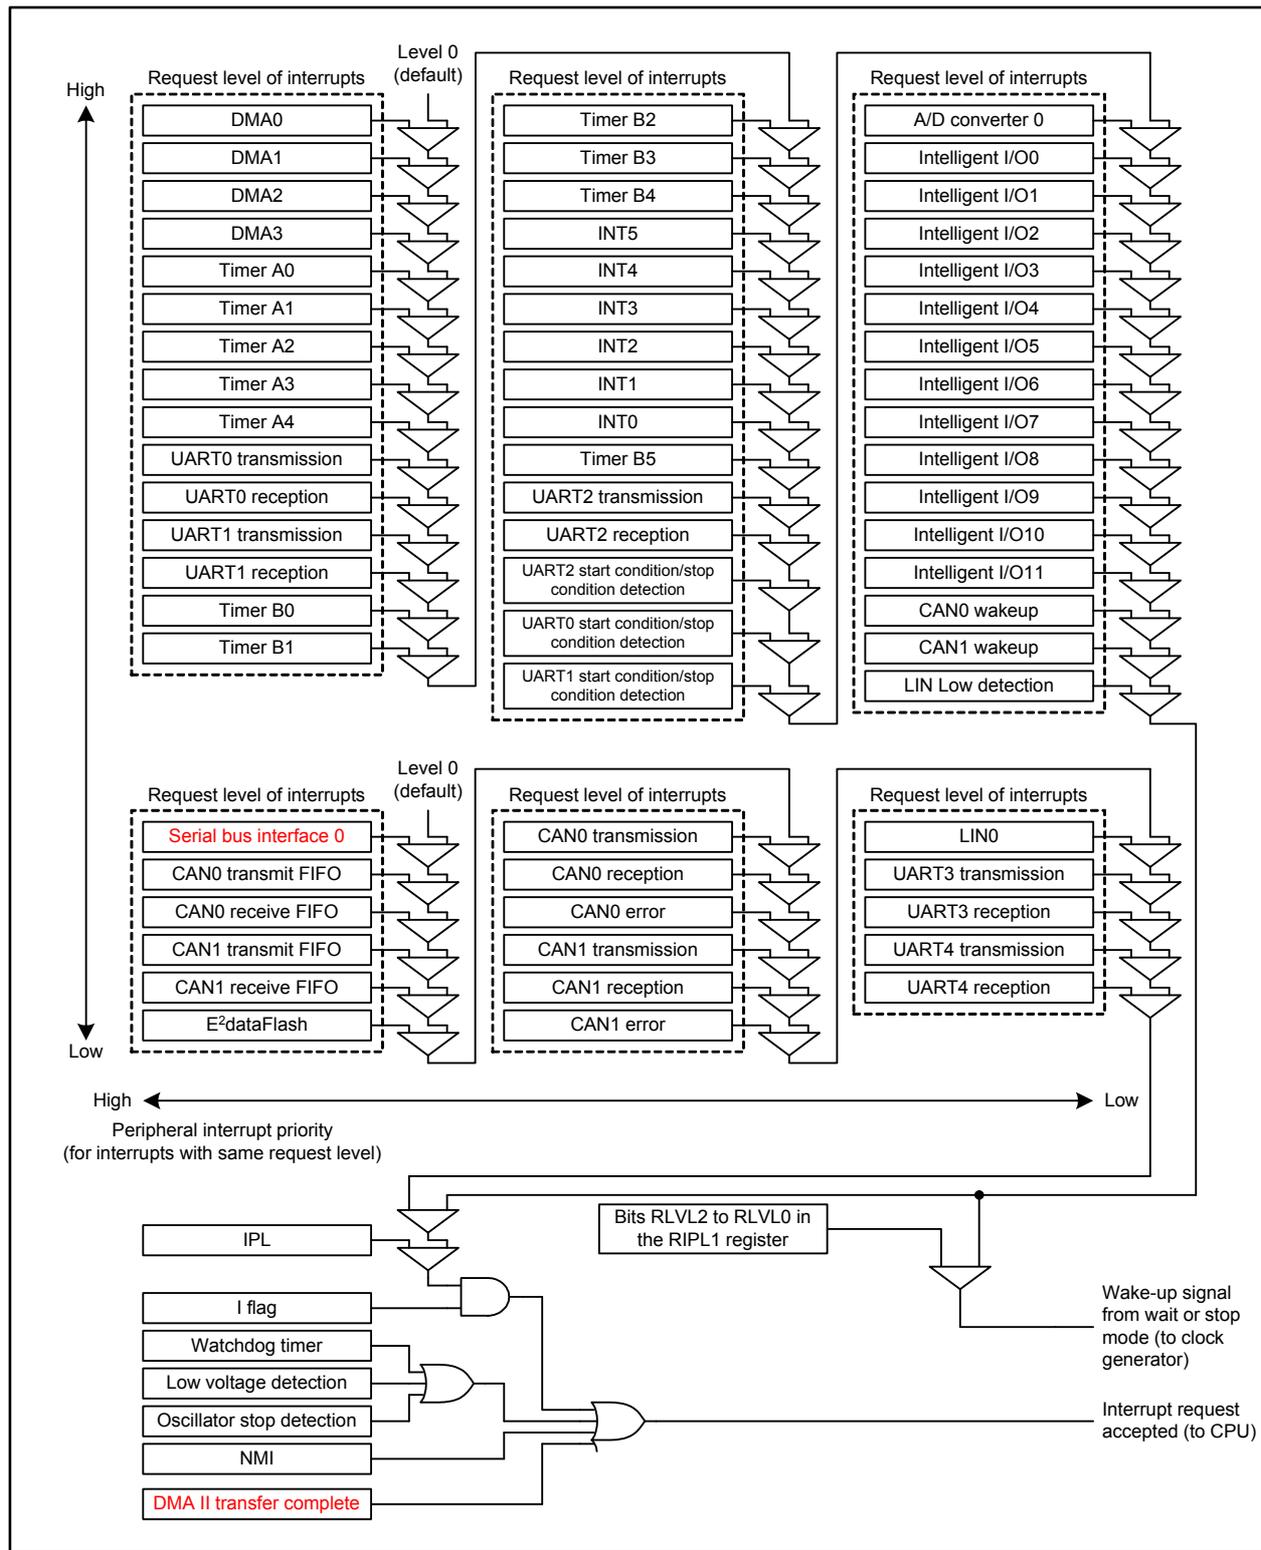
Figure 10.8 Priority Resolver

•Page 134 of 586, Figure 10.8 is corrected as follows:

(Description “Bits RLV2 to RLV0 in the RIPL2 register” and associated signal lines are deleted from Figure 10.8)

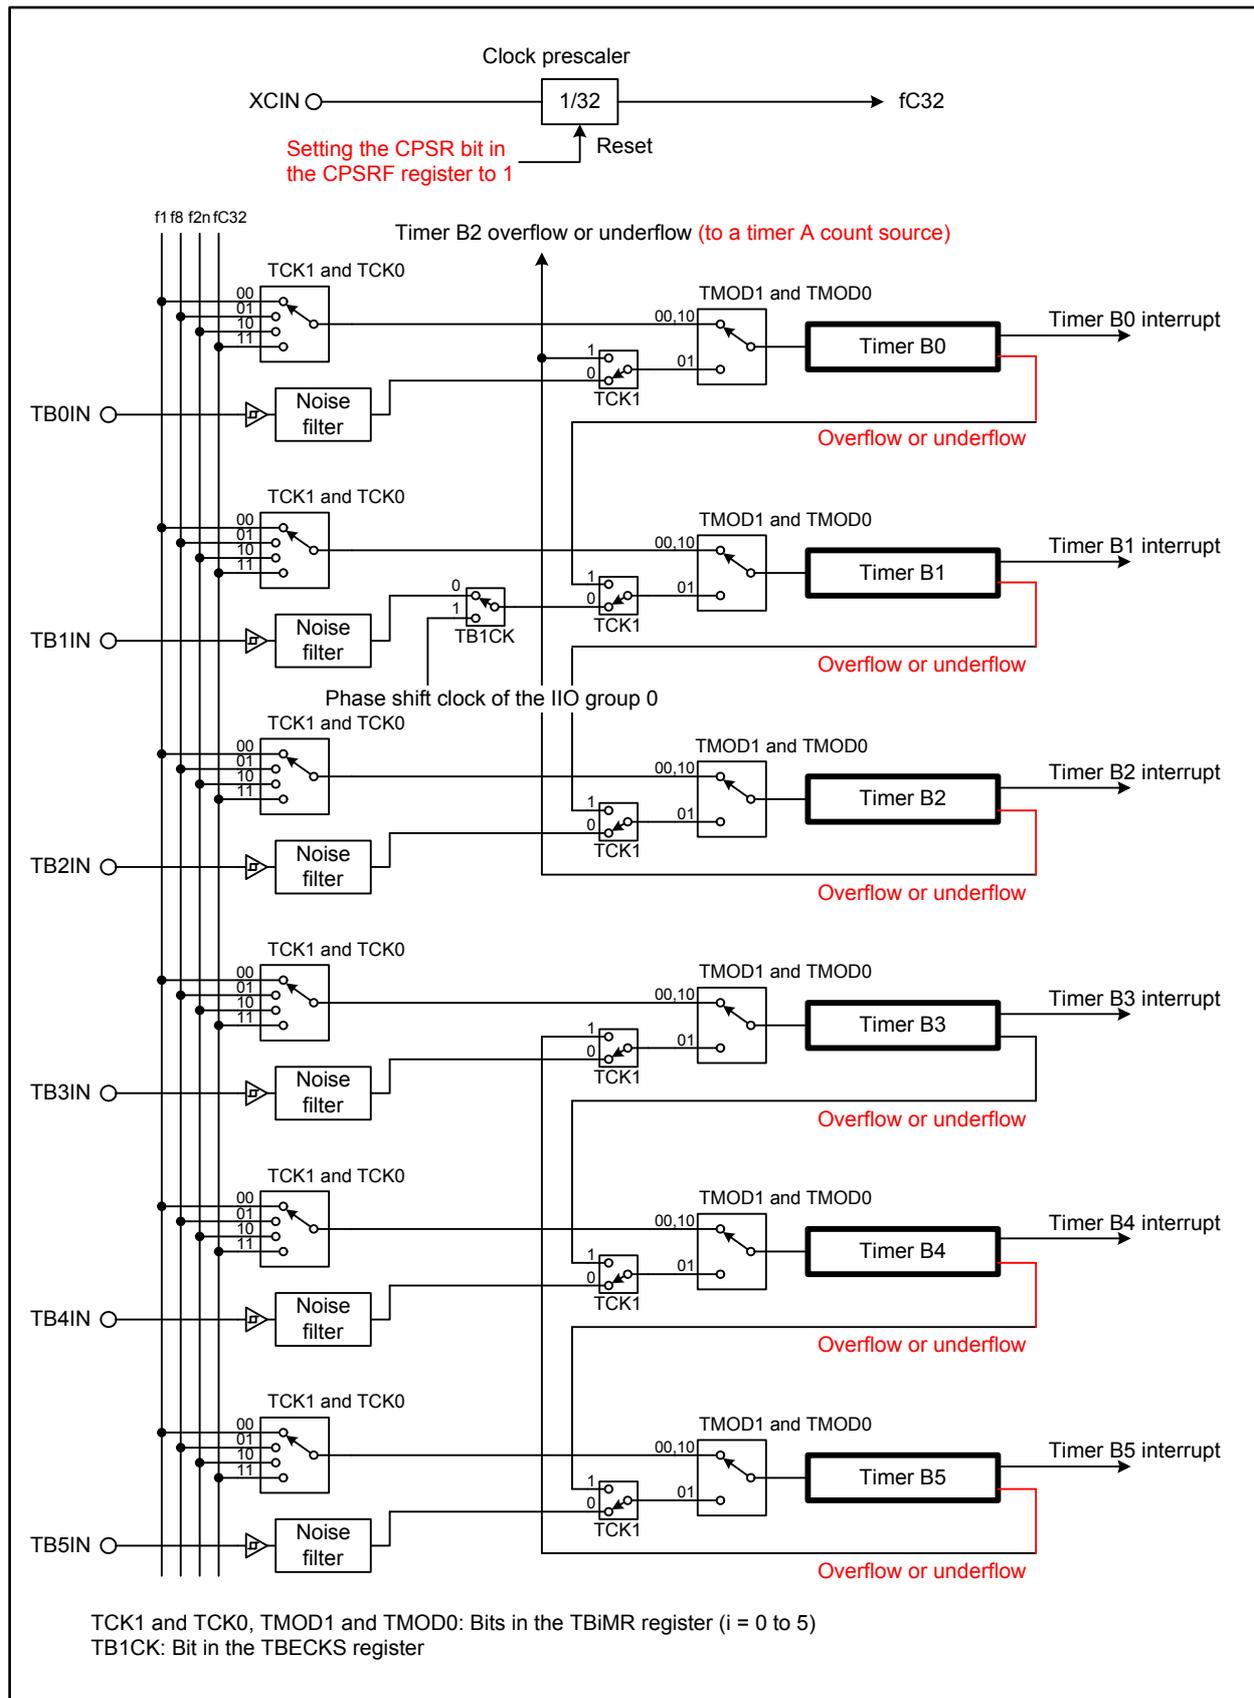
Figure 15.2 Timer B Configuration

•Page 173 of 586, Figure 15.2 is corrected as follows:

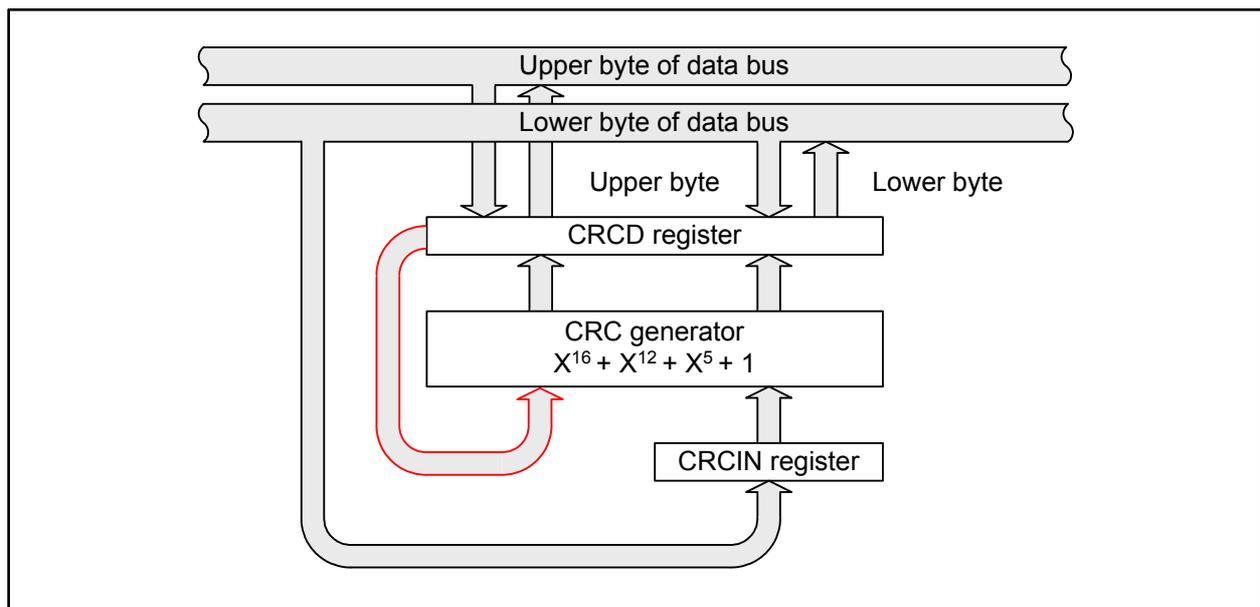
Figure 19.1 CRC Calculator Block Diagram

"CRC-CCITT"
- Page 292 of 586, Figure 19.1 is corrected as follows:

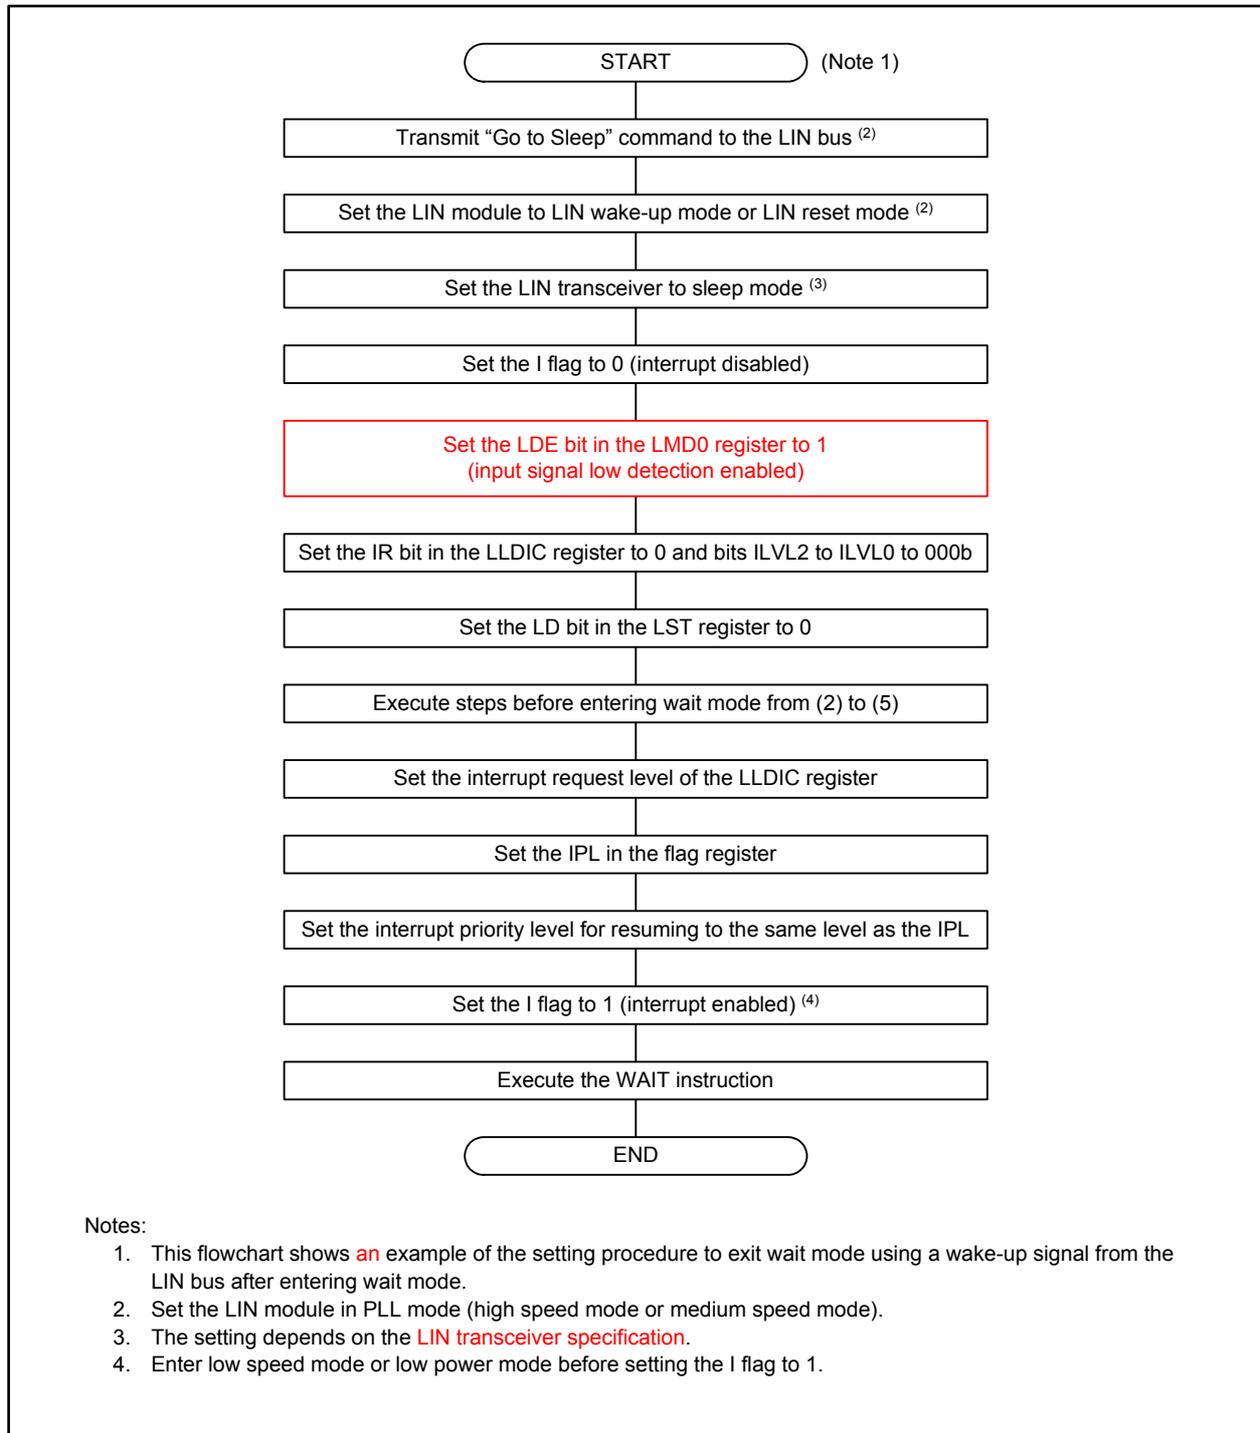
Figure 23.30 Example of Setting Before Transition to Wait Mode

•Page 396 of 586, Figure 23.30 is corrected as follows:

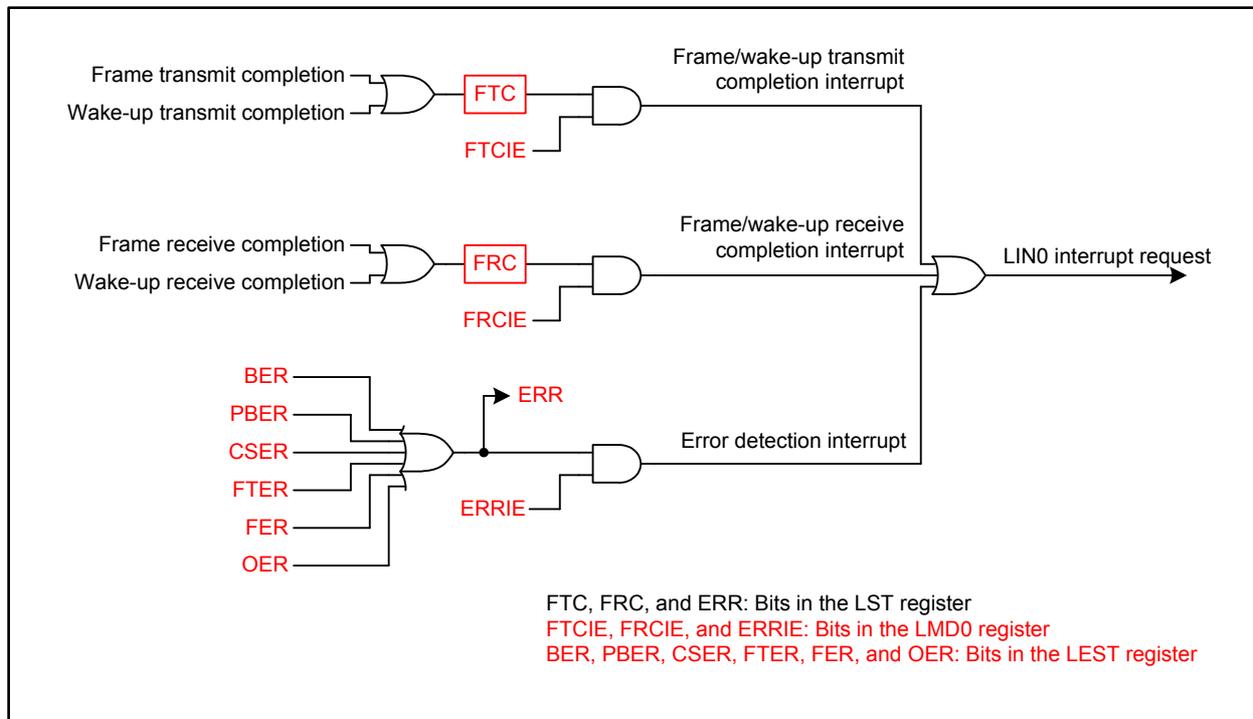
Figure 23.32 LIN0 Interrupt Block Diagram

- Page 400 of 586, the following description is added to line 8 of 23.11:
 “No new interrupt request is generated by the other sources if any of them is 1 since multiple interrupt sources are aggregated.”
- Page 400 of 586, Figure 23.32 is corrected as follows:

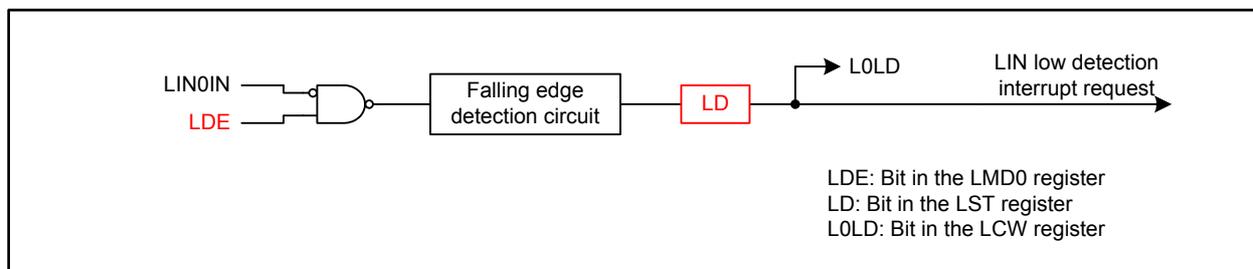
Figure 23.33 LIN Low Detection Interrupt Block Diagram

- Page 400 of 586, Figure 23.33 is corrected as follows:

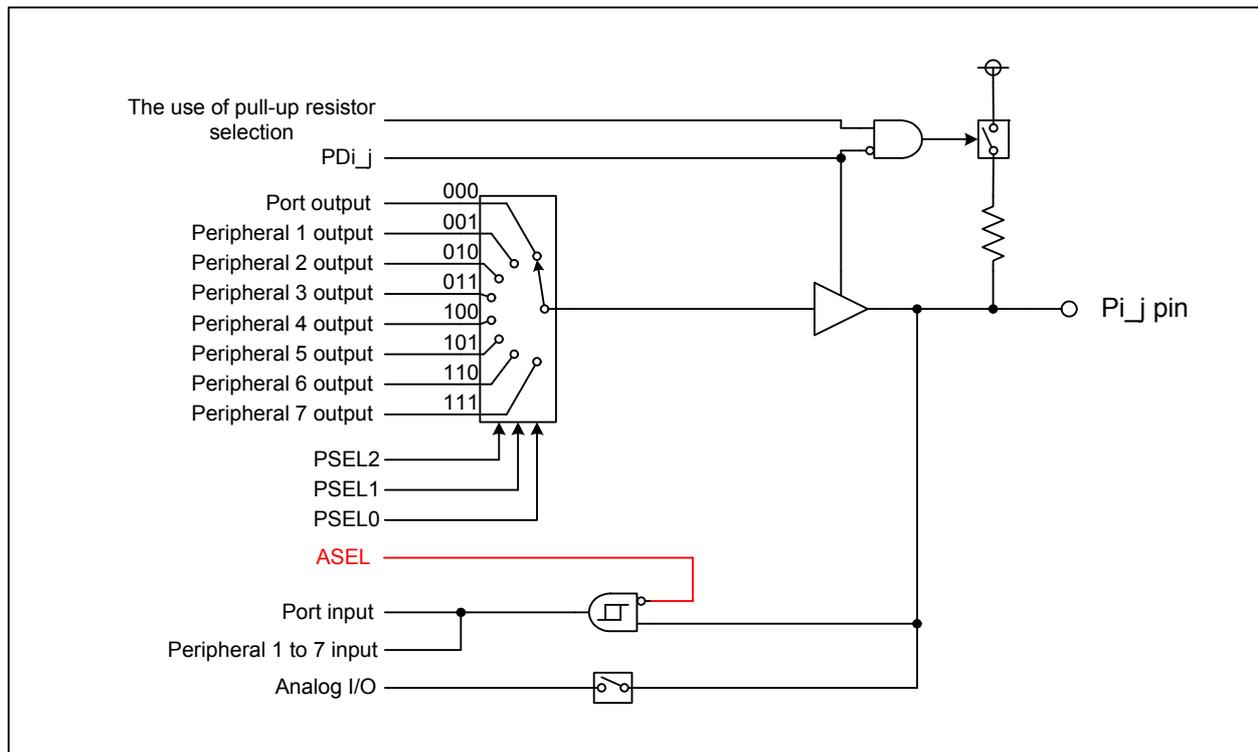
Figure 25.1 Typical I/O Pin Block Diagram (i = 0 to 9; j = 0 to 7)

- Page 470 of 586, Figure 25.1 is corrected as follows (refer to TN-16C-A198A/E):

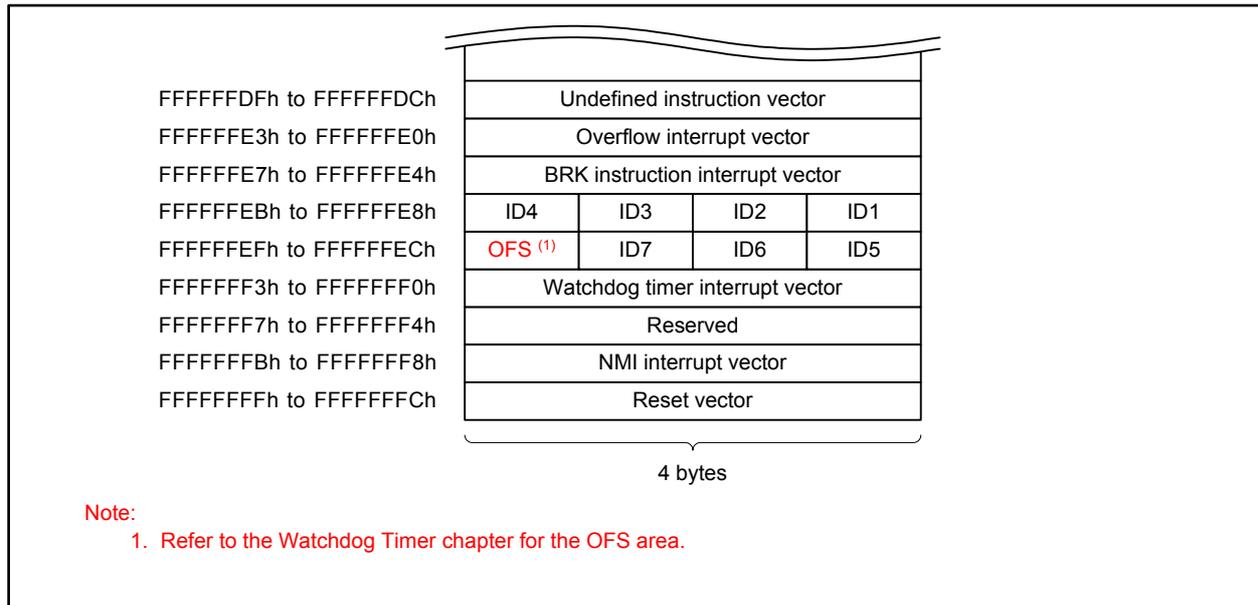
Figure 26.2 Addresses for ID Code Stored

•Page 494 of 586, Figure 26.2 is corrected as follows:

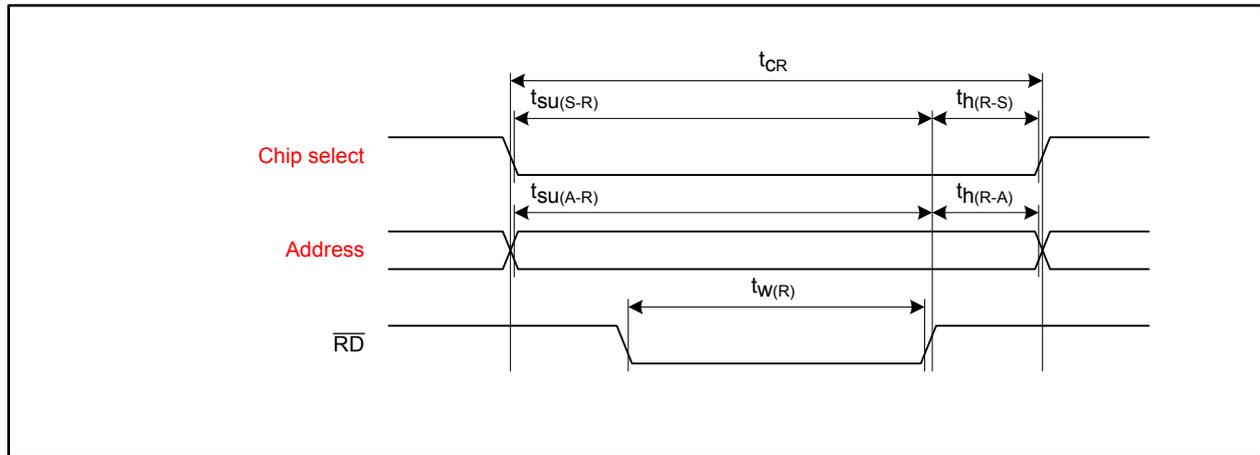
Figure 26.12 Read Timing

- Pages 502 and 504 of 586, descriptions in Figures 26.12 and 26.13 are corrected as follows:

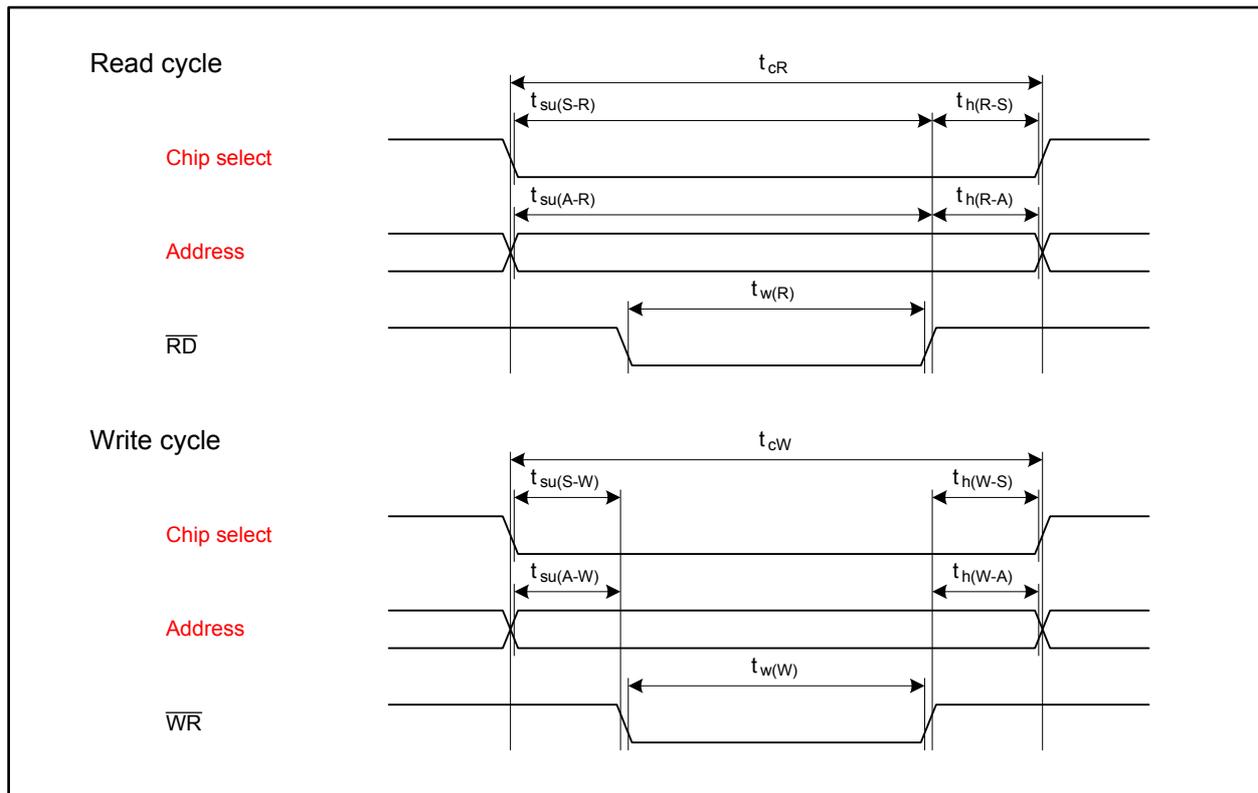
Figure 28.5 Flash Memory CPU Rewrite Mode Timing

- Page 541 of 586, descriptions in Figure 28.5 are corrected as follows:
