# RENESAS TECHNICAL UPDATE

Product Category	MPU/MCU		Document No.	TN-SY*-A0050A/E	Rev.	1.00
Title	Errata for User's Manual regarding the IIC		Information Category	Technical Notification		
Applicable Product	Renesas Synergy™ S3A3 MCU Group	Lot No.	Reference Document	S3A3 Microcontroller Group User's Manual Rev.1.10		
		All

The specified Renesas Synergy S3A3 User's Manual has incorrect statements about the IIC.

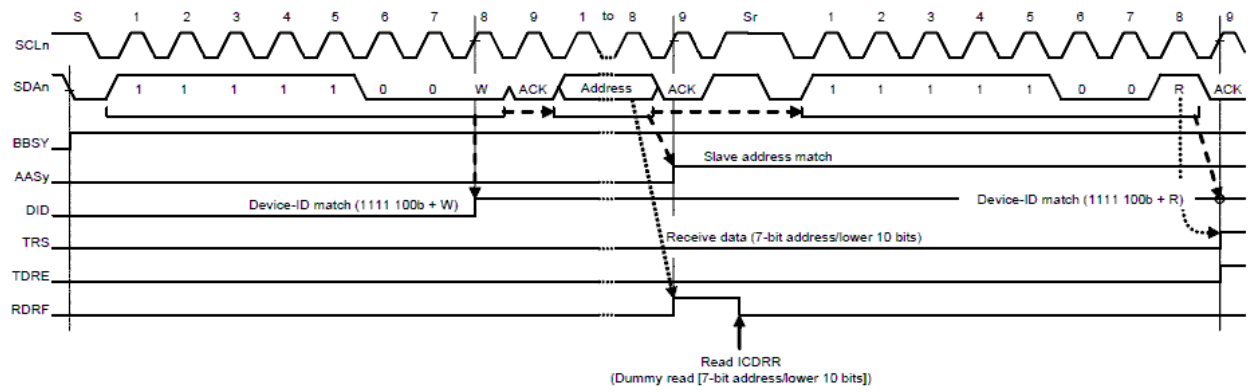
Device-ID reception

Incorrect Figure

When address received after a restart condition is detected does not match the device-ID

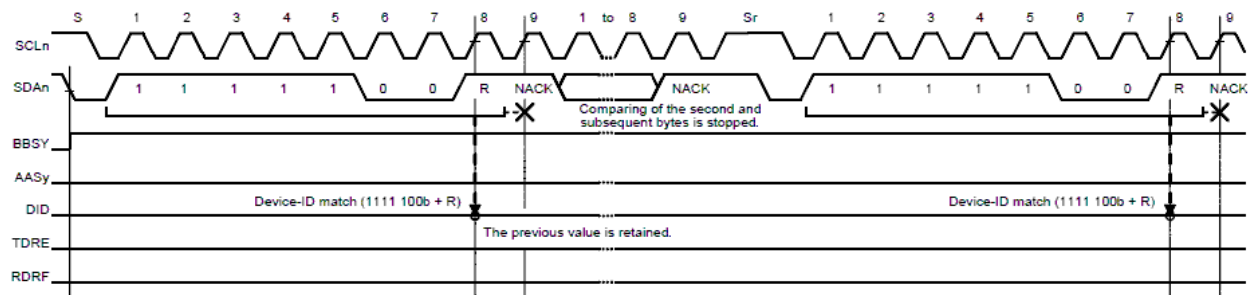
When address before the device-ID + R does not match the slave address

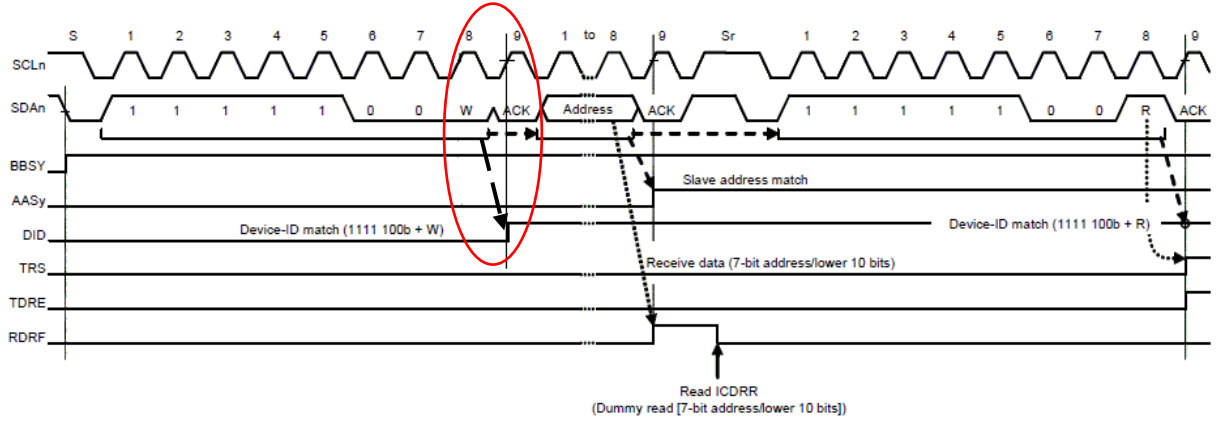
Device-ID reception

Correct Figure

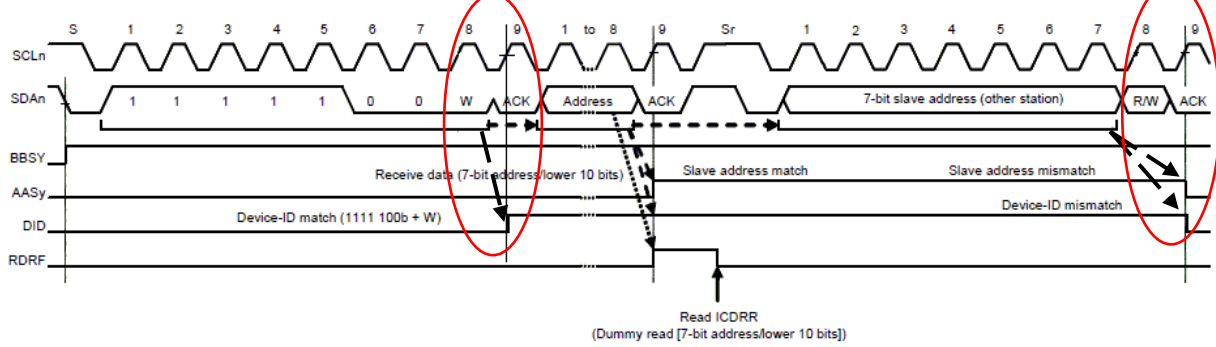
When address received after a restart condition is detected does not match the device-ID

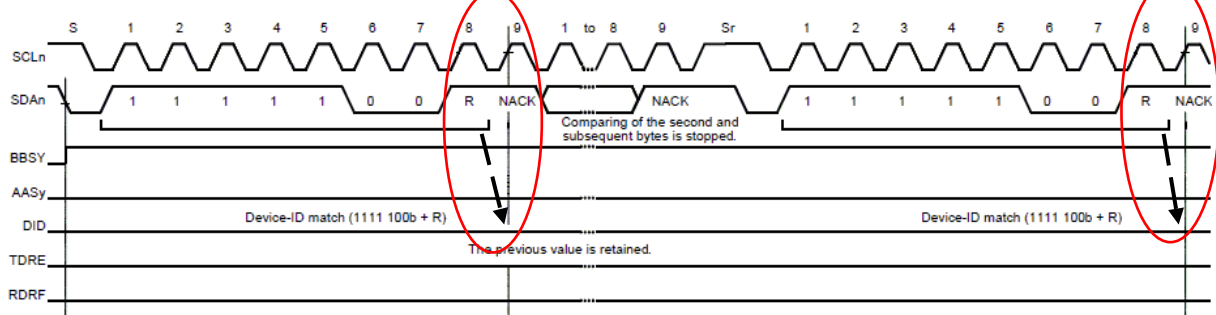
When address before the device-ID + R does not match the slave address

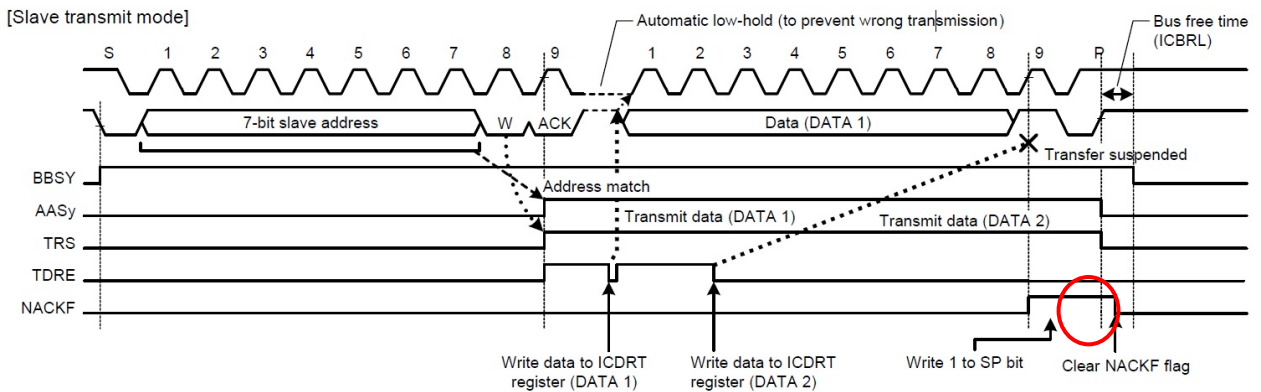
Correct Figure

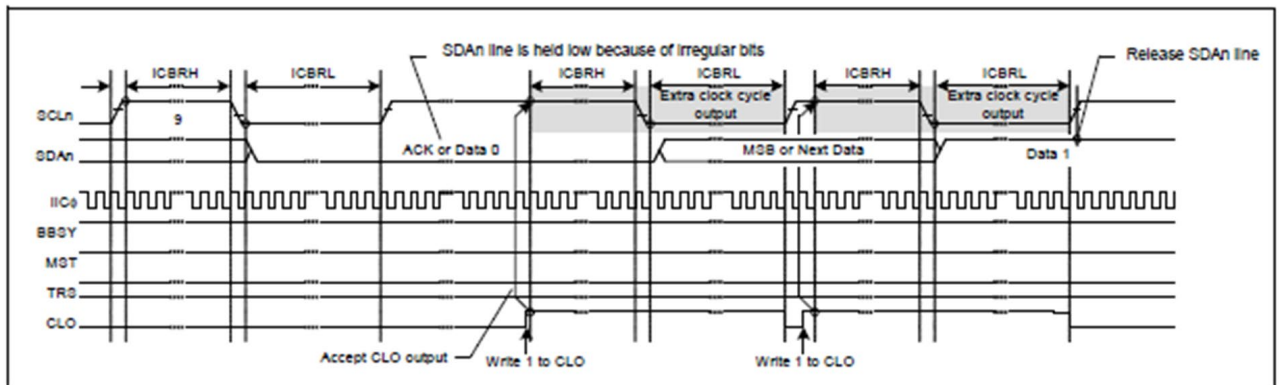
Incorrect Figure

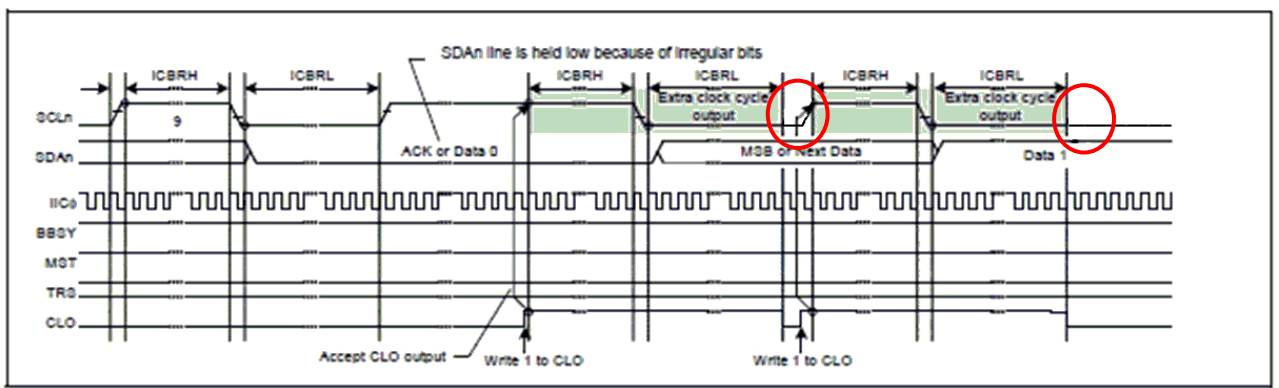
Correct Figure
