RENESAS TECHNICAL UPDATE

Product Category	MPU/MCU		Document No.	TN-SH7-A900A/E	Rev.	1.00
Title	Error correction regarding DMAC interface in RCAN-ET and RCAN-TL		Information Category	Technical Notification		
Applicable Product	See below.	Lot No.	Reference Document	See below.		
		All lots

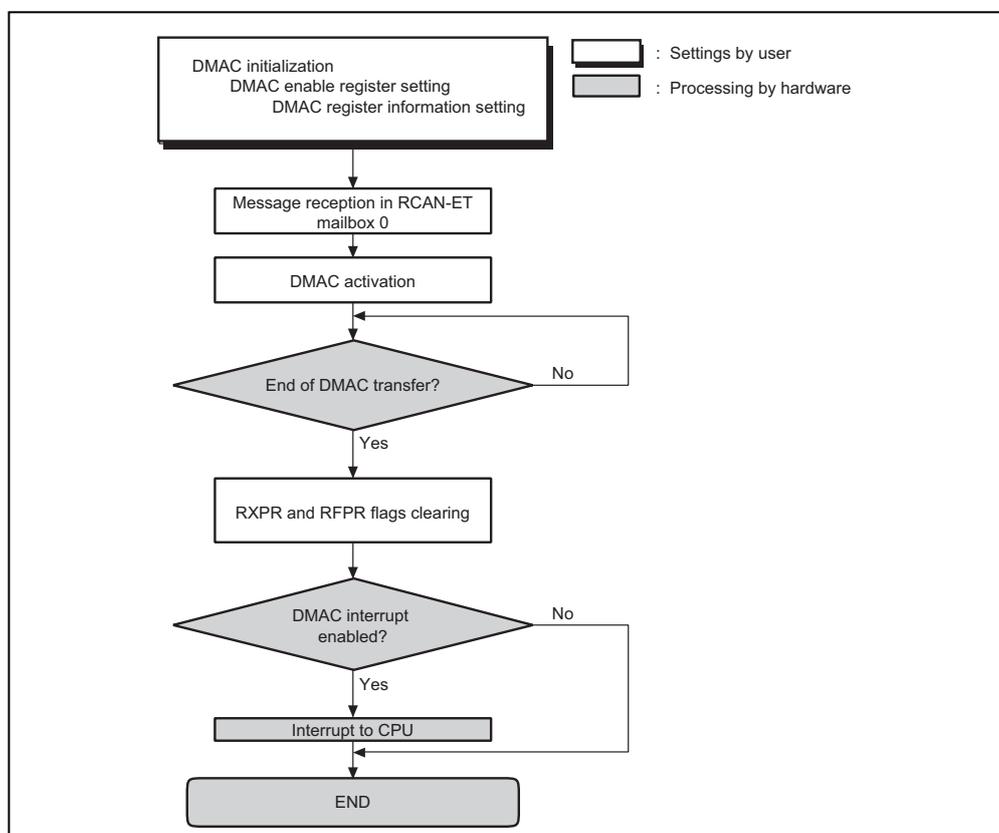
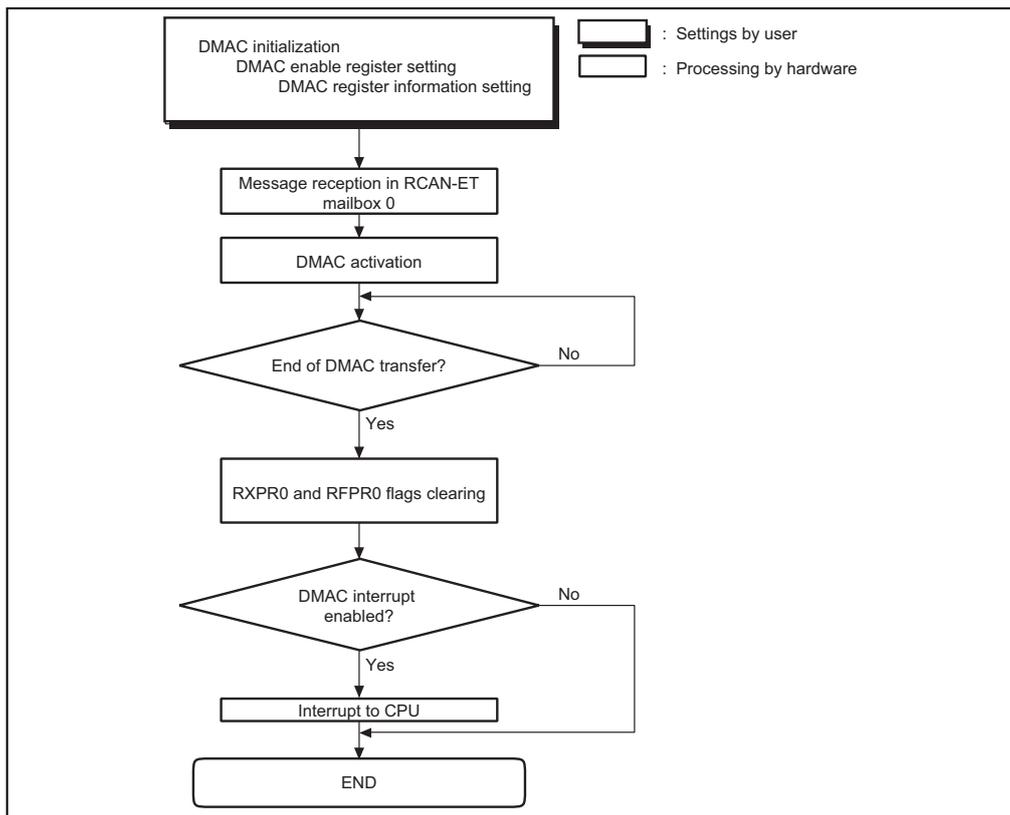
Figure 21.15 DMAC Transfer Flowchart

Since hatching is not necessary, it is removed in the flowchart.
