Microcontroller Technical Information

ID78K0R-QB 78K0R Integrated Debugger	Document No.	ZBG-CD-10-0021	1/1
	Date issued	May 12, 2010	
Usage Restrictions	Issued by	MCU Tool Product Marketing Department MCU Software Division MCU Business Unit Renesas Electronics Corporation	
	Notification classification	√	Usage restriction
		Upgrade	
		Document modification	
		Other notification	
Related documents: ID78K0R-QB Ver. 3.60 Integrated Debugger Operation User's Manual: U19613EJ1V0UM00 (1st edition) 78K0R Integrated Debugger ID78K0R-QB V3.60 Operating Precautions: ZUD-CD-09-0156

78K0R Integrated Debugger ID78K0R-QB - Usage Restrictions

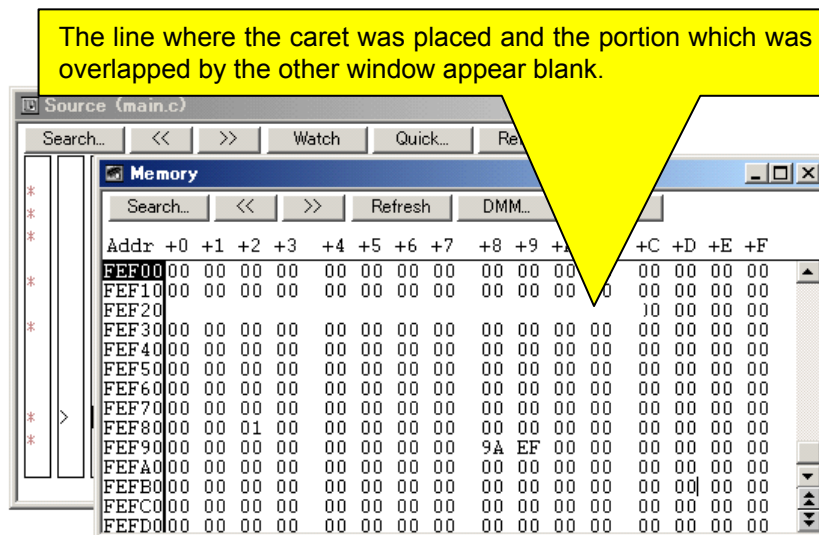
No. 2 Restriction on redraw <Common>

When the **Memory** window is displayed in front of another window, if the window behind the **Memory** window is clicked to the front and then the **Memory** window is clicked to the front again, the line where the caret was placed and the portion which was overlapped by the other window appear blank in the **Memory** window.

Click the **Refresh** button or click on the blanked line to restore the original display.

This issue has been corrected in V3.40.

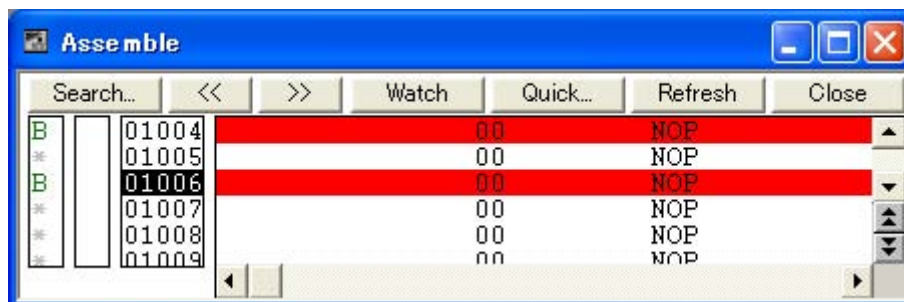
Example 1: If a “break before execution” point is specified for addresses 1004 and 1006, in that order, the break does not occur at address 1006.

Clear all of the “break before execution” points within a 4-byte boundary area and specify just one “break before execution” point, or use software breakpoints instead.

This issue has been corrected in V3.30.

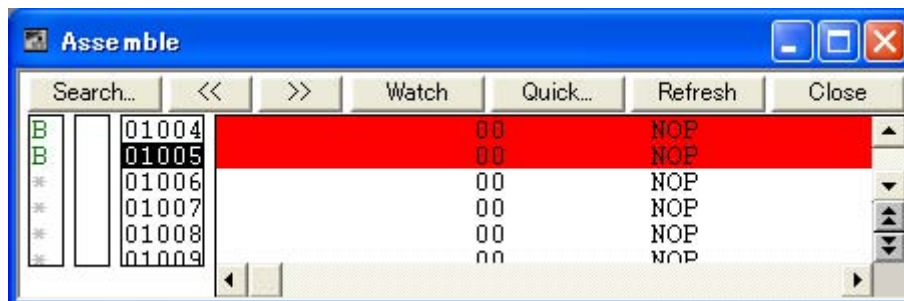
Example 2: If a “break before execution” point is specified for addresses 1004 and 1005, in that order, and the breakpoint at address 1005 is removed, the breakpoint at address 1005 remains valid.

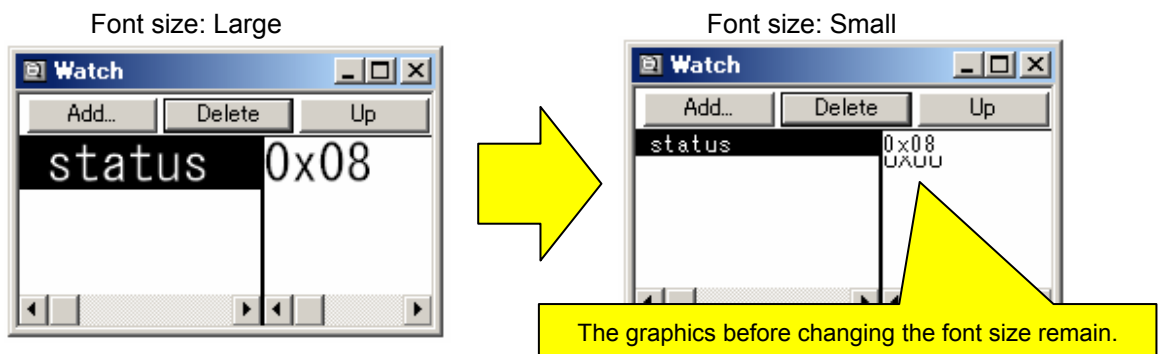
Example of Watch window:

The font size in the **Watch** window and **Local Variable** window can be specified in the **Font** area in the **Debugger Option** dialog box, which is opened by clicking the **Option** menu and then **Debugger Option...**, but if the font size is reduced, the graphics before changing the font size remain in the window.

Minimize the window and then restore the window size, or close the window and then open it again.

This issue has been corrected in V3.40.

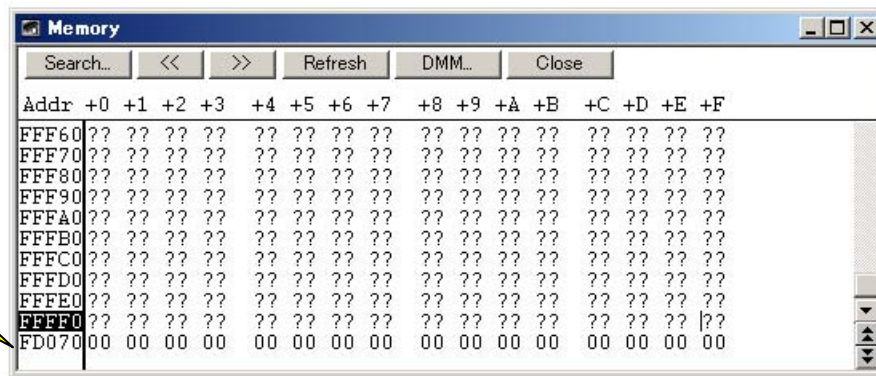
If the **Address Move** dialog box is opened by selecting the `Move` command on the shortcut menu in the **Memory** window, an extra line might be displayed when the end address (0xffff) is input.

An extra line might be displayed.

Do not move to address 0xffff. (Because this address is in the SFR area, displaying this area in the **Memory** window is meaningless.)

This issue has been corrected in V3.40.

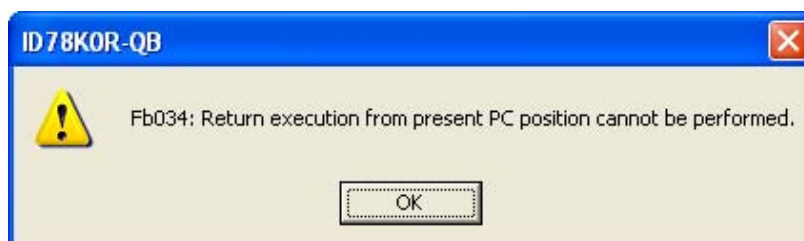
`Return Out` is used to execute a program until execution returns to the address from which the function was called, and uses a stack to predict the call source. Due to this, execution cannot return from locations where the association between the stack and the stack pointer is shifted (location where the stack is currently being manipulated, such as before execution of a function prologue (`{`) or execution of an epilogue (`}`) is in progress, or where the program counter points to the middle, not the beginning, of a C source). If `Return Out` is attempted at a location where `Return Out` cannot be performed, the following error message is output:

When the above error message is output, step through the code and then execute `Return Out`. (After stepping through the code, the difference between the stack address and stack pointer is resolved.)

The error message has been corrected in V3.40.

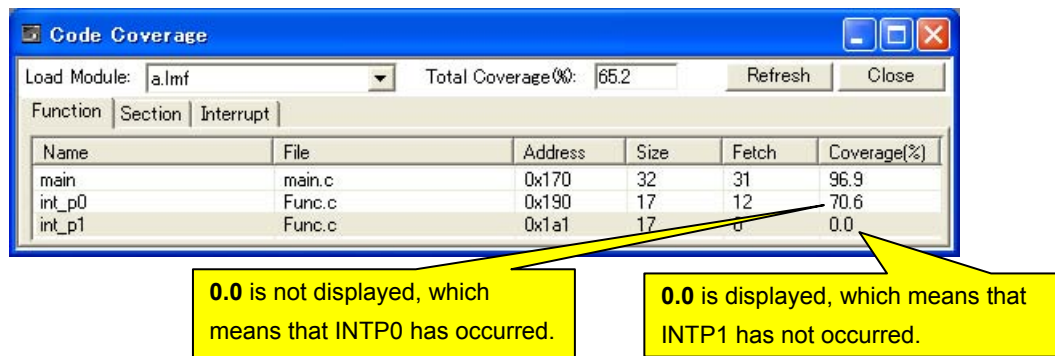
Example: When interrupt INTPO is defined as function `int_p0` and INTP1 as function `int_p1`

The **Interrupt** tab is used to check whether an interrupt has occurred, but this can also be checked by referring to the **Function** tab to check the coverage of the function corresponding to the interrupt.

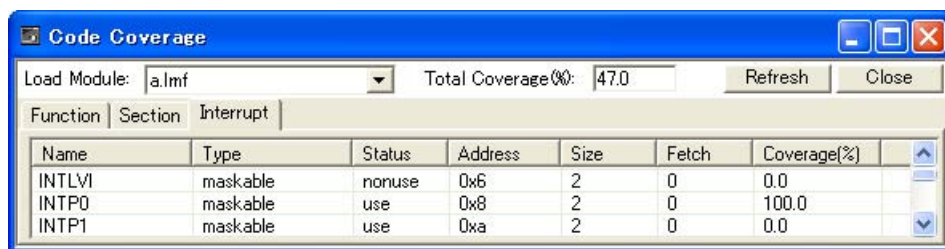
This issue has been corrected in V3.40. The display after correction is as follows:

- **Status:** If the interrupt function is defined, **use** is displayed; otherwise, **nonuse** is displayed.
- **Coverage(%):** If an interrupt has occurred, **100.0** is displayed; otherwise, **0.0** is displayed.

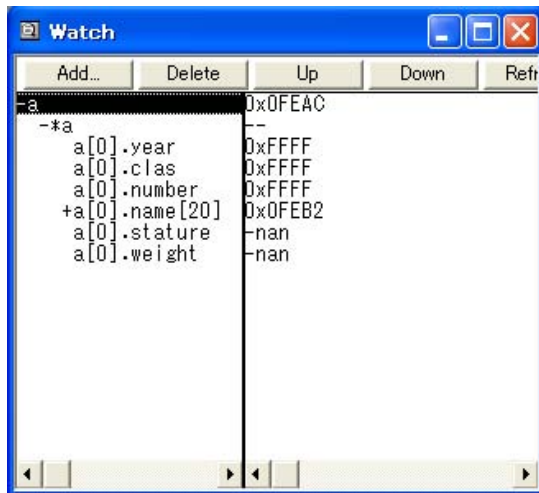
Incorrect display example
(ID78K0R-QB V3.50 or earlier)

When the pointer *a is registered to the **Watch** window, the data for 0x0FFEAC is supposed to be displayed, but the fifth least significant digit becomes 0 and the data for 0x00FEAC is displayed instead.

This issue has been corrected in V3.60.

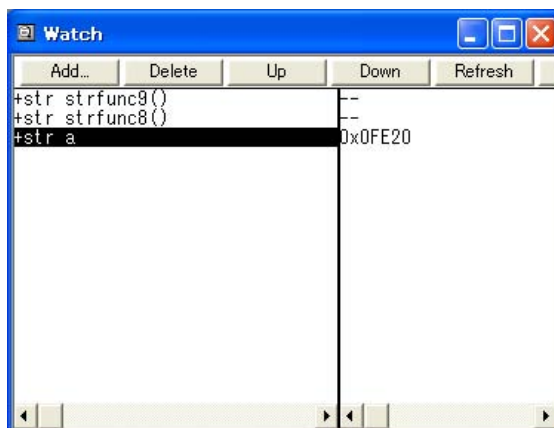
Incorrect display example
(ID78K0R-QB V3.50 or earlier)

When the structure pointer *a* is registered to the **Watch** window, the members (*ec*, *ui*, and *ary*) cannot be expanded for display.
