Concerned Products:	Custome	er Notification	Date: Jan. 28, 1998
IE-789026-NS-EM1	_		NEC-Electronics (Europe) GmbH EAD -Technical Product Support
			Source Doc:
	Bug Report		SBG-T-0442
	Duy	Jirepon	SBG-T-0487
			SBG-T-0524
			SBG-T-0603
			Author: W. Noll
			M. Kratz
	Jan. 28th, 98	Doc. No.:	TPS-LE-B-ST02
1 <sup>st</sup> revision:	May 11th, 98	Doc. No.:	TPS-LE-B-ST02
2 <sup>nd</sup> revision:	June 4th, 98	Doc. No.:	TPS-LEB-ST02

## (A) BUG LIST

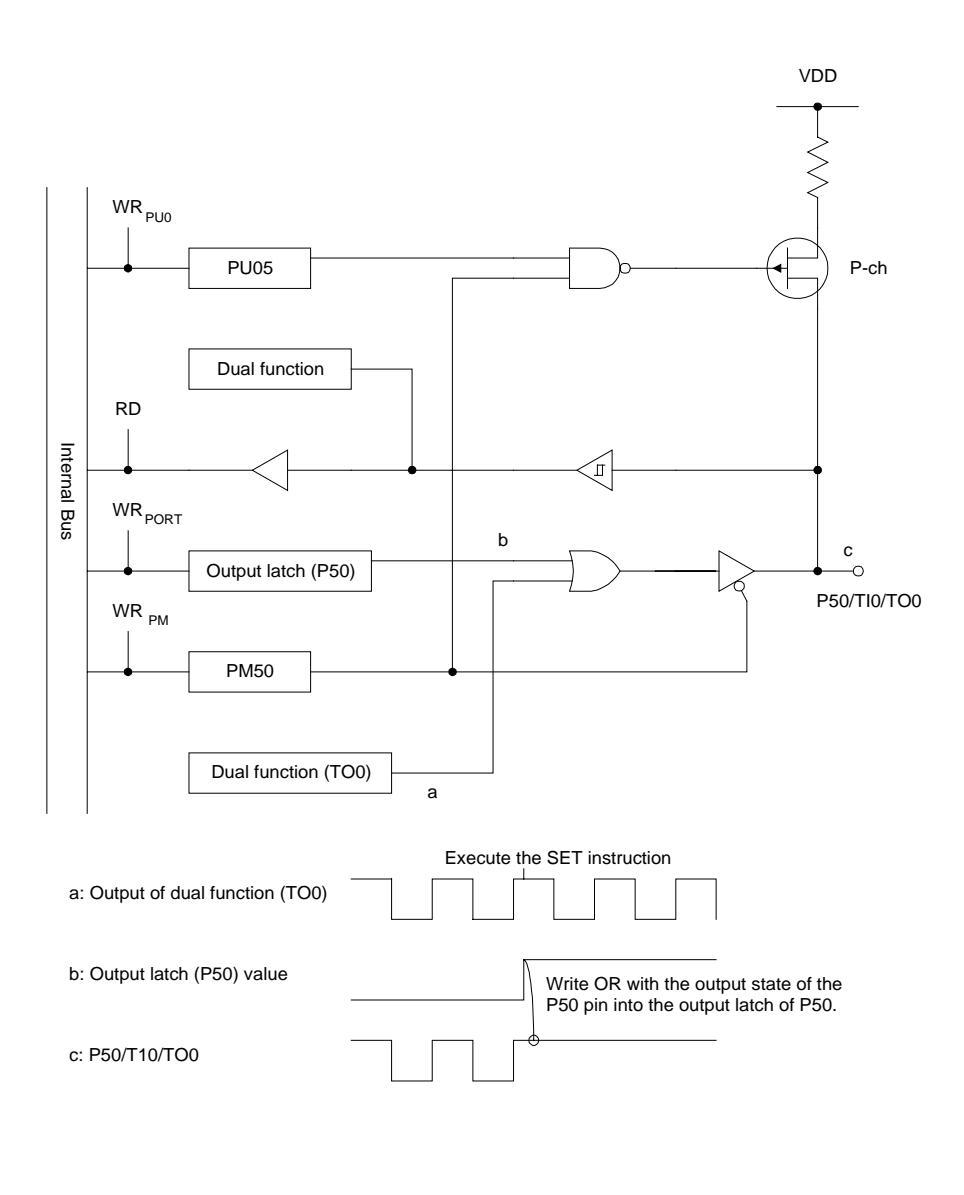
Figure P50 Block Diagram

- ① Uses P50 as the TO0 output to execute "SET1 PORT 5.2" while TO0 is outputting a high level.
- <sup>(2)</sup> The CPU reads all the pin statuses of Port 5 in response to the SET1 operating instruction, sets the relevant bit (P52 in this example) and writes the result to the latch of the Port 5.
- ③ When this SET1 instruction was executed, pin P50 was high level. This results in a high level being written to the output latch of P50, thus causing the pin's output to be fixed to high level. (When outputting TO0, it is necessary to set the output latch to low level first.)

Bug No.	Outline	Description
1	Bit and logical operation at ports 2 and 5	Details Avoid to use bit operation instructions and logical operation instructions on Ports 2 and 5(dual function pins). Instead of this, be sure to use 8 or 16- bit data transfer instructions to control output ports 2 and 5. Reason for operating precautions Executing bit operation instructions (SET1, CLR1) and logical operation instructions (OR, XOR, etc.) on the ports (2 and 5) which have the dual functions of timer output and serial interface may cause the contents of the dual function pins to be different from the expected values. This is because the bit operation instructions and logical operation instructions of the µPD789025, 789026 and 78F9026 are not for performing operations on the contents of the output latch but for performing operations on the status of the relevant pins. We have no plans to change the device circuits. For your reference, <b>Attachment 1</b> shows an example of executing the SET1 instruction on P52 causing P50 to be fixed to "H" and <b>Attachment 2</b> is listing the ports and instructions relevant to this precaution.
