# RENESAS TECHNICAL UPDATE

Product Category	MPU/MCU	Document No.	TN-RL*-A052A/E	Rev.	1.00
Title	Precaution of using High accuracy 1 Hz output		Information Category	Technical Notification	
Applicable Product	RL78/I1B Group R5F10Mxx	Lot No.	Reference Document	RL78/I1B User's Manual: Hardware Rev2.00 R01UH0407EJ0200(Mar 2014)	
		All lot

1-1. Precaution regarding the clock error correction register (SUBCUD) setting procedure when using the high accuracy 1 Hz output.

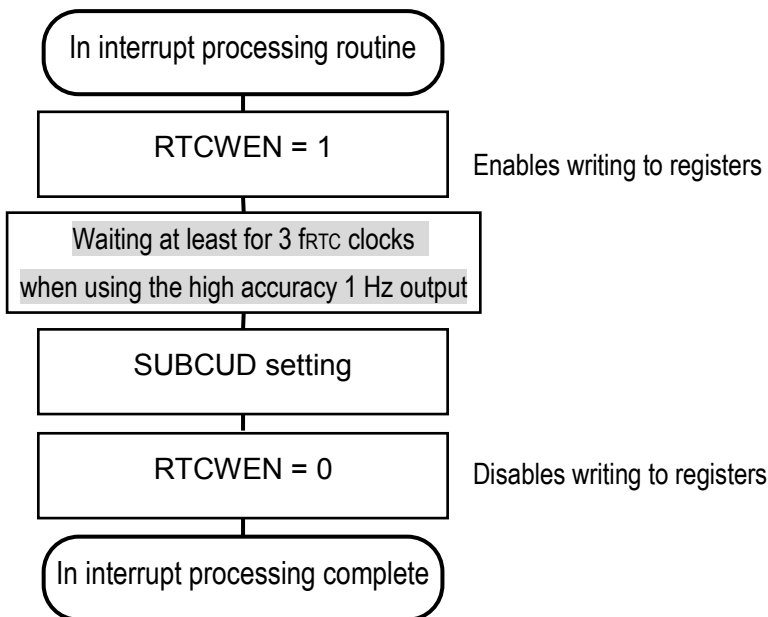
RTC correction may not be successful if there is a conflict between the SUBCUD register rewrite and correction timing. In order to prevent conflict between the correction timing and rewrite of the SUBCUD register, be sure to complete rewrite of the SUBCUD register before the next correction timing occurs (within approx. 0.5 seconds), which is calculated starting from the correction timing interrupt (INTRTIT) or periodic interrupt (INTRTC) that is synchronized with the correction timing.

**When using the high accuracy 1 Hz output and rewriting the SUBCUD register, rewrite the SUBCUD register after waiting at least for 3 fRTC clocks.**

(1) Set the clock error correction register (SUBCUD) after setting RTCWEN to 1 first. Then set RTCWEN to 0 after completion of the register setting.

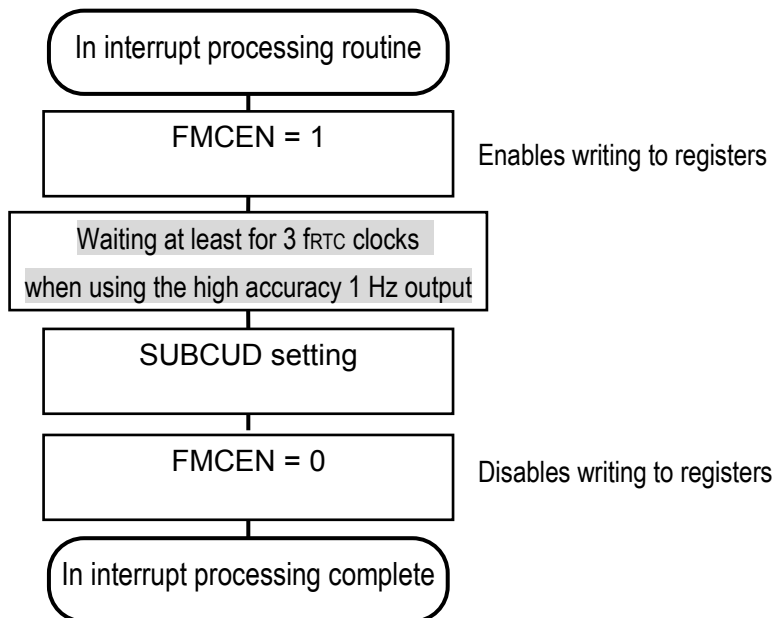
In order to prevent write error to the clock register, write privilege with (2) FMCEN is recommended for rewrite of the SUBCUD register.

(2) Set the clock error correction register (SUBCUD) after setting FMCEN to 1 first. Then set FMCEN to 0 after completion of the register setting.

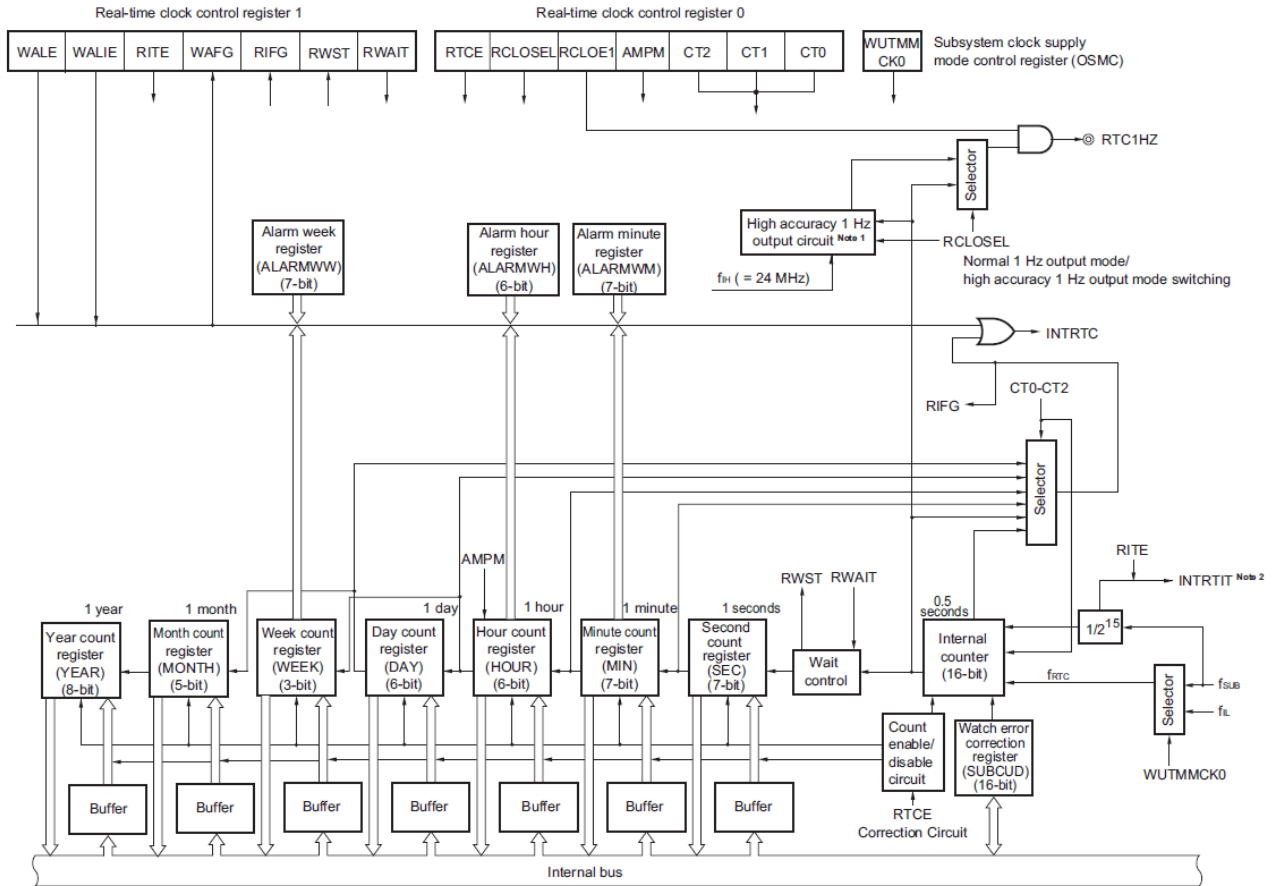
Figure 8-1. Real-time Clock 2 Diagram

1-2. Root correction of the INTRTIT in the Real-time Clock 2 Diagram

Incorrect :

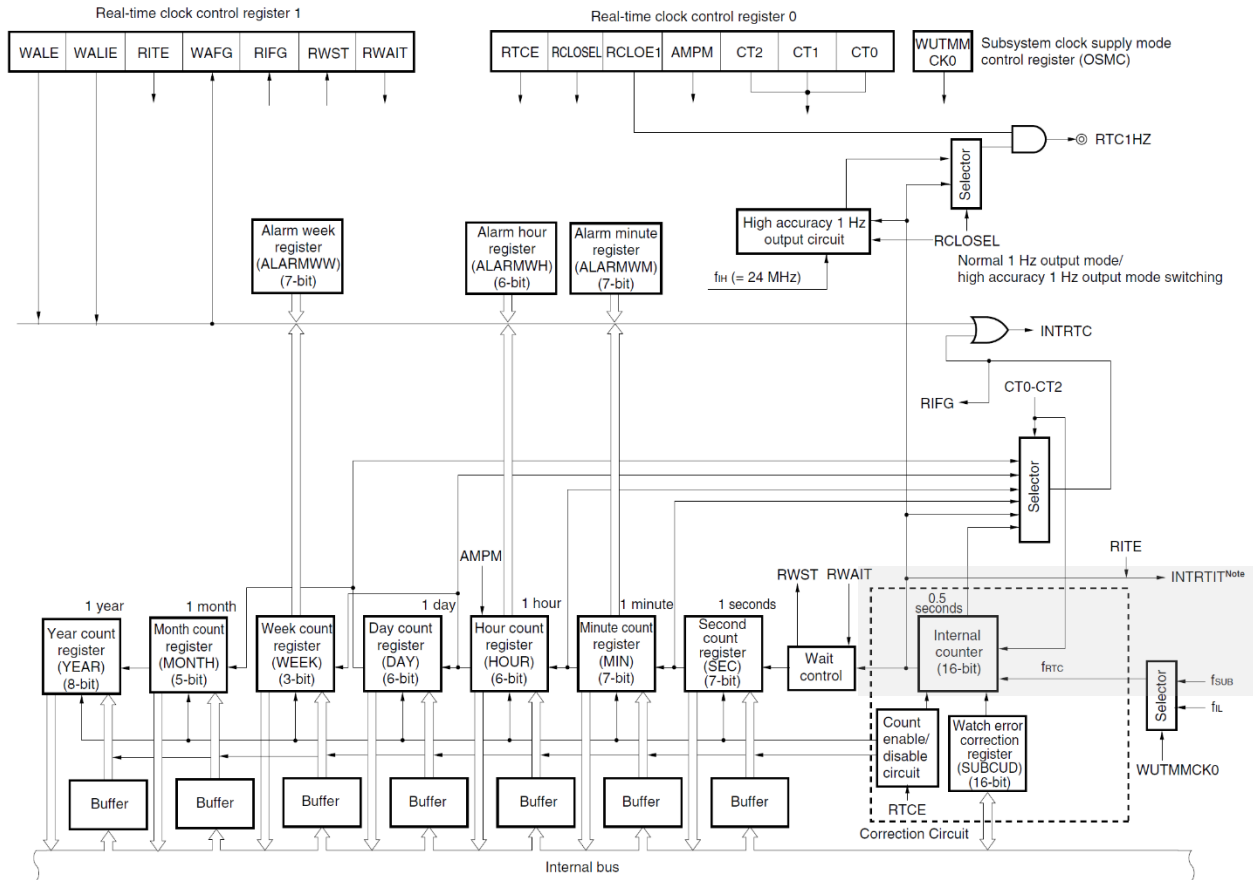
Figure 7-1. Real-time Clock 2 Diagram

Correct:

**Note** An interrupt that indicates the timing to get the correction value from the clock error correction register (SUBCUD). The fetch timing is 1 second ( $f_{SUB}$  base) interval.
