# RENESAS TECHNICAL UPDATE

Product Category	MPU/MCU		Document No.	TN-RX*-A0237B/E	Rev.	2.00
Title	RX230 Group, RX231 Group, RX23W Group Errata to User's Manual: Hardware Regarding the Realtime Clock (RTC)		Information Category	Technical Notification		
Applicable Product	RX230 Group, RX231 Group, RX23W Group	Lot No.	Reference Document	RX230 Group, RX231 Group User's Manual: Hardware Rev.1.20 (R01UH0496EJ0120) RX23W Group User's Manual: Hardware Rev.1.00 (R01UH0823EJ0100)		
		All

This document describes corrections to the "Realtime Clock (RTC)" chapter in User's Manual: Hardware for the applicable products.

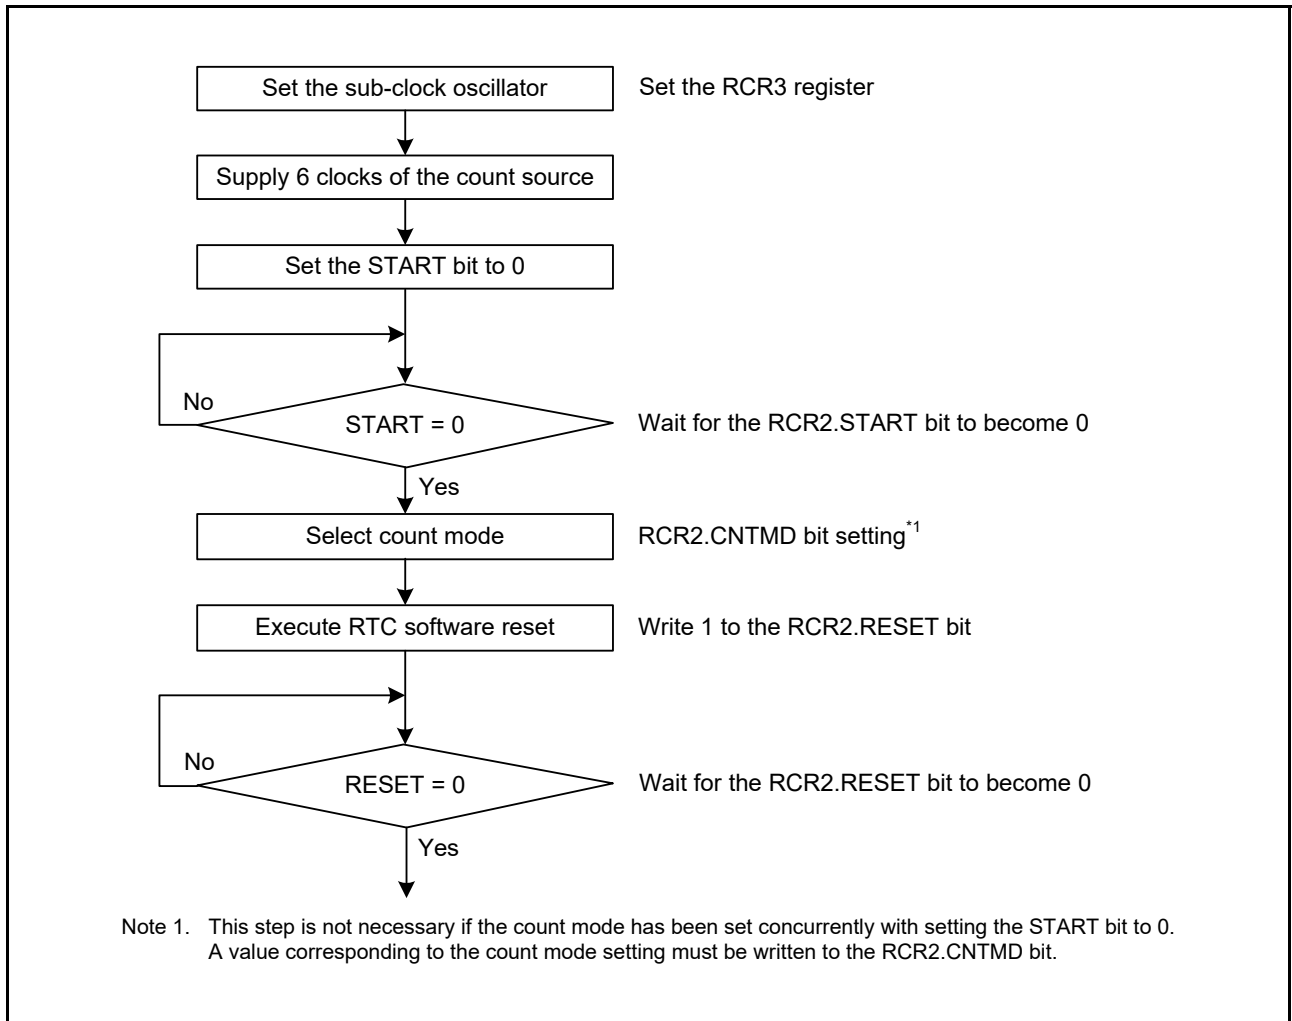
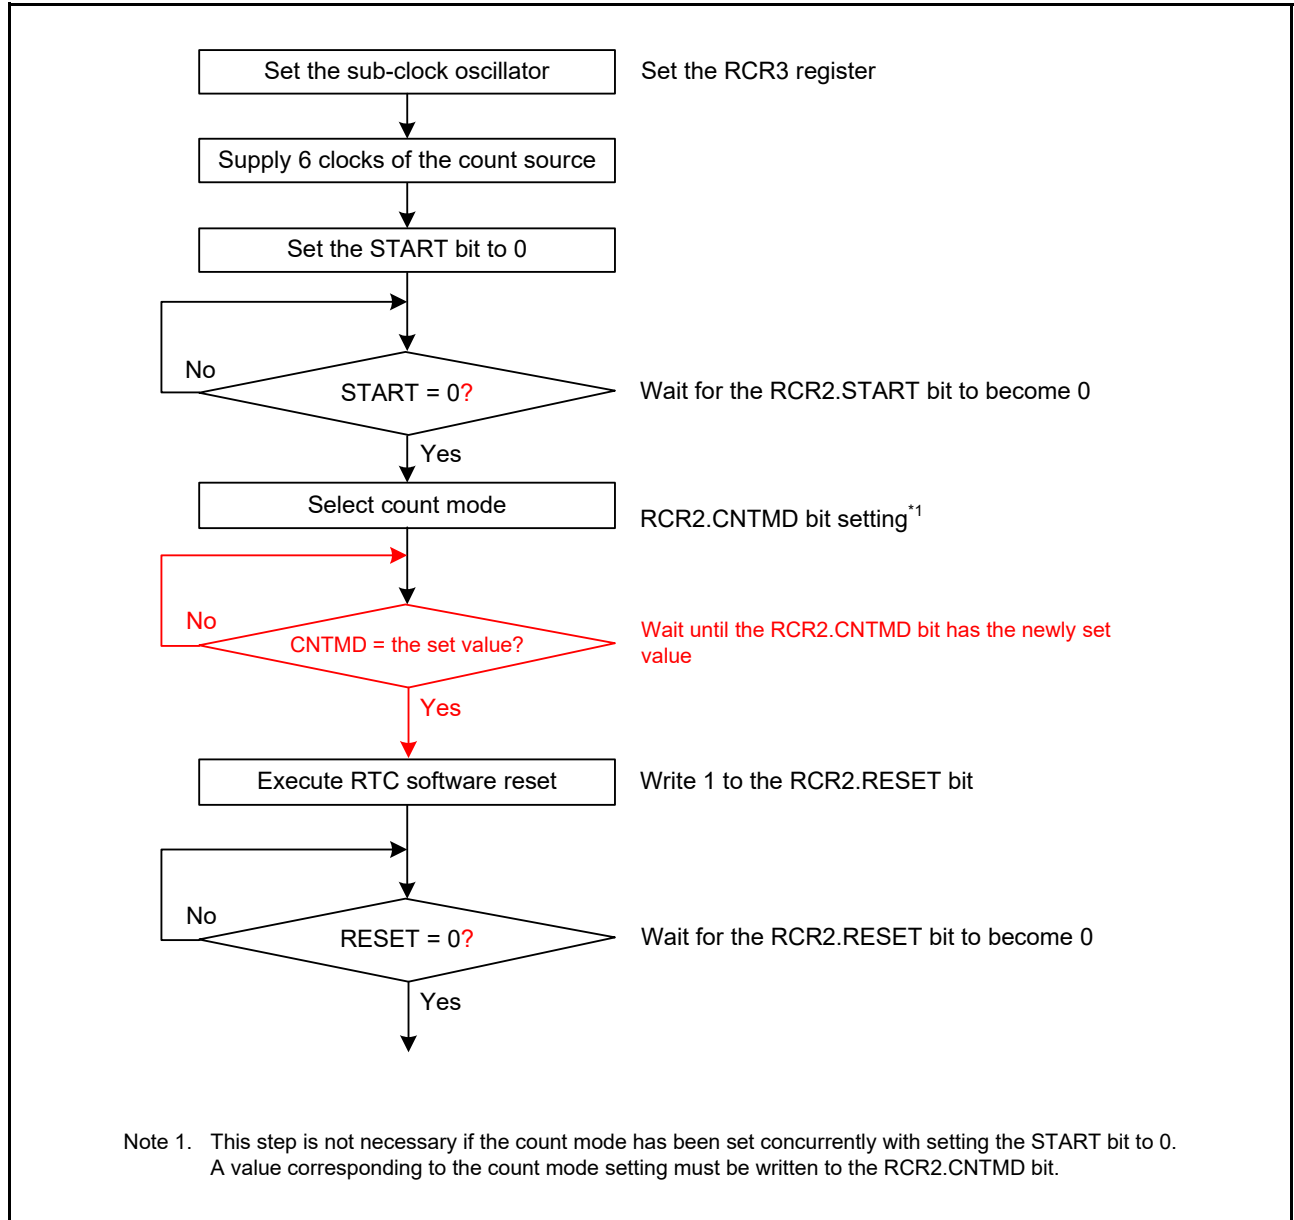
Figure 28.3 Clock and Count Mode Setting Procedure

The setting procedure described in Figure 28.3, Clock and Count Mode Setting Procedure is corrected as follows.

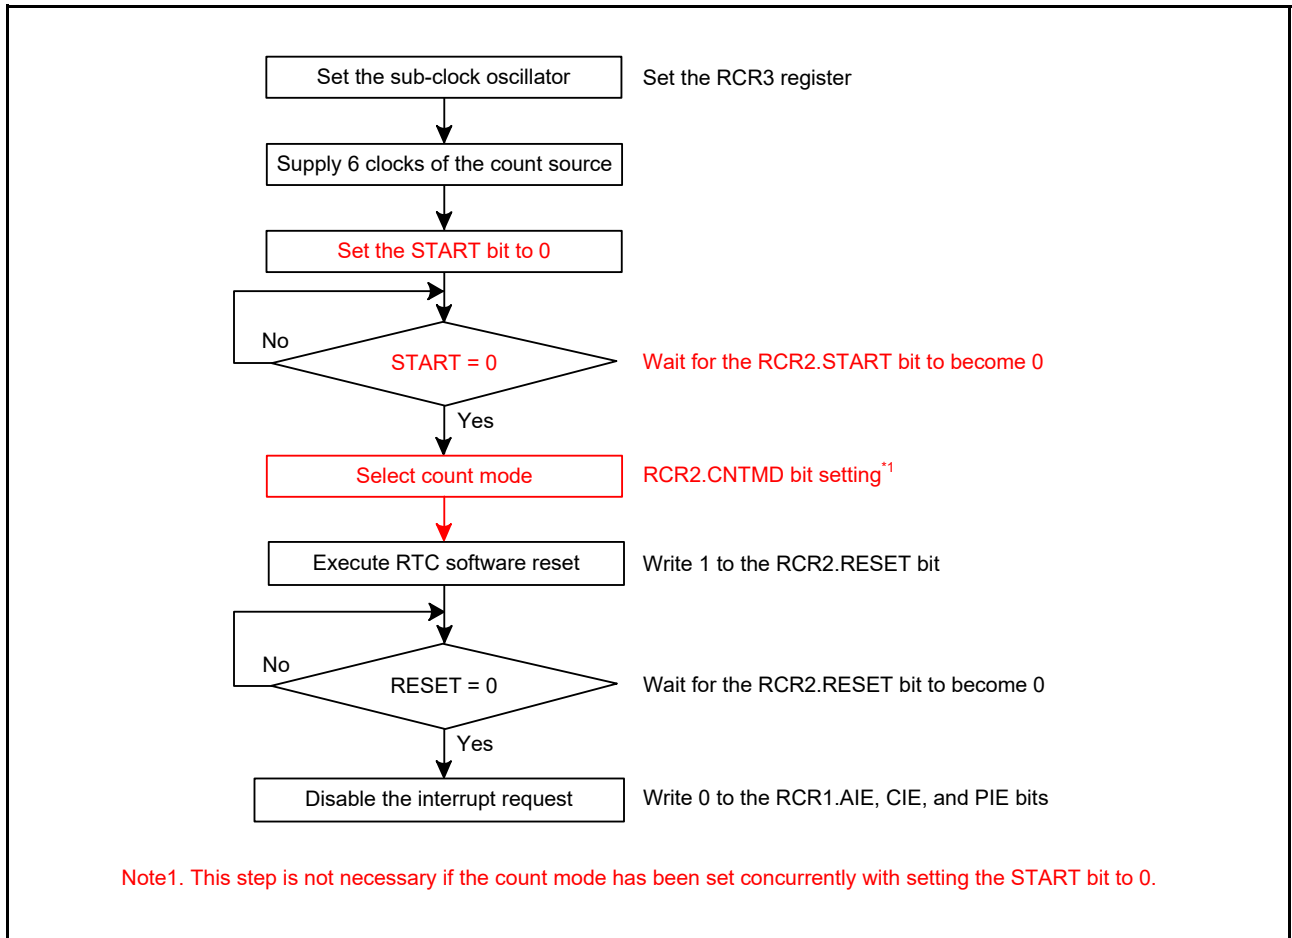
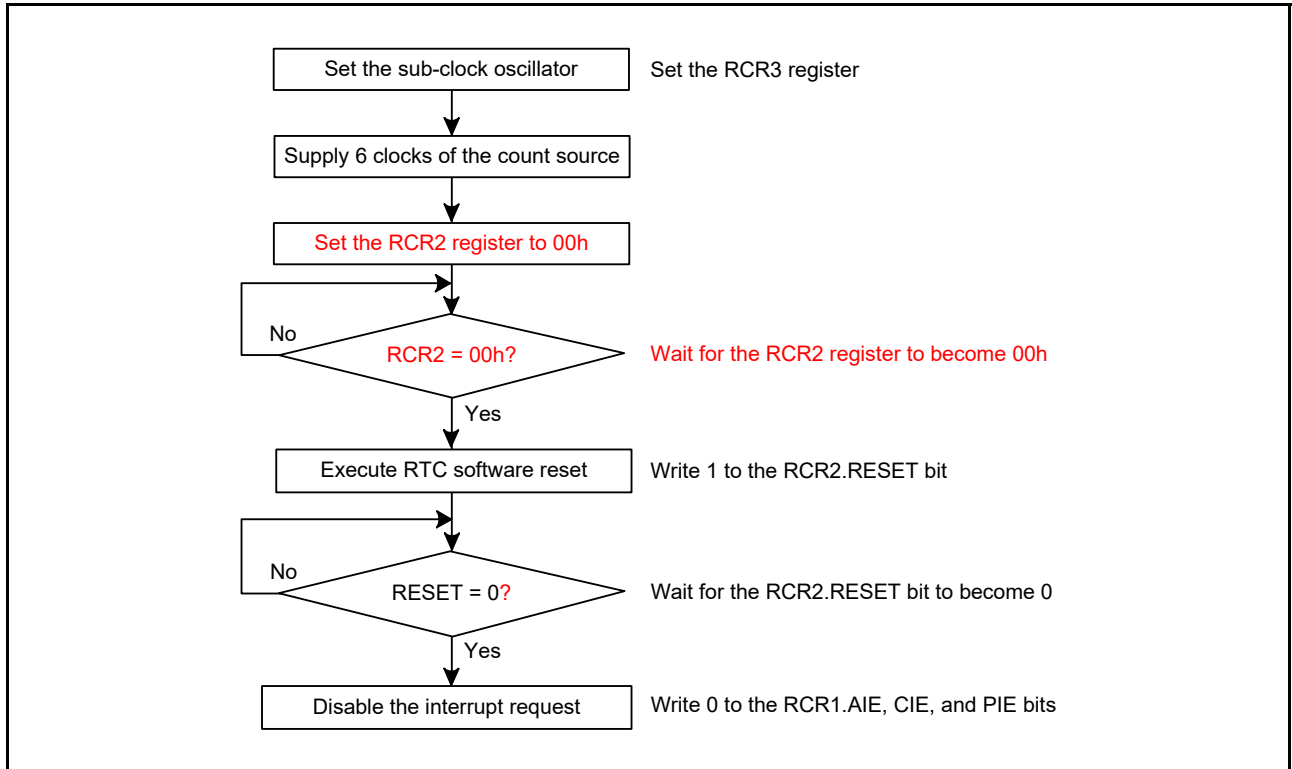
Figure 28.14 Initialization Procedure

The initialization procedure described in Figure 28.14 of section 28.6.7 Initialization Procedure When the Realtime Clock is Not to be Used is corrected as follows.
