Microcontroller Technical Information

SM+ for 78K0R System Simulator for 78K0R Usage Restrictions	Document No.	ZBG-CD-08-0037	1/1
	Date issued	September 25, 2008	
	Issued by	Development Tool Solution Group Multipurpose Microcomputer Systems Division Microcomputer Operations Unit NEC Electronics Corporation	
Related documents SM+ System Simulator Operation: U18601EJ1V0 (1st edition) SM+ System Simulator User Open Interface: U18212EJ2V0 (2nd edition)	Notification classification	√	Usage restriction
			Upgrade
			Document modification
			Other notification

SM+ for 78K0R Ver. 2.21

Restrictions on SM+ for 78K0R

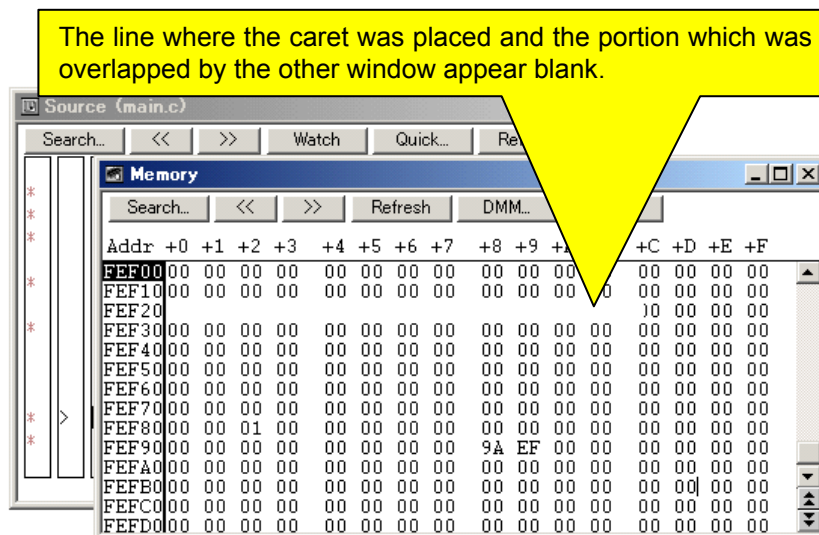
No. 24 Restriction that the display partially appears blank in Memory window

When the Memory window is displayed in front of another window, if the window behind the Memory window is clicked to the front and then the Memory window is clicked to the front again, the line where the caret was placed and the portion which was overlapped by the other window appear blank in the Memory window.

Click the [Refresh] button or click on the blanked line to restore the original display.

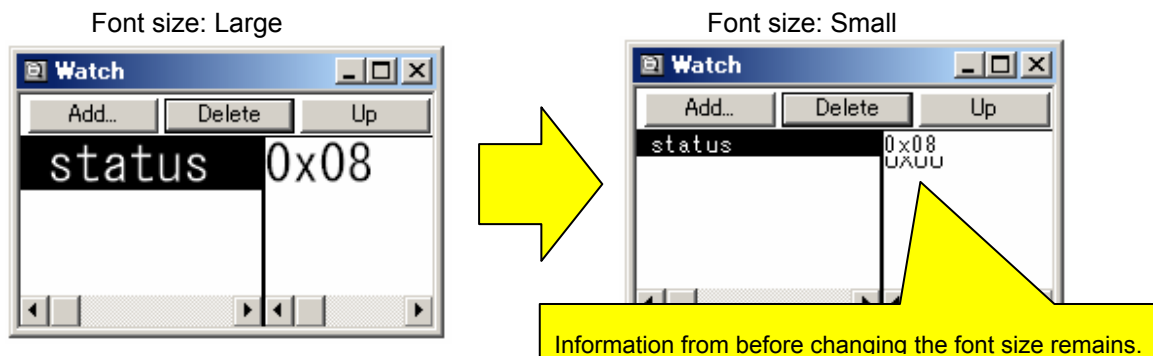
No. 26 Restriction on changing font size

The font size in the Watch window and Local Variable window can be specified in the [Font] area in the Debugger Option dialog box, which is opened by selecting the [Option] menu → [Debugger Option...], but if the font size is reduced, information from before changing the font size remains in the window.

Example of Watch window:

When such a case occurs, minimize the window once and then restore the window size, or close the window once and then open it again.

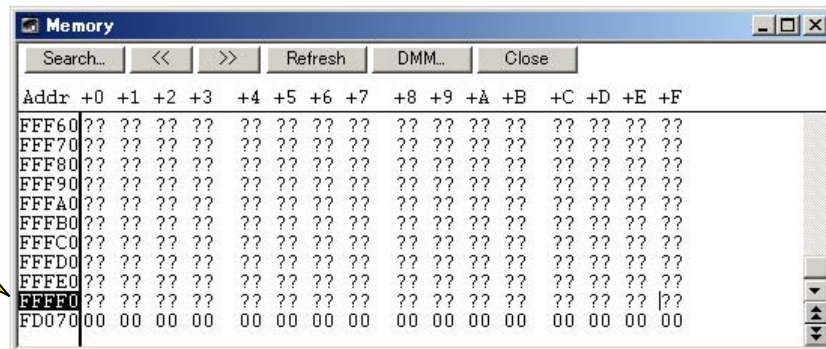
No. 30 Restriction on move via Address Move dialog box

If the Address Move dialog box is opened by selecting the [Move] command from the context menu (right-click menu) in the Memory window and the last address (0xffff) is input, an extra line may be displayed.

An extra line may be displayed.

Do not move to address 0xffff. (This address is in the SFR area, so displaying this area in the Memory window is meaningless.)

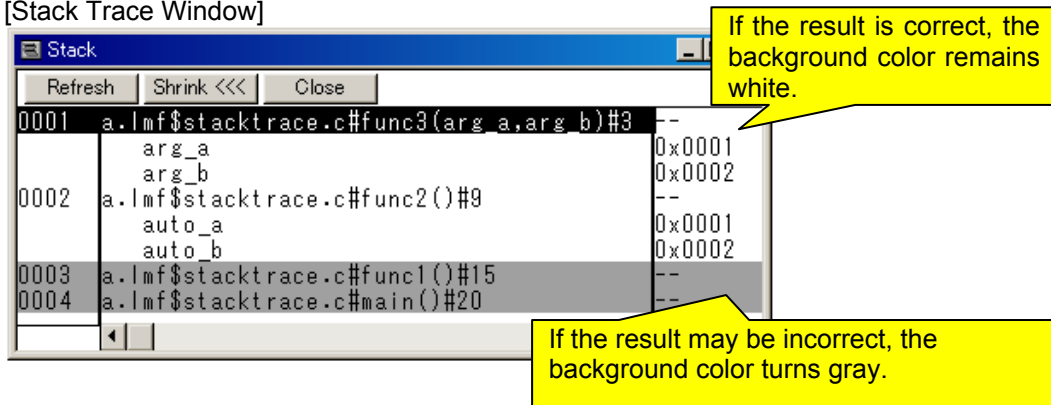
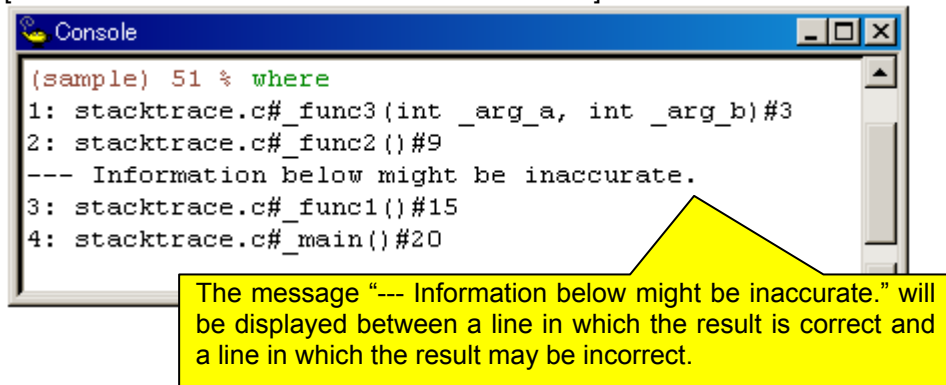
No. 33 Restriction on Stack window

Whether the result of tracing by the stack trace function is correct varies depending on the state of the stack. Following this correction, the specification of the view will be changed as follows.

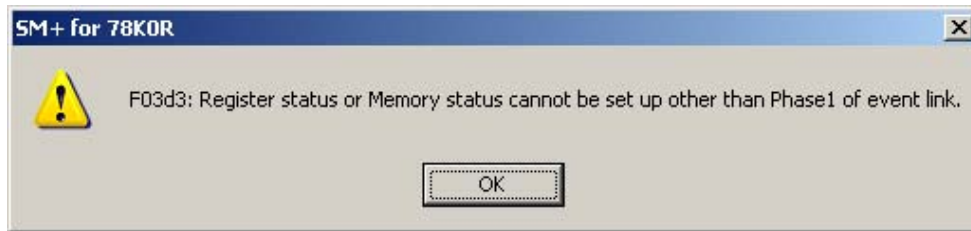
No. 34 Restriction on event links

If an event is created with "Register" or "Memory" specified from the Event Status drop-down list in the Event dialog box, only Phase 1 can use this event as an event link condition. The event can be specified for Phase 2 and later, but does not operate normally.

The following error will occur if the above setting is performed in the corrected version.

Do not set such events as the event link condition [Phase2] or later.

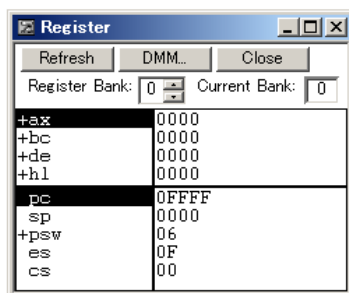
No. 35 Restriction on changing Register window size

When the size of the Register window is changed, the project is saved and the project is reloaded, and the position of the split bar may not be restored. Consequently, the contents of some registers may be hidden.

The position of this bar may not be restored.

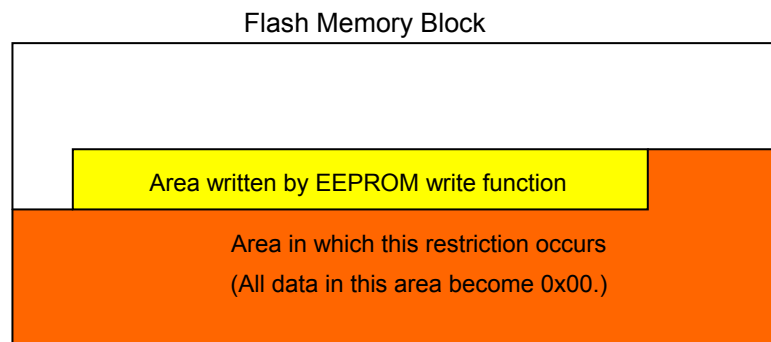
- (1) When the Blank Check function (FlashBlockBlankCheck) is executed while the maximum block number prescribed in the target device is specified as “the number of a block to be checked for blank check”, which is specified for an argument, a blank check error occurs (return value: 0x1b), even if the specified block is blank.
- (2) When the EEPROM Write function (EEPROMWrite) is executed, writing is performed from the write start address, which is specified for an argument, for the amount of written data. At this time, if the write start address and the last address of written data are in the same block, all data in that block and data at addresses later than the written block will become 0x00 (see the figure below).

There is no workaround for (1) and (2).

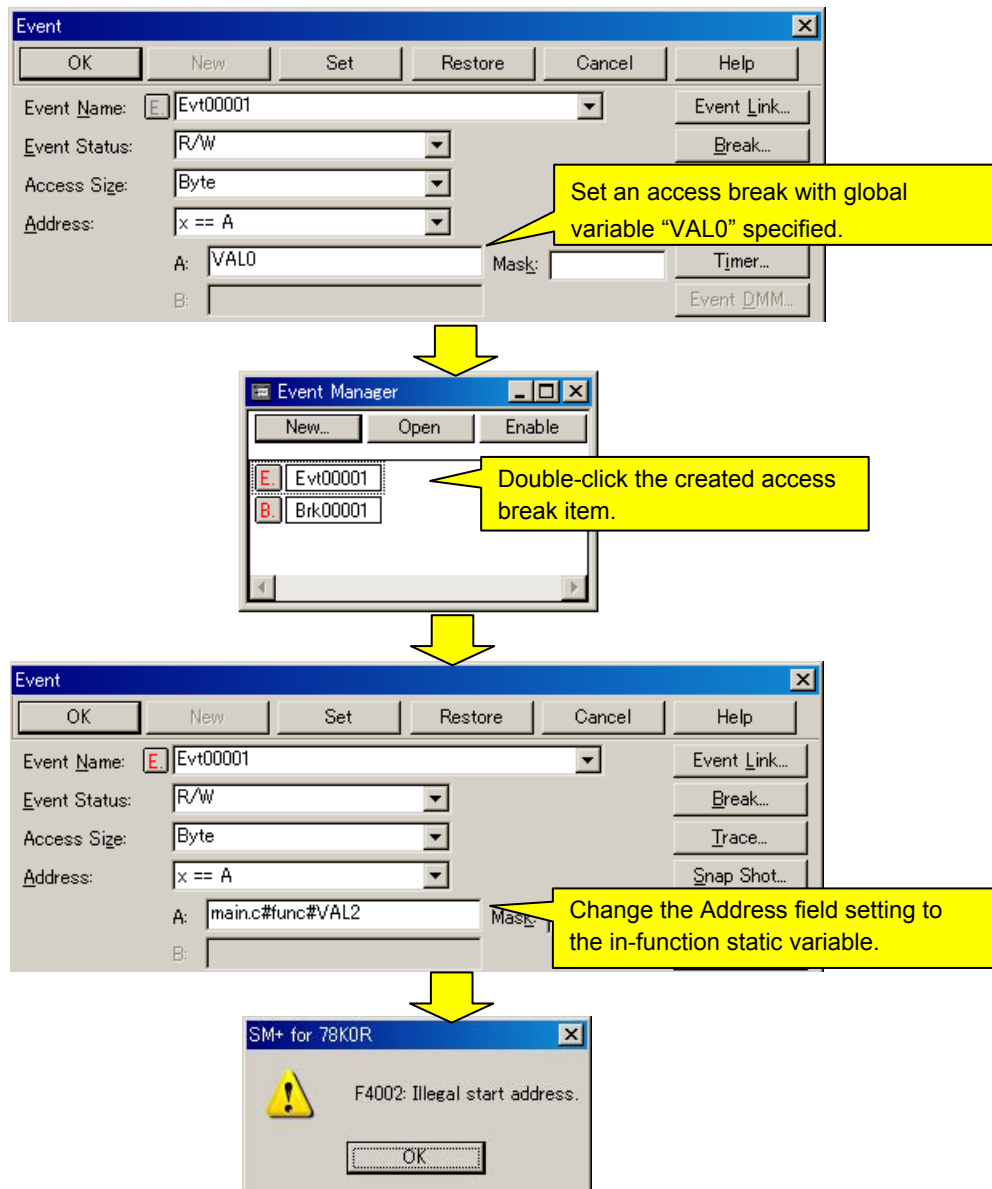
When changing an access break setting in the Event dialog box with an in-function static variable specified in the [Address] field, the error message “F4002: Illegal start address” or “F4003: Illegal end address” is displayed and setting change fails. An example is shown in the figure below.

Delete the break point and create a new access break point.

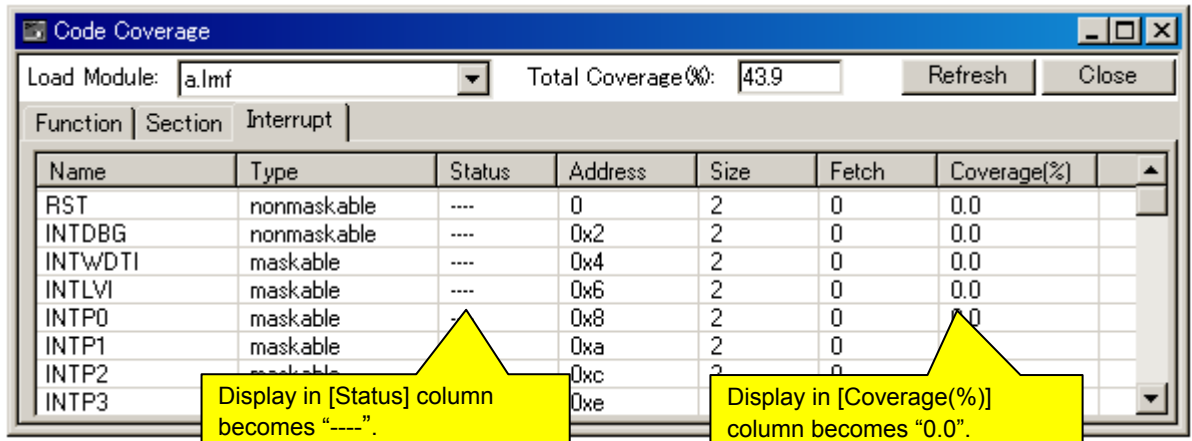
Value "0.0" is displayed in the [Coverage(%)] column on the [Interrupt] tab in the Code Coverage window, regardless of the occurrence of interrupts. In addition, "----" is displayed in the [Status] column on the [Interrupt] tab, regardless of the use of interrupt functions.

The [Interrupt] tab is used to check the occurrence of interrupts, but the occurrence can also be checked by referring to the [Function] tab for the coverage of the function corresponding to the interrupt.

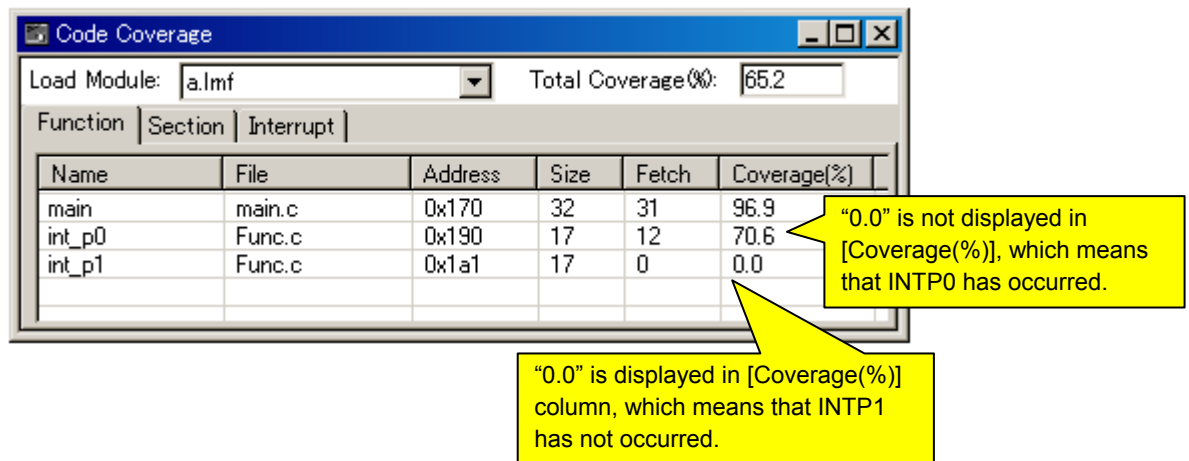
Example When interrupt INTP0 is defined as function "int_p0" and INTP1 as function "int_p1"

- When 0.0 is displayed in [Coverage(%)]: Interrupts have not occurred.
- When a value other than 0.0 is displayed in [Coverage(%)]: Interrupts have occurred.

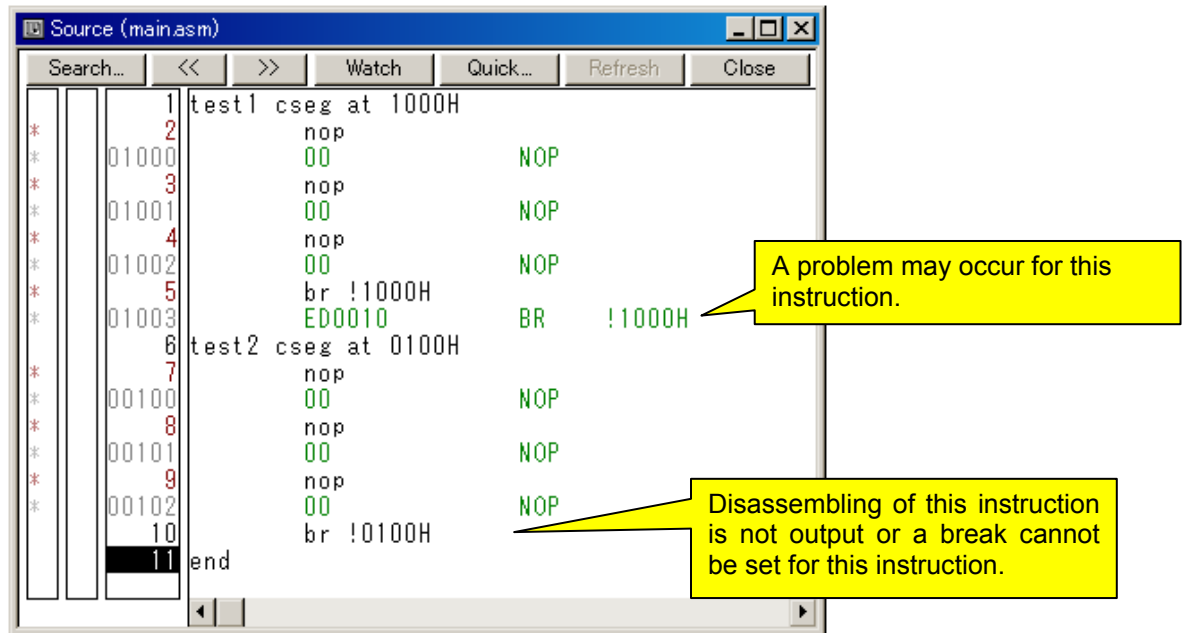
If either of absolute expression CSEG AT or ORG is used in an assembler source file and instructions are allocated to multiple absolute addresses, the following problems may occur at the last instruction.

- Breakpoints cannot be set
- Mixed display is not available

- (1) Two or more absolute addresses are specified in an assembler source file.
- (2) The absolute address specified nearer to the top of the file is smaller than that specified further from the top of the file. (In the above example, *test1*, which is nearer to the top of the file, is allocated to address 1000H, and *test2*, which is further from the top of the file, is allocated to address 0100H, which causes a problem.)

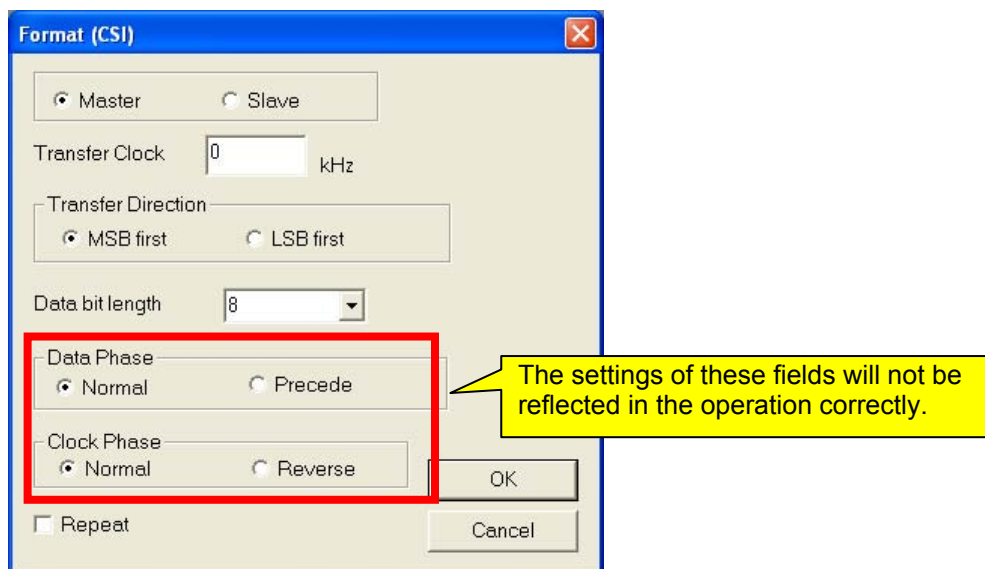
When the Serial window is used in the CSI master mode, the settings of the Data Phase and Clock Phase fields in the [Format (CSI)] dialog box will not be reflected in the waveform output from the Serial window. As a result, transmission and reception are not performed correctly.

There is no workaround.
