A Note on Using Emulator Debugger M3T-PD32RM V.1.00 Release 1

M3T-PD32RM V.1.00 Release 1

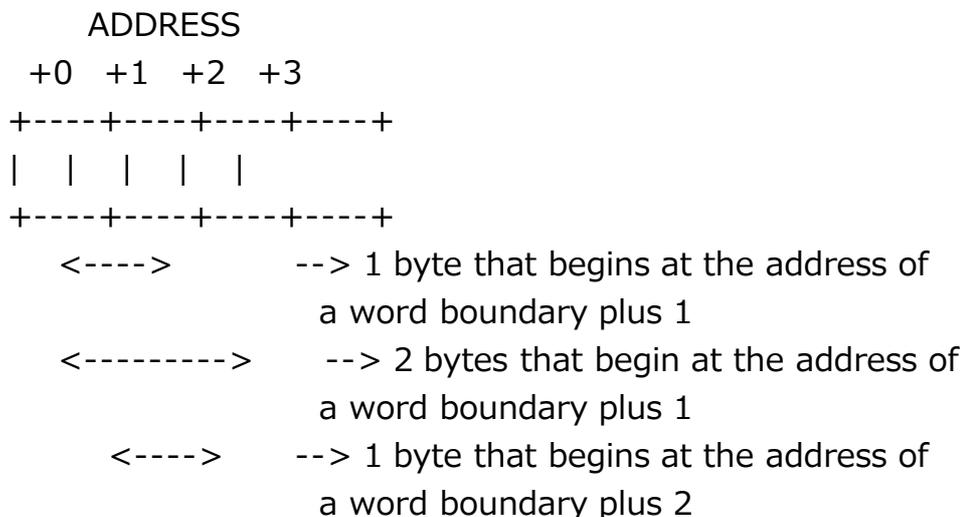
Target programs (load modules) may not be downloaded.

(1) A target program is downloaded into the RAM area.

(2) The beginning address and length of each data block are such as shown below.

This problem can be circumvented by using the problem-fixed firmware.

- (1) Download the M32RCPE0.S file (Ver.0.00.23). (File name: m32rcpe0.zip, Size: 39.5KB)
- (2) Decompress the downloaded file to obtain the m32rcpe0.s file.
- (3) With the decompressed m32rcpe0.s file, overwrite the old m32rcpe0.s file in the folder where the pd32rm.exe file resides.
- (4) Launch the M3T-PD32RM, and you see the message "We should download new firmware". Then press the OK button. This message is displayed at the first launch only.
- (5) Confirm the version of the new firmware.
 - (i) Restart the M3T-PD32RM.
 - (ii) Open the Help menu and select About; then the version of the problem-fixed firmware shown below will be displayed.
