[Notes]

R20TS0622EC0100  
Rev.1.00  
Oct. 01, 2020

CS+ Code Generator for RH850,  
AP4 Coding Assistance Tool for RH850

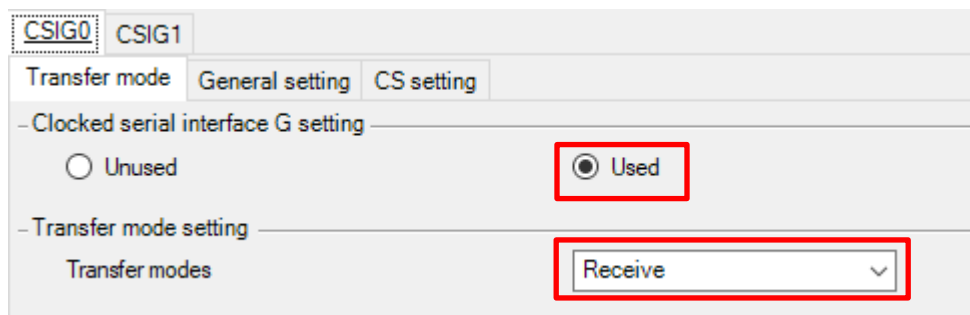
#### ■ GUI configuration when using receive mode on CSIG0

When using CSIG and receive mode or transmit/receive mode selected on the following peripherals, transmission processing will not work from the second time because the variable of receive count initialization is incorrect.

- RH850/F1K: 100-pin products  
CSIG0
- RH850/F1K: 144-pin, 176-pin products  
CSIG0, CSIG1

Manually modify the variable name of receive count from “g\_<csign>\_tx\_num” to “g\_<csign>\_rx\_num” in the following source file <sup>(Note)</sup>. <csign> varies depending on the selected peripheral.

- Source file: “r\_cg\_csig.c”.
- Function: “MD\_STATUS R\_<CSIGn>\_Receive (uint16\_t\* rx\_buf, uint16\_t rx\_num)”

Note: If code is generated again, the previous state is restored. Modification is necessary each time you perform code generation.
