R20TS0747EC0100  
Rev.1.00  
Sep. 16, 2021

CS+ Code Generator for RH850,  
AP4 Coding Assistance Tool for RH850

1. Notes on using CSIH Master receive and Master transmit/receive operation mode

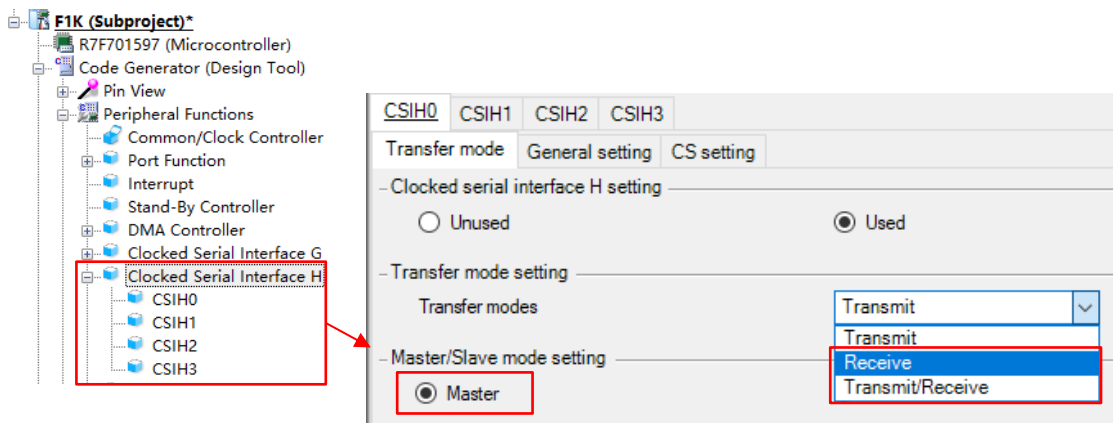
Figure 1-1 Setting of CSIH operation mode

When using CSIH as Master “Receive” and Master “Transmit/Receive” mode (refer to figure 1-1), master can only receive the first data correctly. From the second data, master fails to receive.

- RH850/F1K:  
CSIH0, CSIH1, CSIH2, CSIH3

User can manually modify the register setting code in the following source file

- Source file: “r\_cg\_csih\_user.c”.
- Function: “void r\_<csihn>\_interrupt\_receive (void)”

```
void r_Config_CSIH0_interrupt_receive(void)
{
    uint8_t err_type;
    uint16_t temp;
    .....
    else
    {
        temp = g_csih0_rx_total_num;
        if (temp > g_csih0_rx_num)
        {
            *gp_csih0_rx_address = CSIH0.RX0W;
            gp_csih0_rx_address++;
            g_csih0_rx_num++;
            CSIH0.TX0W |= 0U;          --> change "=" to "|="
        }
        .....
    }
}
```
