[Notes]

R20TS0747EC0100

CS+ Code Generator for RH850,
AP4 Coding Assistance Tool for RH850

- Notes on using CSIH Master receive and Master transmit/receive operation mode

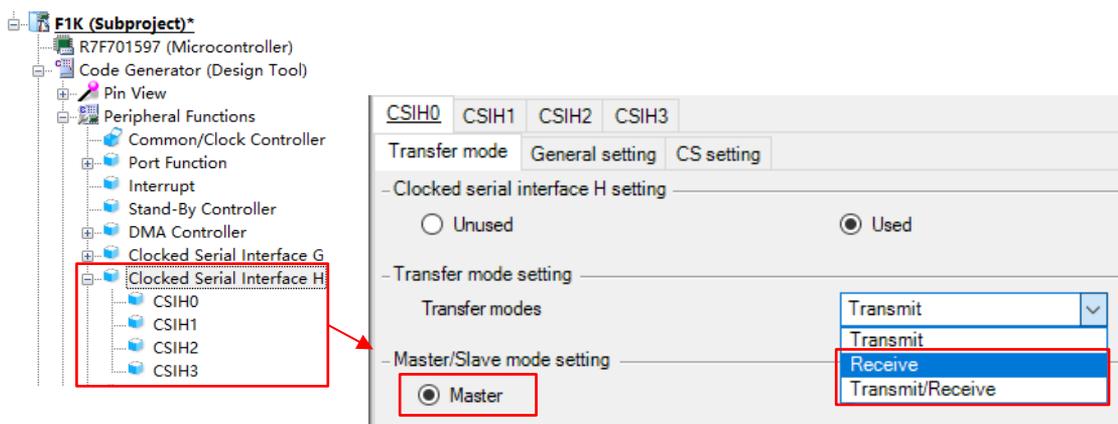
Figure 1-1 Setting of CSIH operation mode

When using CSIH as Master “Receive” and Master “Transmit/Receive” mode (refer to figure 1-1), master can only receive the first data correctly. From the second data, master fails to receive.

- RH850/F1K:
CSIH0, CSIH1, CSIH2, CSIH3

User can manually modify the register setting code in the following source file

- Source file: “r_cg_csih_user.c”.
- Function: “void r_<csihn>_interrupt_receive (void)”

The following is an example of the required modification when *<csih>* is CSIH0 in the RH850/F1K group. The code in red color is wrong code before modification, while the code in blue color is correct code after modification.

```
void r_Config_CSIH0_interrupt_receive(void)
{
    uint8_t err_type;
    uint16_t temp;
    .....
    else
    {
        temp = g_csih0_rx_total_num;
        if (temp > g_csih0_rx_num)
        {
            *gp_csih0_rx_address = CSIH0.RX0W;
            gp_csih0_rx_address++;
            g_csih0_rx_num++;
            CSIH0.TX0W |= 0U;          --> change "=" to "|="
        }
        .....
    }
}
```
