[Notes]

R20TS0523EJ0100

# CS+ Code Generator for RX, e<sup>2</sup> studio Code Generator Plug-in, AP4 Coding Assistance Tool for RX

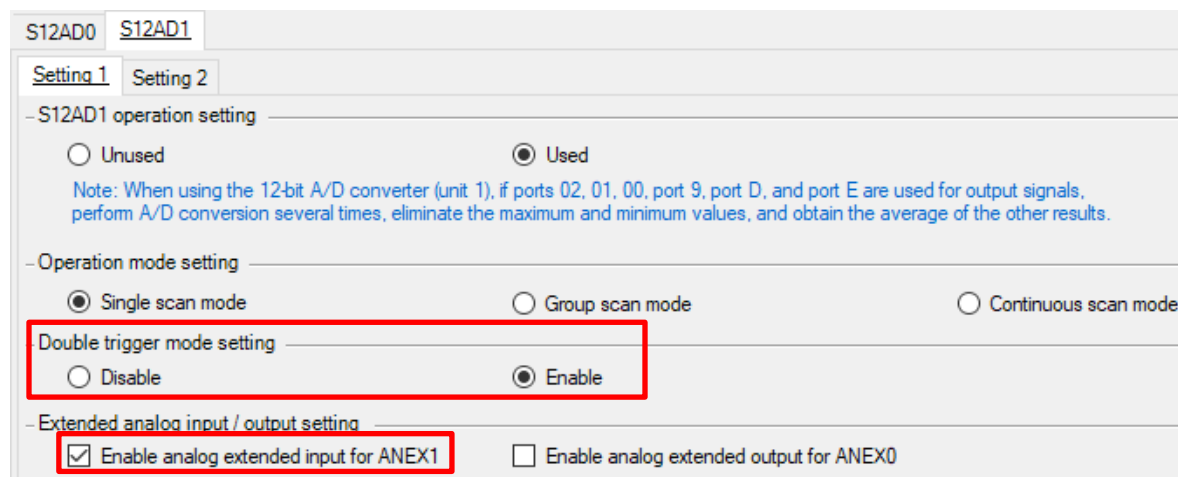
Error location

When using Double trigger mode on Single Scan Mode component of the 12-bit A/D converter, “Enable analog extended input for ANEX1” is still available for configuration even though it cannot be used simultaneously.

Do not select [Enable analog extended input for ANEX1] when using double trigger mode.
