Smart Configurator for RH850

Outline

When using Smart Configurator for RH850, note the following points.

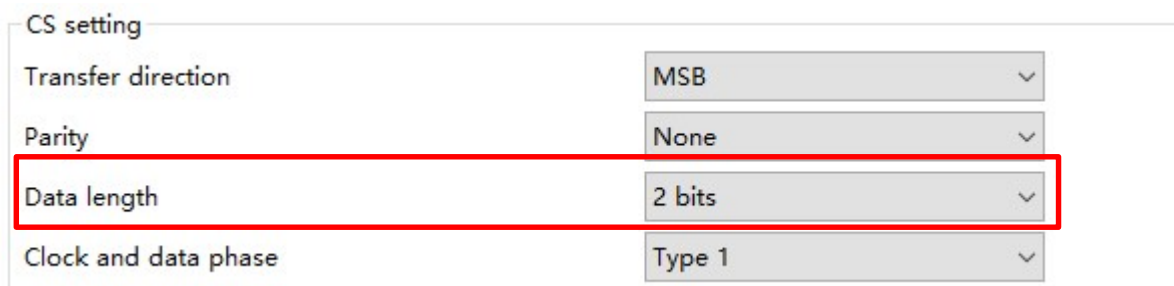
When using CSI master mode and CSI Slave mode on the following peripherals, data transmission occurs error when data length are selected as “2 bits”, “3 bits”, “4 bits”, “5 bits” and “6 bits” on GUI (refer to Figure 1-1 Setting of CSI Master Data length and Figure 1-2 Setting of CSI Slave Data length).

- RH850/F1KM-S1: 48-pin, 64-pin, 80-pin, 100-pin products
CSIG0
- RH850/F1KM-S4: 100-pin products
CSIG0
- RH850/F1KM-S4: 144-pin products
CSIG0, CSIG1
- RH850/F1KM-S4: 176-pin, 233-pin products
CSIG0, CSIG1, CSIG2, CSIG3

Please don't select data length as "2 bits", "3 bits", "4 bits", "5 bits" and "6 bits" on CSI Master and CSI slave GUI when using CSIG.

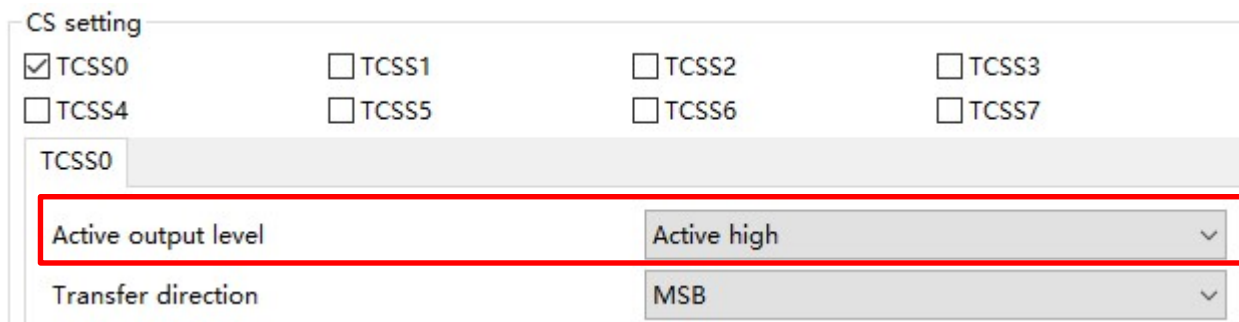
Figure 2-1 Setting of Active output level

When using CSI mater mode on the following peripherals and specifying "High level" as CS active signal (refer to Figure 2-1 Setting of Active output level), the data transmission with slave device failed.

- RH850/F1KM-S1: 48-pin, 64-pin products
CSIH0
- RH850/F1KM-S1: 80-pin products
CSIH0, CSIH1, CSIH2
- RH850/F1KM-S1: 100-pin products
CSIH0, CSIH1, CSIH2, CSIH3
- RH850/F1KM-S4: 100-pin, 144-pin, 176-pin, 233-pin products
CSIH0, CSIH1, CSIH2, CSIH3

User can manually modify the register setting code in the following source file

- Source file: "<Configuration-name>.c".
- Function: "void R_<Configuration-name>_Create (void)"

CSIH0.CTL0 = _CSIH_OPERATION_CLOCK_STOP;
    .....
    /* Set CSIH0 control setting */
    CSIH0.CTL1 = _CSIH_INTERRUPT_TIMING_NORMAL |
    _CSIH_DATA_CONSISTENCY_CHECK_DISABLE | _CSIH_HANDSHAKE_DISABLE |
    _CSIH_SLAVE_SELECT_DISABLE | _CSIH_CHIPSELECT0_ACTIVE_HIGH;
    .....
}

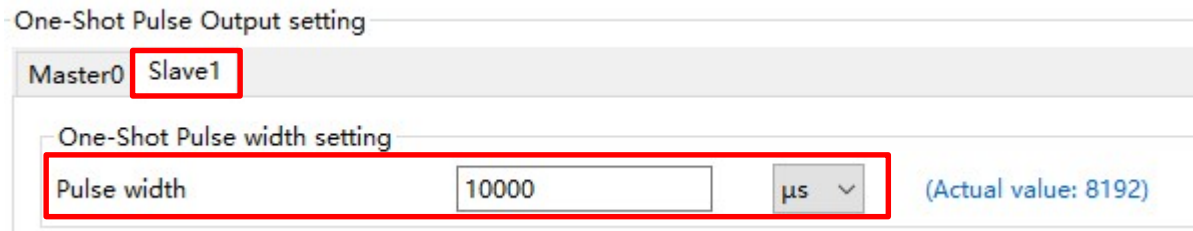
Figure 4-1 Setting of One-shot pulse width

When using One-Pulse Output and One-Shot Pulse Output on the following peripherals, the actual output pulse width has one count clock cycle error due to wrong value is set to timer data register.

- RH850/F1KM-S1: 48-pin, 64-pin products
TAUD0
- RH850/F1KM-S1: 80-pin, 100-pin products
TAUB0, TAUD0
- RH850/F1KM-S4: 100-pin, 144-pin products
TAUB0, TAUD0
- RH850/F1KM-S4: 176-pin, 233-pin products
TAUB0, TAUB1, TAUD0
- RH850/U2A16 (292-pin and 516-pin products)
TAUD0, TAUD1, TAUD2
- RH850/U2A8 (292-pin product)

Step1: User can config a One-Shot Pulse Output function, including “One-shot pulse width setting” of slave channel (refer to Figure 4-1 Setting of One-shot pulse width).

Step2: Click “Generate Code” and check the following macro value in “Config_TAUB0.h” file, the value in red need to be confirmed.

Step3: If user find the actual One-shot pulse width output in his own system is not as expected 10000 us, user can increase this macro value by “1”, as the following value in blue.

/*****
Macro definitions
*****/
#define _TAUB0_CHANNEL0_COMPARE_VALUE          (0x270FU)
#define _TAUB0_CHANNEL1_COMPARE_VALUE          (0x2710U)

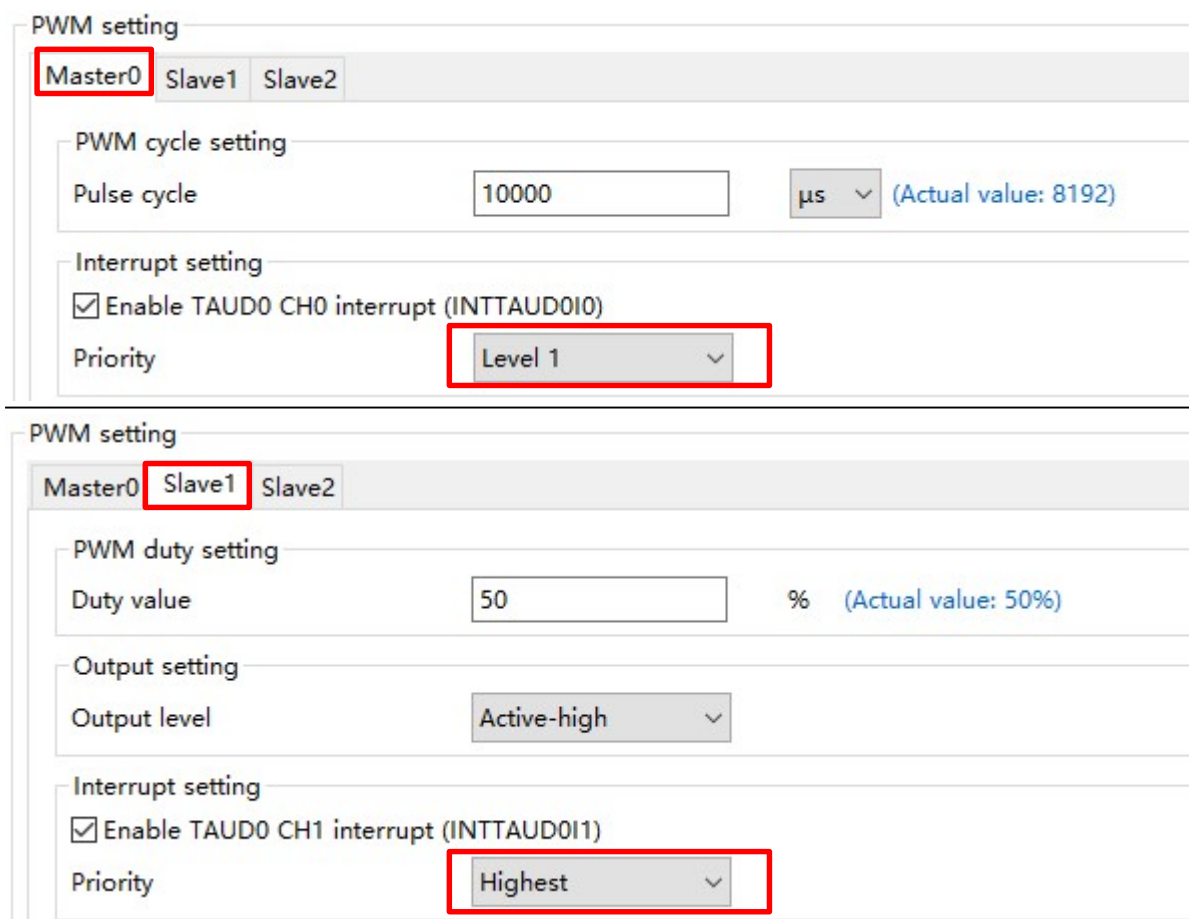
Figure 5-1 Setting of master and slave interrupt priority

When using PWM Output and Triangle PWM Output on the following peripherals, the slave channel interrupt priority is always same as master channel even though user has set different priority level on GUI (refer to Figure 5-1 Setting of master and slave interrupt priority).

- RH850/F1KM-S1: 48-pin, 64-pin, 80-pin, and 100-pin products
TAUD0
- RH850/F1KM-S4: 100-pin, 144-pin, 176-pin, and 233-pin products
TAUD0

User can manually modify the register setting code in the following source file: change the slave channel interrupt priority macro to the priority which is set on GUI. The interrupt priority macro name can be found in “`¥smc_gen¥general¥r_cg_macrodriver.h`” file.

- Source file: “<Configuration-name>.c”.
- Function: “void R_<Configuration-name>_Create (void)”

/* Set INTTAUD0I0 setting */
    INTC1.ICTAUD0I0.BIT.TBTAUD0I0 = _INT_TABLE_VECTOR;
    INTC1.ICTAUD0I0.UINT16 &= _INT_PRIORITY_LEVEL1;
    /* Set INTTAUD0I1 setting */
    INTC2.ICTAUD0I1.BIT.TBTAUD0I1 = _INT_TABLE_VECTOR;
    INTC2.ICTAUD0I1.UINT16 &= _INT_PRIORITY_HIGHEST;
