RENESAS TECHNICAL UPDATE

Product Category	MPU/MCU		Document No.	TN-RX*-A0238B/E	Rev.	2.00
Title	RX113 Group, RX130 Group Errata to User's Manual: Hardware Regarding the Realtime Clock (RTC)		Information Category	Technical Notification		
Applicable Product	RX113 Group, RX130 Group	Lot No. All	Reference Document	RX113 Group User's Manual: Hardware Rev.1.20 (R01UH0448EJ0120) RX130 Group User's Manual: Hardware Rev.3.00 (R01UH0560EJ0300)

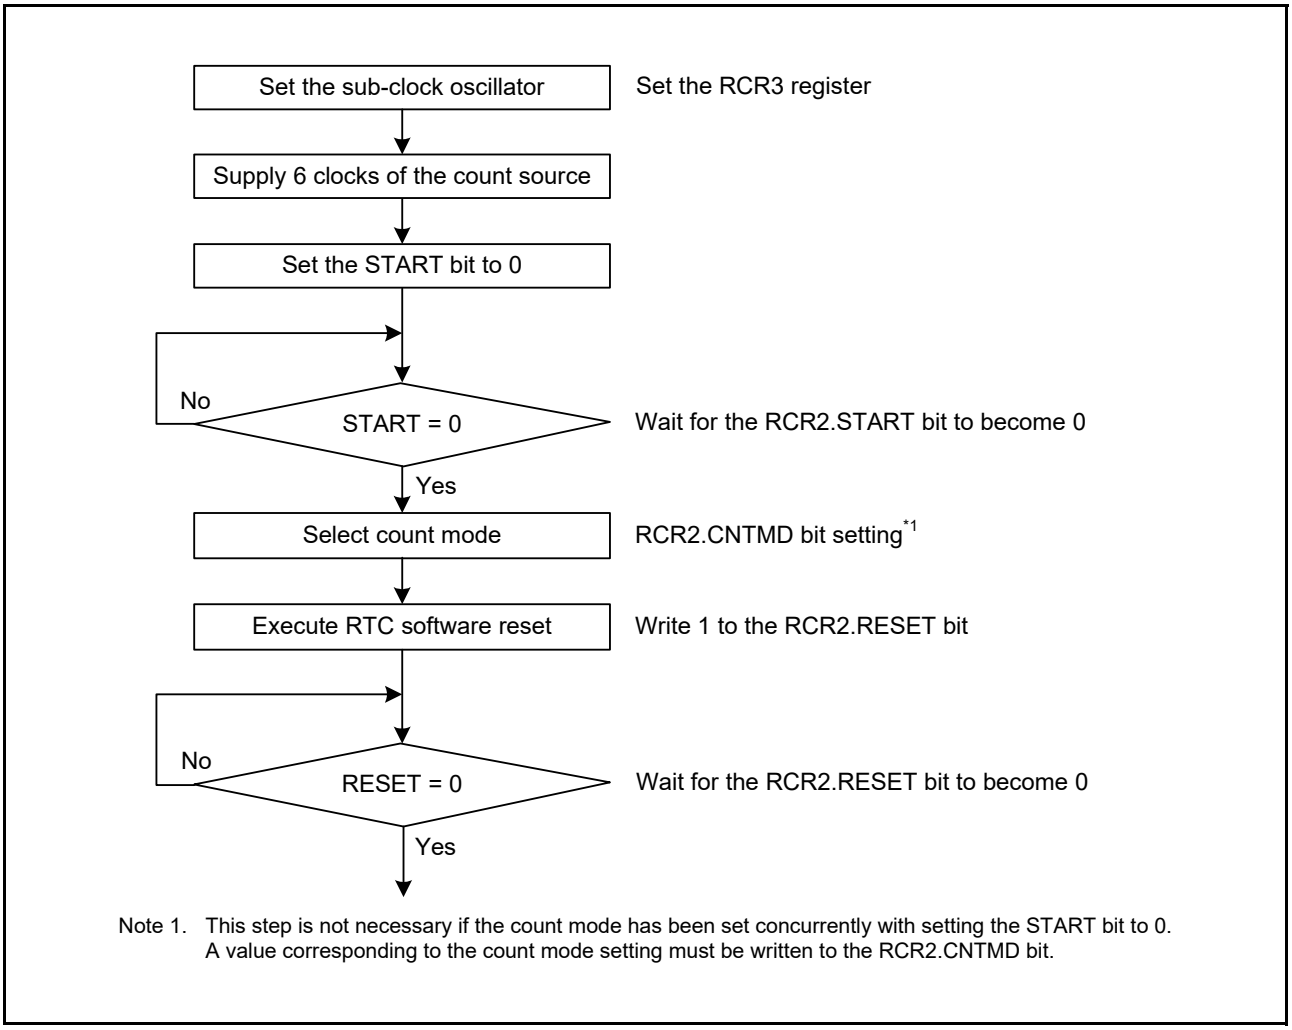
Figure 24.3 Clock and Count Mode Setting Procedure

The setting procedure described in Figure 24.3, Clock and Count Mode Setting Procedure is corrected as follows.

Note 1. This step is not necessary if the count mode has been set concurrently with setting the START bit to 0. A value corresponding to the count mode setting must be written to the RCR2.CNTMD bit.

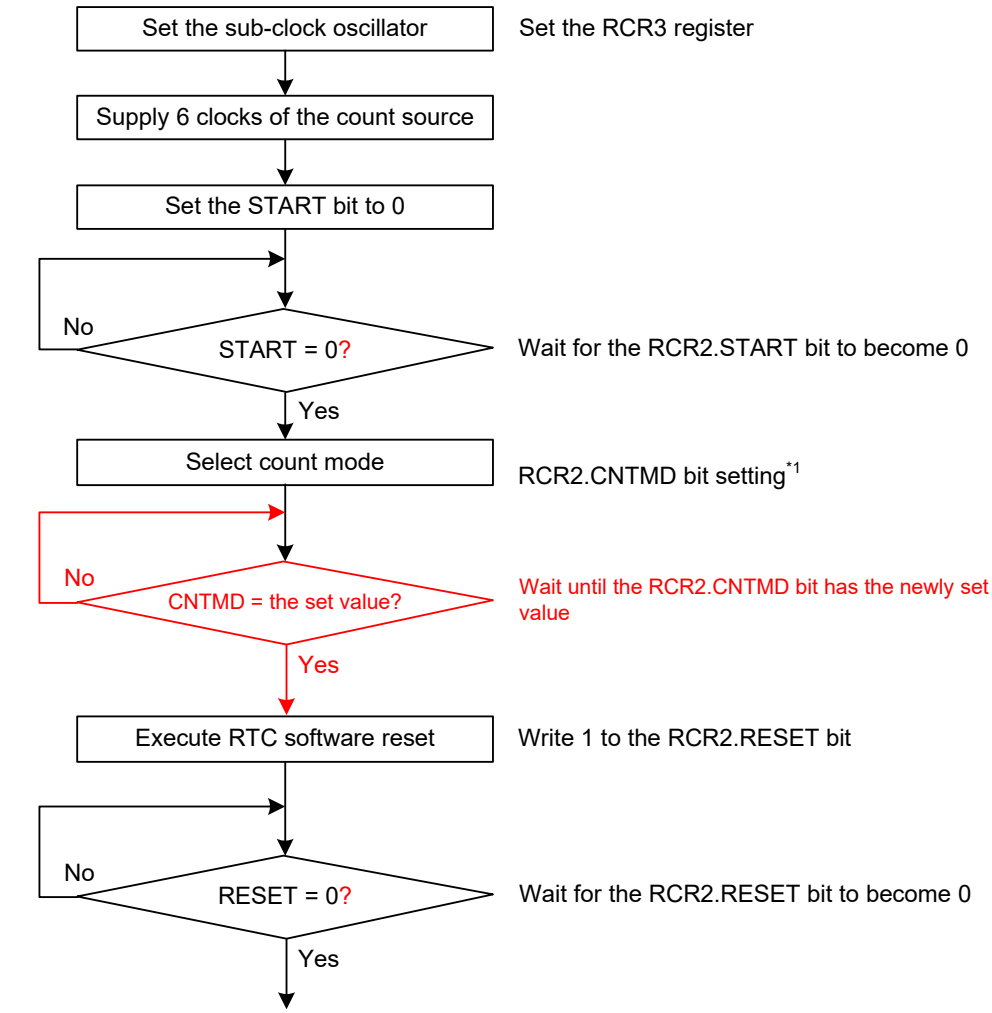
Figure 24.3 Clock and Count Mode Setting Procedure

Note 1. This step is not necessary if the count mode has been set concurrently with setting the START bit to 0. A value corresponding to the count mode setting must be written to the RCR2.CNTMD bit.

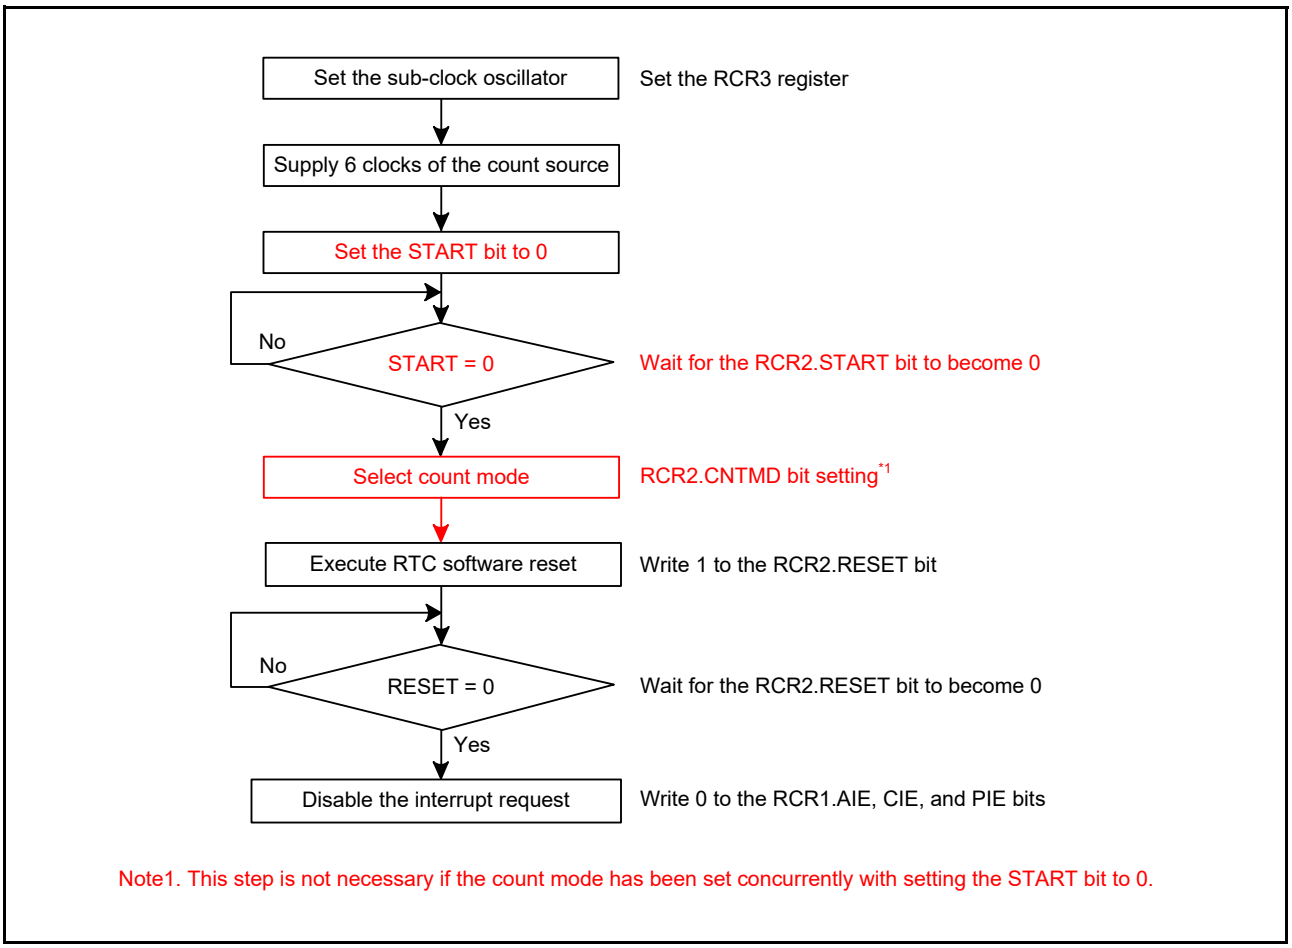
Figure 24.12 Initialization Procedure

The initialization procedure described in Figure 24.12 of section 24.5.7 Initialization Procedure When the Realtime Clock is Not to be Used is corrected as follows.
