CASE STUDY

How System Level Noise in Digital Interfaces can Lead to Spurious Errors in Serial Flash Memory

Paul Hill, Renesas Electronics Corporation
Gordon MacNee, Renesas Electronics Corporation

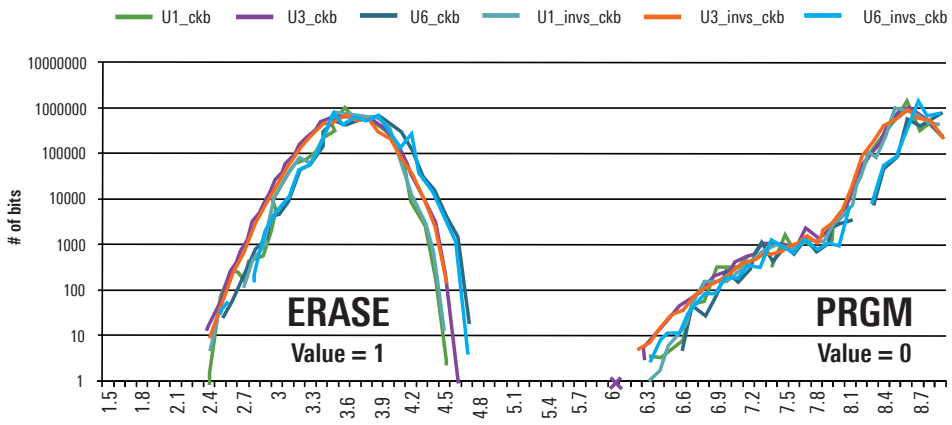
As an example, consider the image in Figure 1. It shows healthy cell margins for six flash devices. Two distinct patterns emerge between cells programmed with data representing logical 1 (2V to 5V) and 0 (>6v). By comparison, the image in Figure 2 shows memory cell margin for three flash devices that have suffered data corruption caused by overshoot and undershoot on the control lines.

Figure 1: This image shows good cell margin separation data for flash memory that has been programmed and erased.

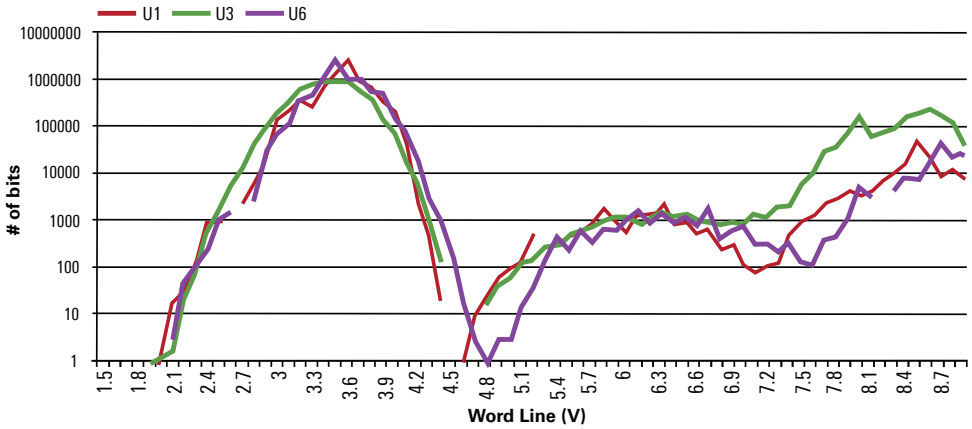
Figure 2: This image shows poor cell margin separation data for flash memory where there has been significant noise present on the SPI lines

The data in Figure 2 shows the effects of excessive overshoot and undershoot on the serial interface. Figure 3 below shows a representation of what this overshoot would look like in a real application.

The result of this noise was erroneous device operation, which showed up as errors in the serial flash memory stored values. Initially, the true impact of the errors was missed, as polling the STATUS register on a less frequent basis reported fewer errors, leading the designer to make incorrect assumptions on the root cause of the failure.

Although this fault appeared as a memory failure, the root cause was not with the flash devices. This was discovered by Renesas engineers by probing the SPI signals and identifying the system noise present. While the noise could be partly attributed to an impedance mismatch present on the PCB track between the MCU and flash memory, it wasn't the full story. The source of the noise was actually the MCU interface, which defaults to a high drive level at power-up. The excessive drive was enough to cause overshoot and undershoot on the SPI lines, which in some cases can be misinterpreted as signal transitions, leading to read or write errors. However, in this instance it was found that the overshoot held sufficient energy to disrupt the flash charge pump, which was in turn causing the errors.

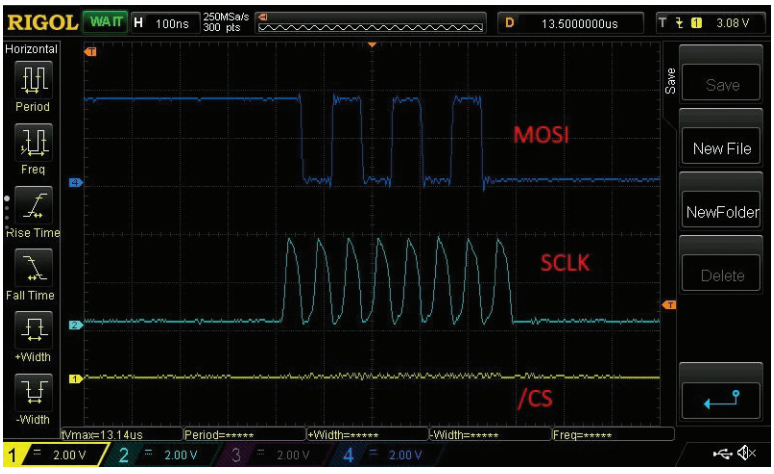
Figure 4: With no overshoot apparent, the serial flash memory's charge pump was able to operate correctly and provide reliable functionality

Reducing the drive current, through firmware, reduced the overshoot and undershoot to effectively zero (Figure 4), and in turn resulted in error-free operation of the flash memory.
