Code Generator for RL78(CS+ for CA,CX) V2.07.00

Release Note

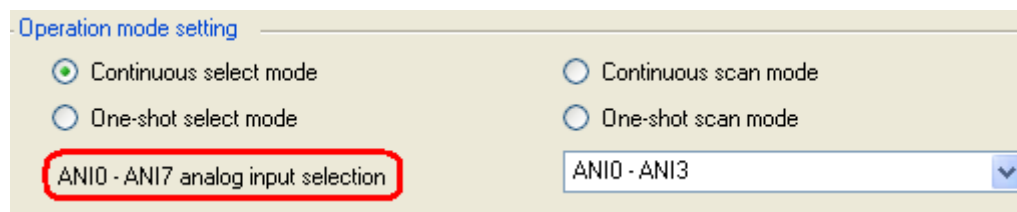
4.1.6 GUI correction of an A/D converter

In the A/D converter, it corrected so that the message displayed with the fixed value as the number of analog input channels might be dynamically displayed according to a number of channels.

This issue has been corrected in Code Generator for RL78,78K0R,78K0 V1.00.03

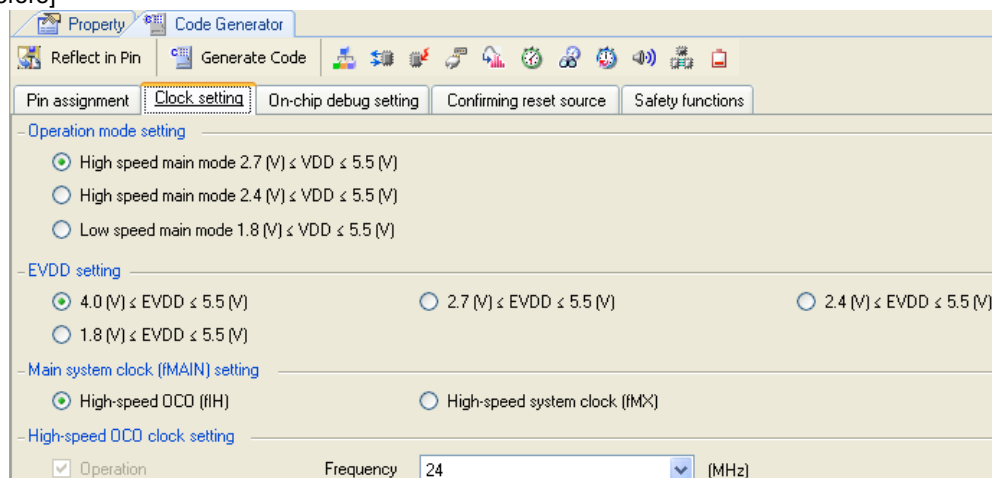
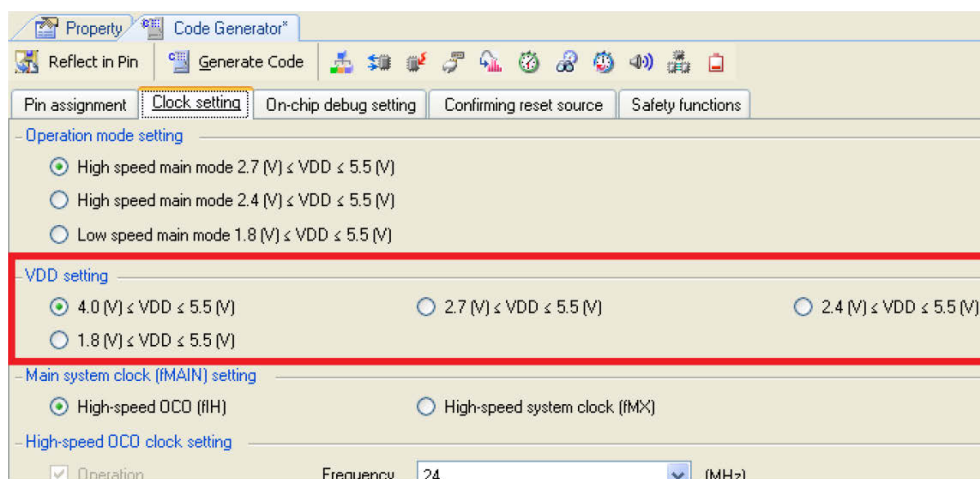
Although there was not EVDD in RL78/G12 device, it corrected that the notation remained on GUI.

This issue has been corrected in Code Generator for RL78,78K0R,78K0 V2.00.00.

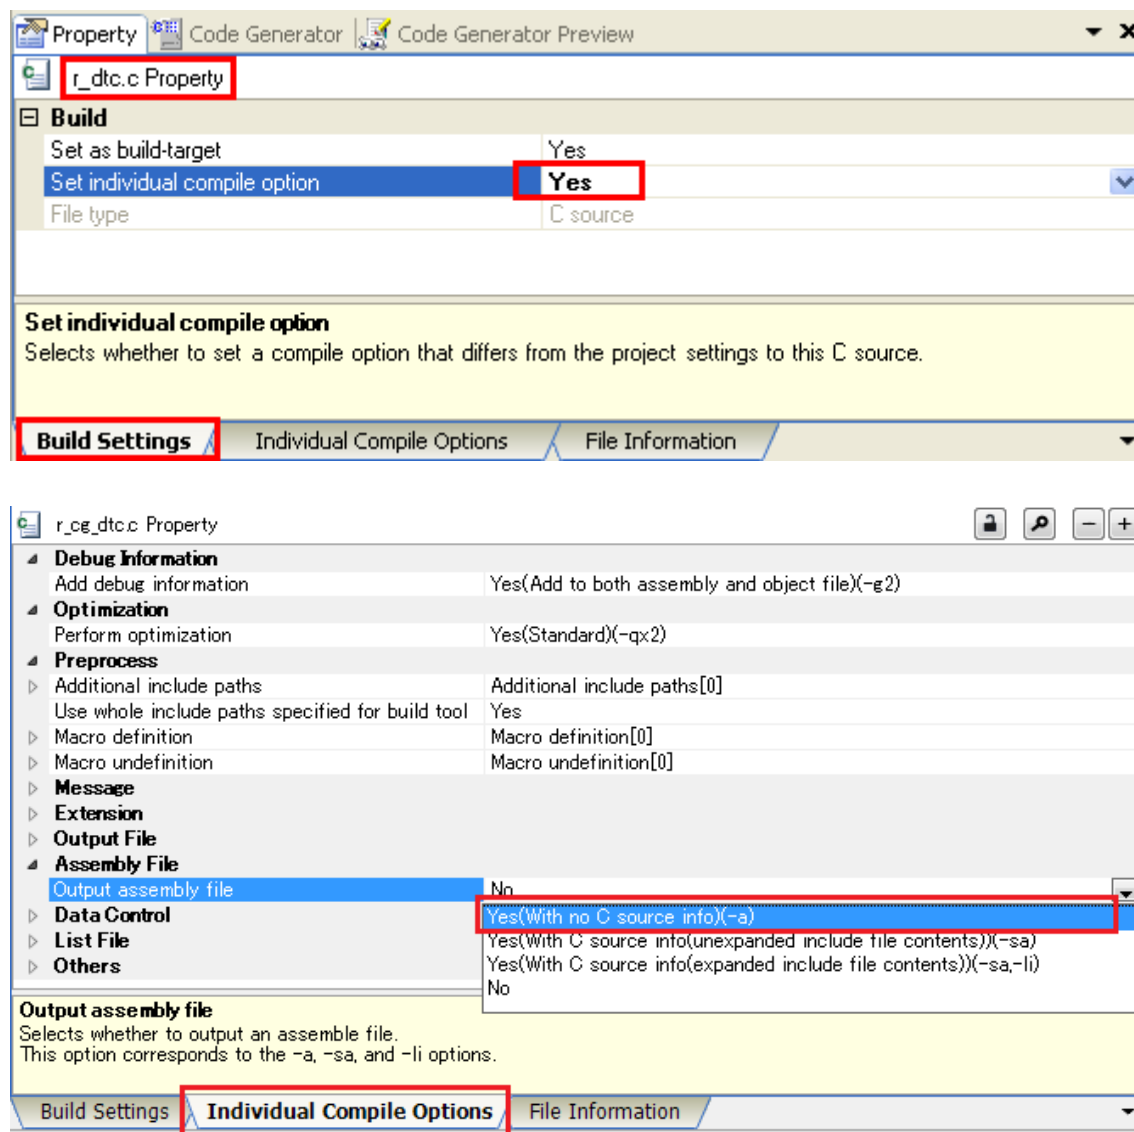
When DTC is used, please set up the following individual option of building. The DATA section is added for DTC to output sauce file "r_cg_dtc.c." Unless the individual option is set up, the following warning message is displayed and an object file is not generated.

(CC78K0R warning W0837: Output assembler source file , not object file)

[Workaround]   There is no workaround

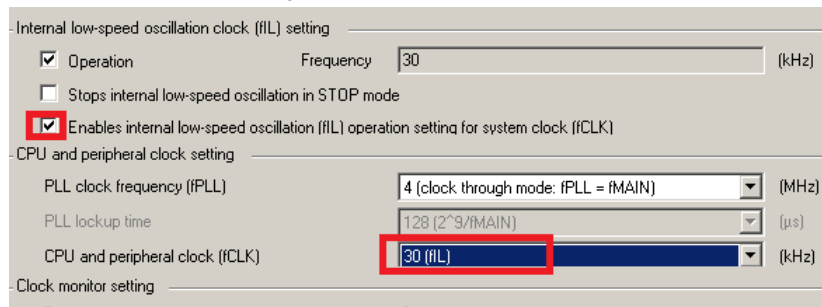
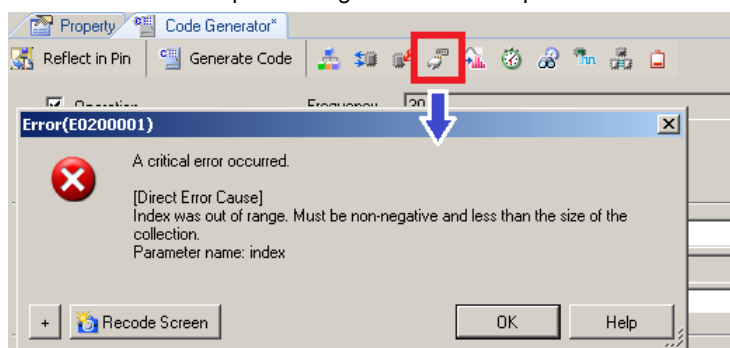
a) Clock

- Check in the two following items.

- Selection of a serial panel will generate an exception.

There is no workaround. RL78 Code Generator is corrected in V2.00.01

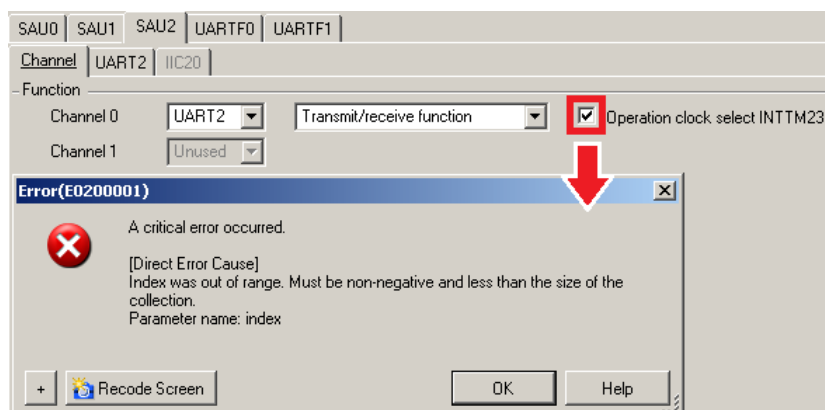
b) Timer and serial

- Use interruption for the channel 3 of timer TAU2 in a certain mode.

- If a clock of operation checks one serial of serial SAU0, SAU1, and SAU2 "Operation clock select INTTM23", an exception will occur.

There is no workaround. RL78 Code Generator is corrected in V2.00.01

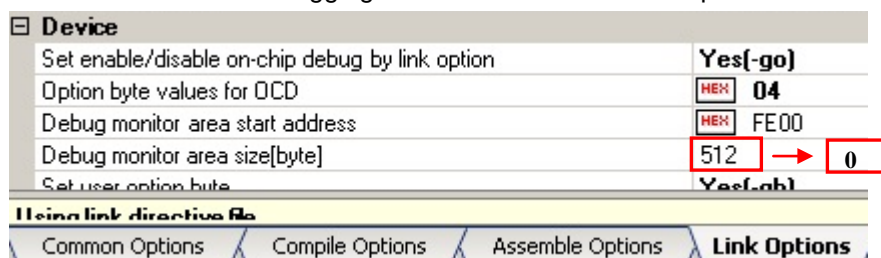
Even if it checks by on-chip debugging operation setup "for it not to be used", debugging monitor area size will be secured.

[Workaround]   Please write 0 to the debugging monitor area size of Link Options.
