RENESAS TECHNICAL UPDATE

Product Category	MPU/MCU		Document No.	TN-SH7-A826A/E	Rev.	1.00
Title	SH7450 Group, SH7451 Group User's Manual Hardware Errata Rev.A		Information Category	Technical Notification		
Applicable Product	SH7450 Group, SH7451 Group	Lot No.	Reference Document	SH7450 Group, SH7451 Group User's Manual: Hardware Rev.1.10 (R01UH0286EJ0110)

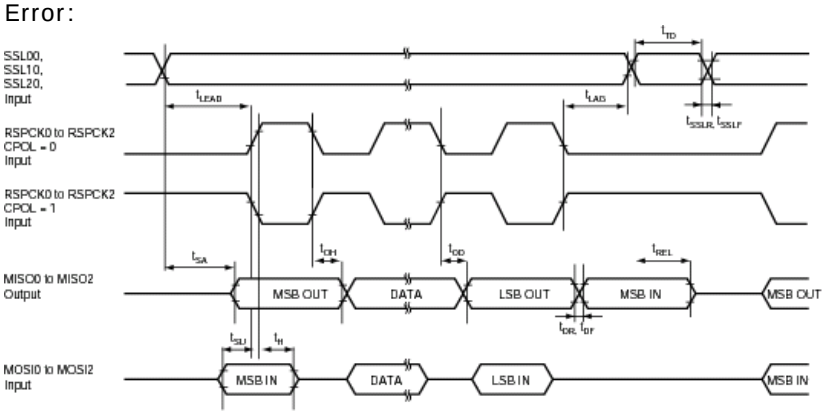
<table>
<tr><th>Rev.</th><th>Page</th><th>Part</th><th>Contents</th></tr>
<tr><td>Adds by REV.A</td><td>38-33</td><td>Table 38.26 RSPI Timing</td><td>
Table 38.26 RSPI Timing : Incorrect description corrected.
Error:
<table>
<tr><th colspan="2">Item</th><th>Symbol</th><th>Min.</th><th>Max.</th><th>Unit</th><th>Figures</th></tr>
<tr><td>Data input setup time</td><td>Slave</td><td>t_{SU}</td><td>25 + 2 x t_{cyc}</td><td>-</td><td>ns</td><td>38.28 to 38.31</td></tr>
</table>
Correct:
<table>
<tr><th colspan="2">Item</th><th>Symbol</th><th>Min.</th><th>Max.</th><th>Unit</th><th>Figures</th></tr>
<tr><td>Data input setup time</td><td>Slave</td><td>t_{SU}</td><td>25 - 2 x t_{cyc}</td><td>-</td><td>ns</td><td>38.28 to 38.31</td></tr>
</table>
</td></tr>
<tr><td>Adds by REV.A</td><td>38-35</td><td>Figure 38.30 RSPI Timing (Slave, CPHA = "0")</td><td>
Figure 38.30 RSPI Timing (Slave, CPHA = "0") : Incorrect description corrected. O in a figure shows the added part.
