# Errata

## SLG46517

### CE-GP-001

*This document contains the known errata for SLG46517 and the recommended workarounds.*

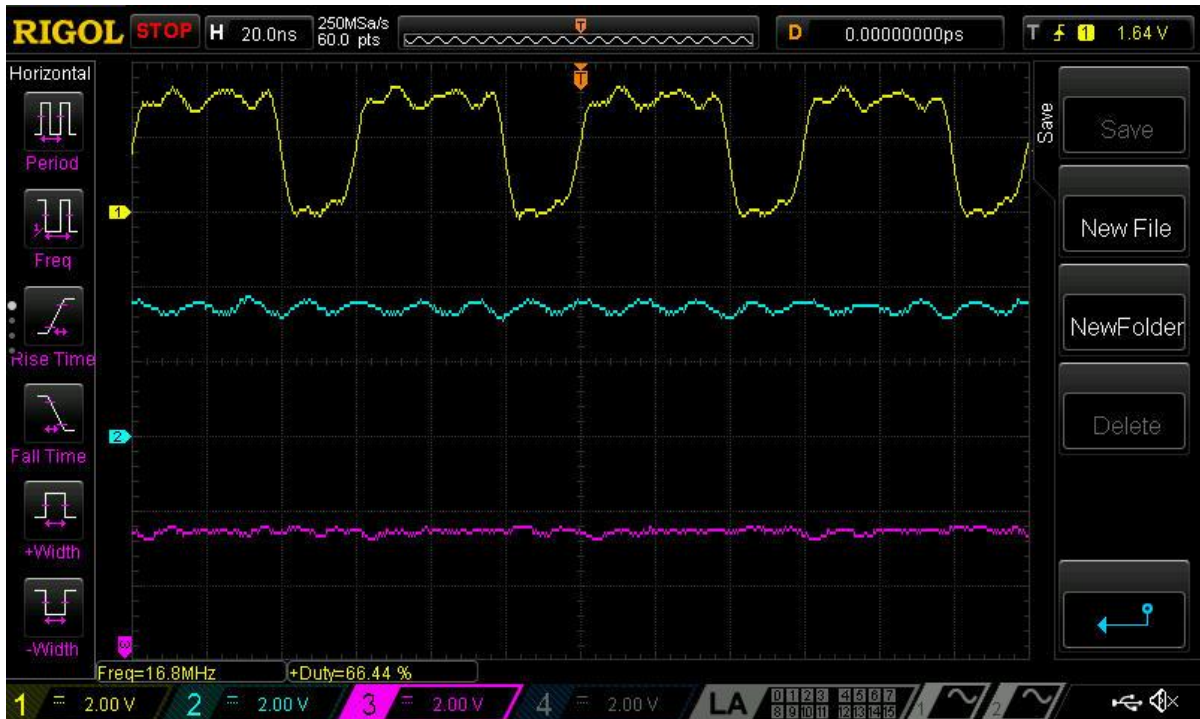
Figure 8

4. Period is 60ns. Pulse width is 40ns DC=66.67% (Correct functionality)

Currently there is no workaround for this issue. Filter block is good at filtering short spontaneous glitches. It is intended to be used in series connection before the delay cell to avoid its latching.

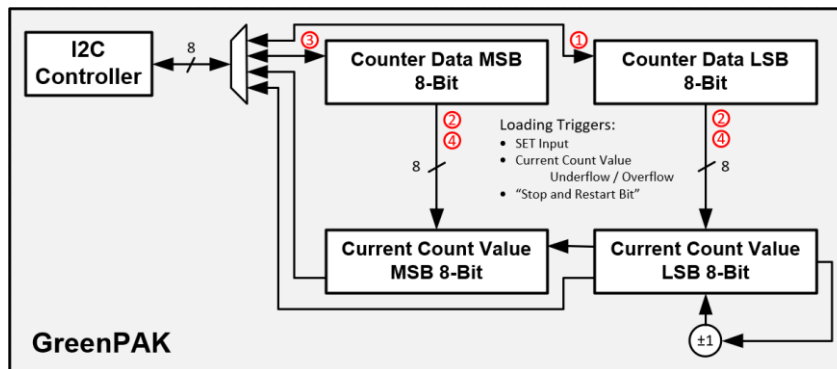
Figure 11: 16-Bit I2C Counter Block Diagram

This behavior results in two output pulses on OUT when only one pulse is expected. Observing this behavior depends upon the asynchronous timing between the counter’s clock and the I2C write command to the Counter Data registers. For some applications, the extra pulse on OUT can be ignored and the counter will self-correct after underflowing, overflowing, or being SET/RESET through the GreenPAK connection matrix.

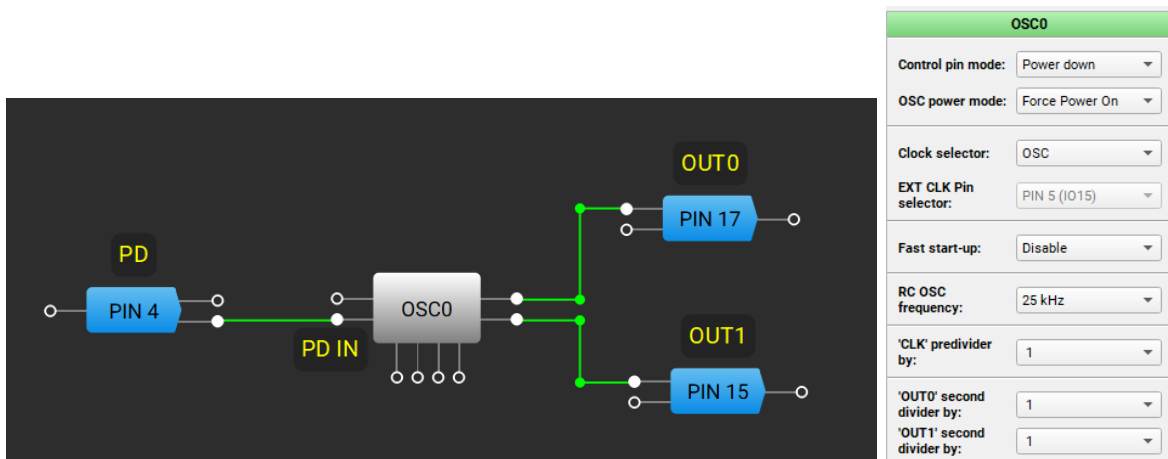
Figure 13. Test Design

When a short pulse of less than ~40 ns is applied to the PWR DOWN input.

If a pulse with a duration of less than ~40 ns is applied to the PWR DOWN input of the oscillator, the oscillator outputs remain stuck for milliseconds, as shown in figures below. The issue is observed for all available oscillators.
