## SLG4653x-E Errata Note

This document contains the known errata for SLG46533-E, SLG46534-E, SLG46535-E, SLG46536-E, SLG46537-E, SLG46538-E and the recommended workarounds.

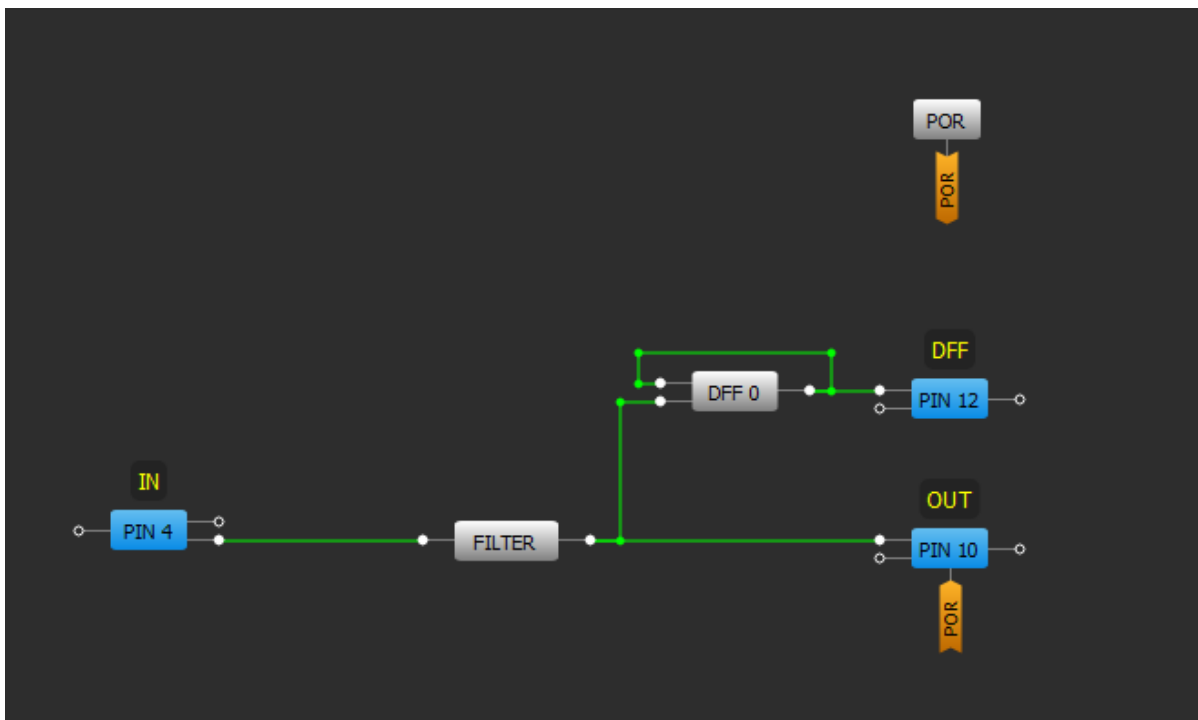
Figure 4

If clock type high frequency input comes in, the FILTER cell may not filter it out. There are several factors like input frequency, duty cycle, and LOW duration in such signal that may lead to its passing through FILTER block.

Channel 1 (yellow/top line) – PIN#4 (IN).

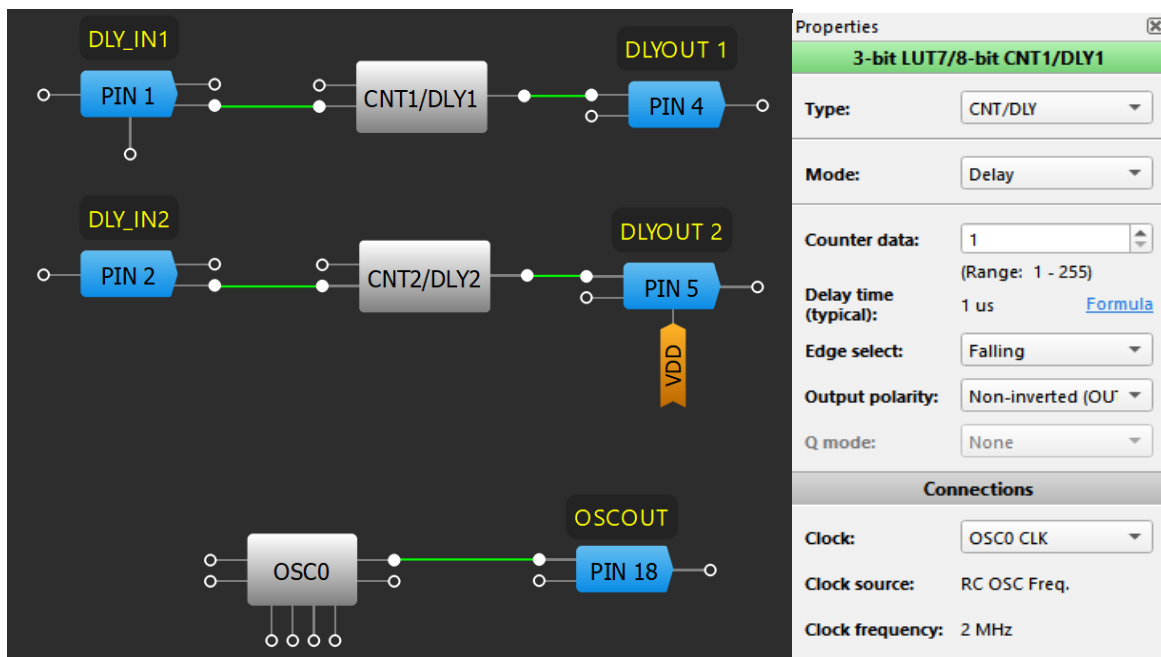
Figure 16. Test Circuit

The error is difficult to capture as the timing must be exact within ns, and short (ns) pulses are difficult to generate glitch precise enough to induce the problem. GPIO naturally filter out ns pulses, so for purposes of errata capture, two simultaneous falling-edge DLY circuits (as shown in Figure 16) were used. By lining up two delays precisely at a particular timing relationship, it can be used the internal Auto Power On (OR logic) to generate the glitch pattern necessary to cause the error.

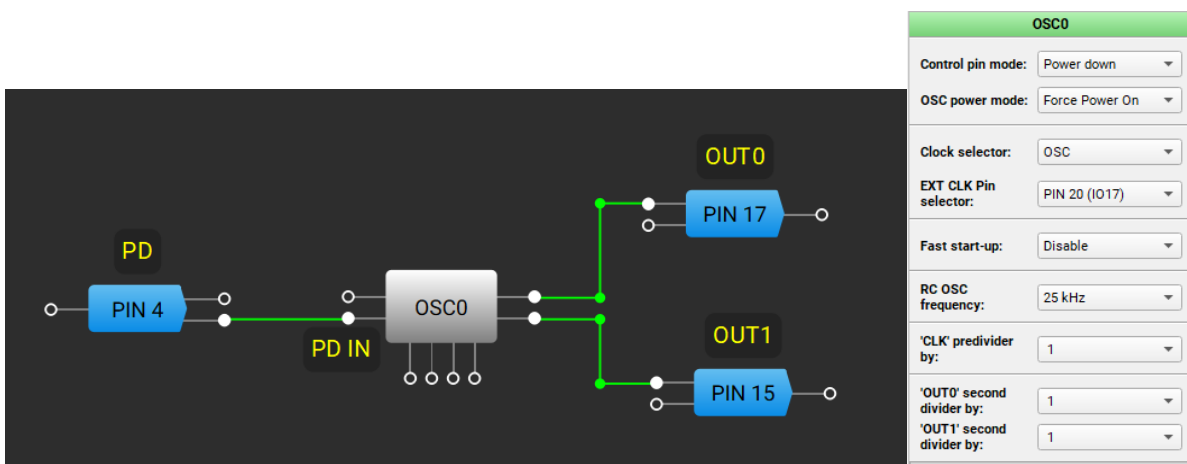
Figure 19. Test Design

When a short pulse of less than ~40 ns is applied to the PWR DOWN input.

Change Fast start-up setting to Enable or omit applying glitches at PWR DOWN input in OSC.
