Applilet3 for RL78 V1.10.00 Release Note

This chapter describes changes from Applilet3 for RL78 V1.09.00 to V1.10.00.

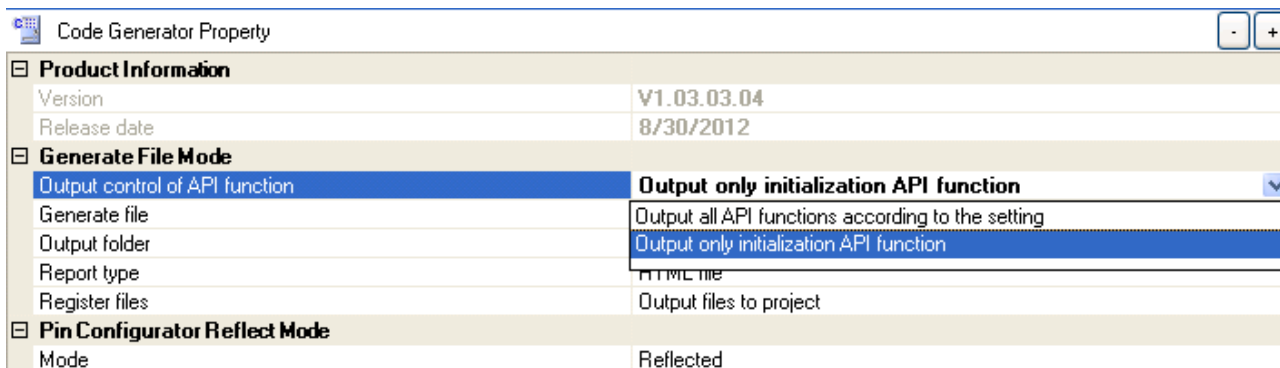
"Output only initialization API function": Outputs only initialization functions (Create functions) regardless of the GUI settings.

Users can configure the settings such as interrupt functions according to their needs.
