Chapter 1. Target Devices

Chapter 4. Changes

This chapter describes change from Code Generator for RL78 (CS+ for CA,CX) V2.10.00 to V2.11.00

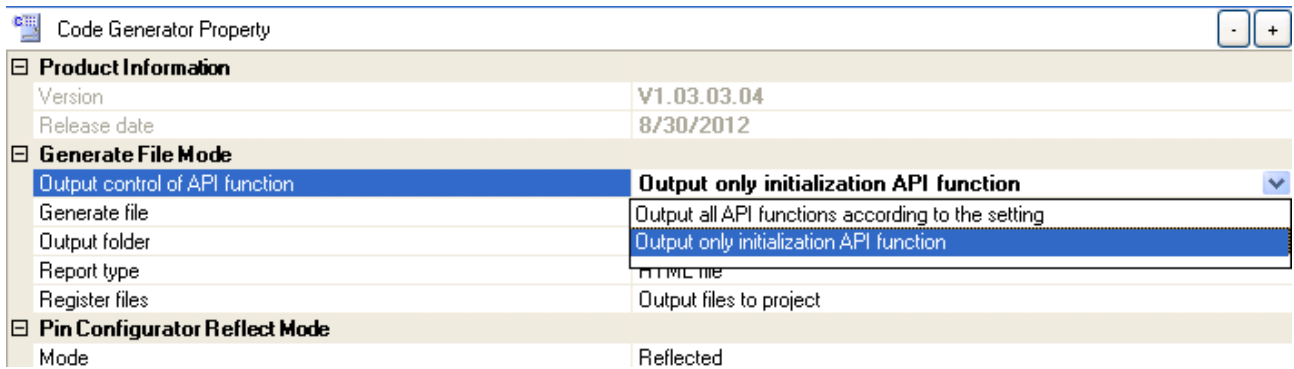
Users can configure the settings such as interrupt functions according to their needs.

This issue has been corrected in CubeSuite+ Code Generator for RL78,78K0R,78K0 V1.00.06
