Concerned Products:	Customer Notification	Date: 16 March 2000
<p><i>μPD784224</i> <i>μPD784224Y</i> <i>μPD784225</i> <i>μPD784225Y</i></p> <p><i>μPD78F4225</i> <i>μPD78F4225Y</i></p>		NEC-Electronics (Europe) GmbH EAD -Technical Product Support
Bug Report		Source Doc: SBG-T-0483 SBG-T-0504 SIF-T-?? (TQ-TH970820/1) SIF-T-10395 (TQ-TH971215/2) SBG-T-0619 NN
		Author: A. Twardy
Date of initial issue: 07 August 1998		Doc. No.: TPS-LE-B-4223

(A) BUG LIST

(B) BUG DESCRIPTION

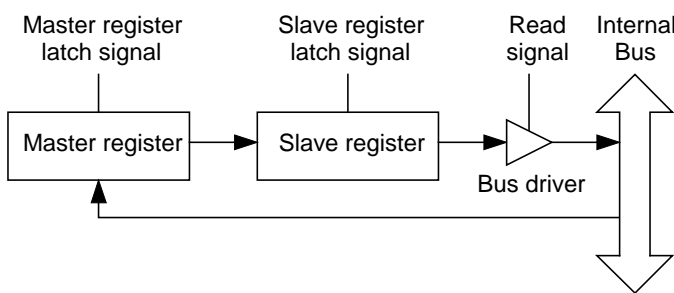
Bug No.	Outline	Description
6	Timer compare register access while corresponding timer register matches (continuation)	<p>6.3 PWM output mode</p> <p>The compare registers of the concerned timers consist of two buffers the master and the slave register. The simplified diagram is show below.</p>

<p>In PWM mode the data transfer from the master to the slave register is performed when an overflow occurs. This bug occurs when performing a data transfer from the concerned master register to the slave register when an overflow occurs in an attempt to rewrite the value of the master register, thus damaging the data to be transferred.</p> <p>The description of the bugs are in detail as following:</p> <p>6.3.1 Writing to a compare register while the corresponding timer register matches does not change the output signal of the timer to the inactive level.</p> <p>6.3.2 Writing to CRn0 (master register) once and then writing again when the corresponding timer register (TMn) overflows causes an undefined value to be transferred to CRn0 (slave register).</p> <p>6.3.3 Reading the compare register when an overflow of the corresponding timer occurs stops the transfer of data form CRn0 (master register) to CRn0 (slave register). The transfer is performed when overflow of the timer occurs.</p> <p>Please refer to the timing diagrams shown below.</p> <div style="border: 1px solid black; padding: 5px; margin: 10px 0;"> <p>Please note, however, that the timing charts below are schematic representations of operations and therefore do not indicate a precise operation timing.</p> </div> <p><u>Normal operation as PWM timer</u></p>
