# Microcomputer Technical Information

<p><math>\mu</math>PD789860, 789861 Subseries</p> <p>Usage Restrictions</p>	Document No.	SBG-DT-03-0195-E	1/2
	Date issued	July 18, 2003	
	Issued by	Microcomputer Group 2nd Solutions Division Solutions Operations Unit NEC Electronics Corporation	
Related documents $\mu$ PD789860, 789861 Subseries User's Manual: U14826EJ3V0UM00 $\mu$ PD789860, 789861 Data Sheet: U13917EJ1V1DS00 $\mu$ PD78E9860, 78E9861 Data Sheet: U16524EJ1V0DS00	Notification classification	√	Usage restriction
			Upgrade
		√	Document modification
			Other notification

$\mu$ PD789860, 789861, 78E9860, 78E9861

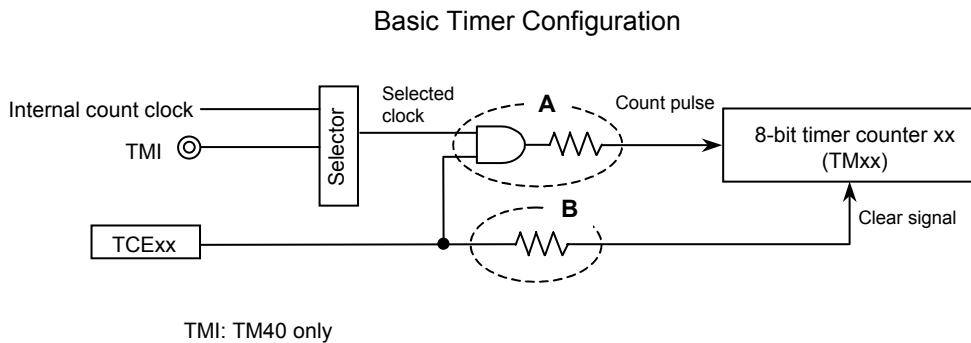
The basic timer configuration applicable to this restriction is shown in the figure below.

- The selected clock and the count operation flag (TCExx) are ANDed, and the result is supplied to the counter
- The TMxx counter value is cleared when the count operation flag (TCExx) is set

If a count pulse is delayed for the clear signal (“delay A > delay B”) as the result of setting the count operation flag (TCExx) while the selected clock is high, the TMxx count value is incremented. An error of up to 1.5 clocks is generated.
