# NEC Microcomputer Technical Information

<p>V853 32-Bit Microcontrollers Usage Restrictions</p>	Document No.	ZBG-CC-05-0074	1/1
	Date issued	December 15, 2005	
	Issued by	Solution Development Group Multipurpose Microcomputer Systems Division 4th Systems Operations Unit NEC Electronics Corporation	
<p>Related documents</p> <p>Hardware User's Manual: U10913EJ6V0UM00 (6th edition)            Architecture User's Manual: U10243EJ7V0UM00 (7th edition)            Data Sheet (mask ROM): U13188EJ6V1DS00 (6th edition)            Data Sheet (flash memory): U13189EJ5V1DS00 (5th edition)</p>	Notification classification	√	Usage restriction
			Upgrade
			Document modification
			Other notification

## List of Usage Restrictions in V853

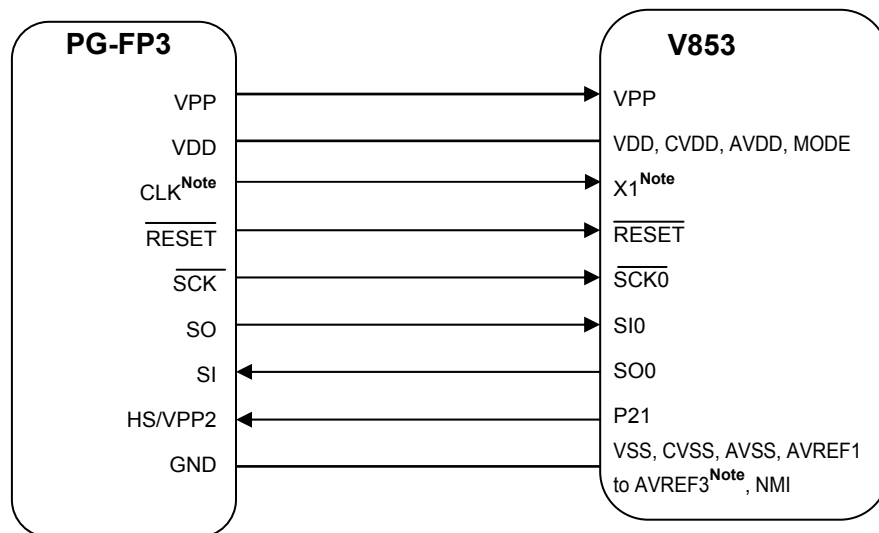
### CSI Communication Mode with Handshake Supported (MSB-first transfer)

- (1) Directly connect the HS pin (or Vpp2 pin) of the target interface of the NEC Electronics flash programmer PG-FP3 to pin 21 of the device.
- (2) Change the COMM PORT setting to SIO ch-3+handshake on the GUI (host PC).
- (3) Start programming.

**Note** Change the connection according to the environment used.
