Errata Sheet

SLG46108

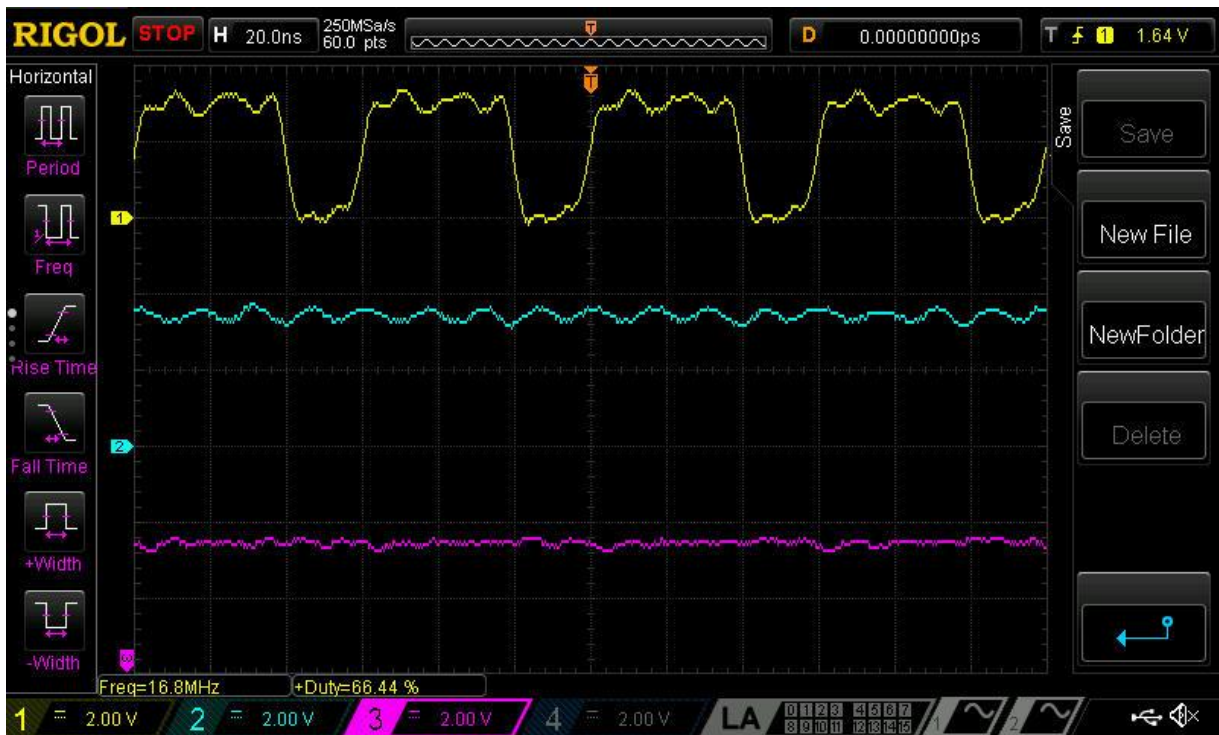
4. Period is 60 ns. Pulse width is 40 ns, DC = 66.67 % (correct functionality).

Workaround:

Currently there is no workaround for this issue. Filter block is good at filtering short spontaneous glitches. It is intended to be used in series connection before the delay cell to avoid its latching (see issue #3).
