## SLG4653x Errata

**CE-GP-002**

*This document contains the known errata for SLG46533, SLG46534, SLG46535, SLG46536, SLG46537, SLG46538 and the recommended workarounds.*

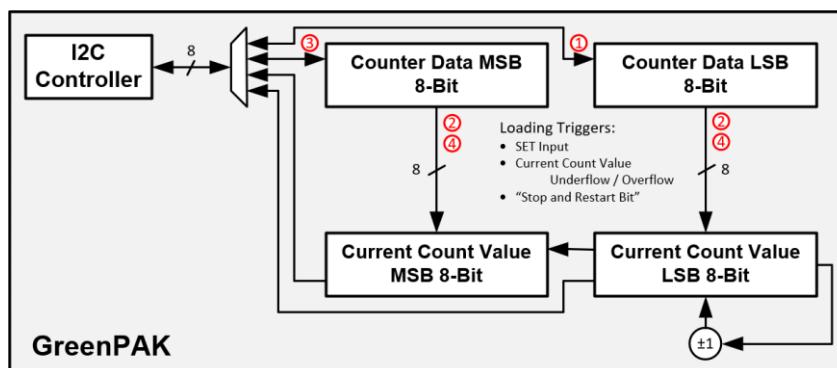
Figure 11: 16-Bit I2C Counter Block Diagram

As previously mentioned, the 16-bit value is loaded from the I2C buffers to the Counter Data registers in 8-bit chunks. Right at time “1”, the LSB byte (0x01) is loaded into the Counter Data registers. This makes the Counter Data value temporarily equal to 0x0001. At time “2” between the internal I2C load signals, the counter receives a rising edge on its clock input. This causes the Current Count Value to underflow and to be loaded with the Counter Data value which is 0x0001. At time “3”, the MSB byte (0x01) is loaded into the Counter Data registers setting the Counter Data value to 0x0101. At time “4”, the Current Count Value underflows again and is set to the Counter Data value of 0x0101.

This behavior results in two output pulses on OUT when only one pulse is expected. Observing this behavior depends upon the asynchronous timing between the counter's clock and the I2C write command to the Counter Data registers. For some applications, the extra pulse on OUT can be ignored and the counter will self-correct after underflowing, overflowing, or being SET/RESET through the GreenPAK connection matrix.

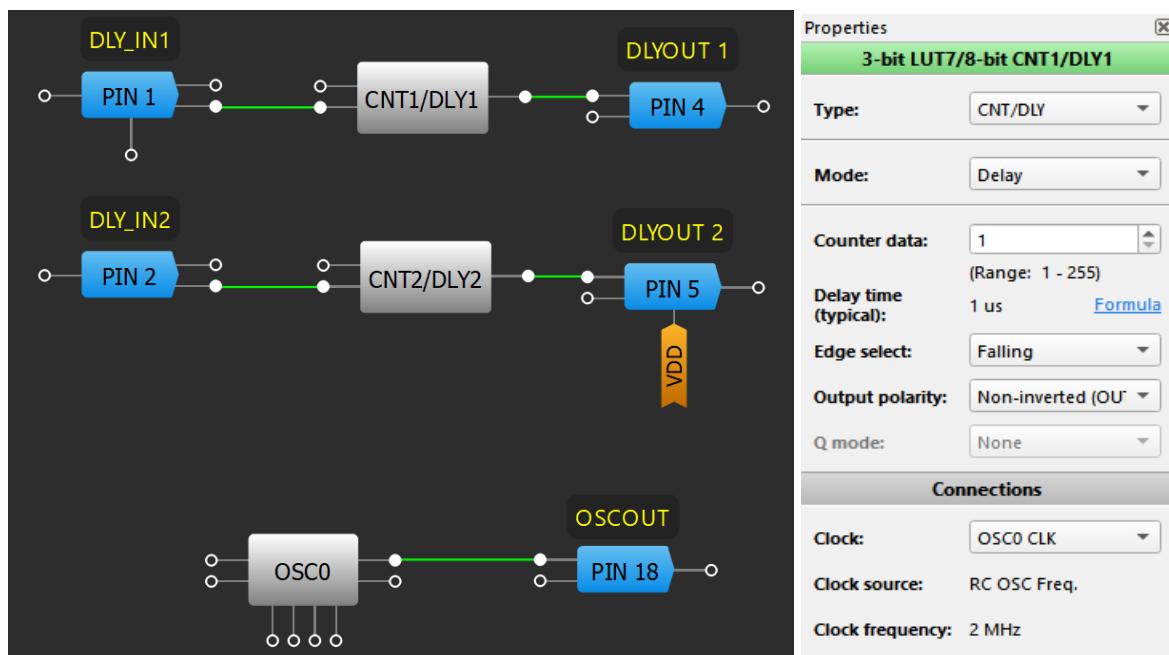
Figure 16: Test Circuit

For this chip, the Auto Power On circuitry of the 25 kHz/2 MHz generators contains a circuit errata, which can potentially fail to power on the OSC for a specific pattern and timing of the OR of all related DLY trigger signals. The pattern is shown in [Figure 15](#) (boxed in red) and consists of a relatively longer pulse (~145 ns) followed by a shorter (~5 ns) glitch of opposite polarity.

The error is difficult to capture as the timing must be exact within ns, and short (ns) pulses are difficult to generate glitch precise enough to induce the problem. GPIO naturally filter out ns pulses, so for purposes of errata capture, two simultaneous falling-edge DLY circuits (as shown in [Figure 16](#)) were used. By lining up two delays precisely at a particular timing relationship, we can use the internal Auto Power On (OR logic) to generate the glitch pattern necessary to cause the error.

1. Use signal conditioning circuits to prevent glitch on DLY inputs < 200 ns. Examples:
  - a. ACMP with Hysteresis
  - b. External RC in front of Digital Input with Schmitt Trigger
  - c. Filter cell.
2. Set OSC power mode to Force Power On mode instead of Auto Power On.
3. Use different oscillator, such as 25 MHz Ring OSC, which does not have Auto Power On issue.

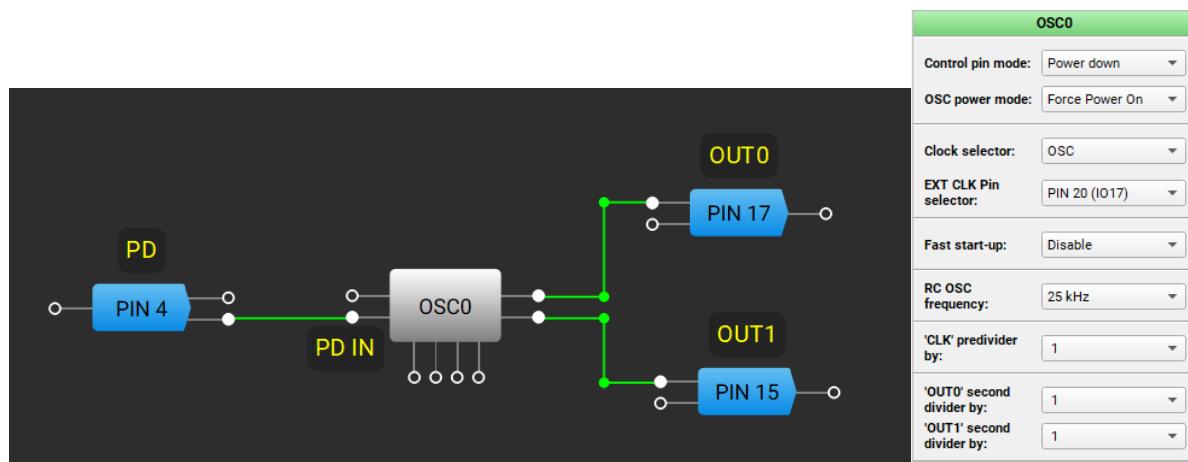
**Figure 19. Test Design****3.8.3 Technical Description**

When a short pulse of less than ~40 ns is applied to the PWR DOWN input.

If a pulse with a duration of less than ~40 ns is applied to the PWR DOWN input of the oscillator, the oscillator outputs remain stuck for milliseconds, as shown in figures below. The issue is observed for all available oscillators.

Use the “Force power on” OSC power control option to make the OSC operate at all times. However, this will cause increased constant current consumption.
