SLG46583 Errata

CE-GP-002

This document contains the known errata for SLG46583 and the recommended workarounds.

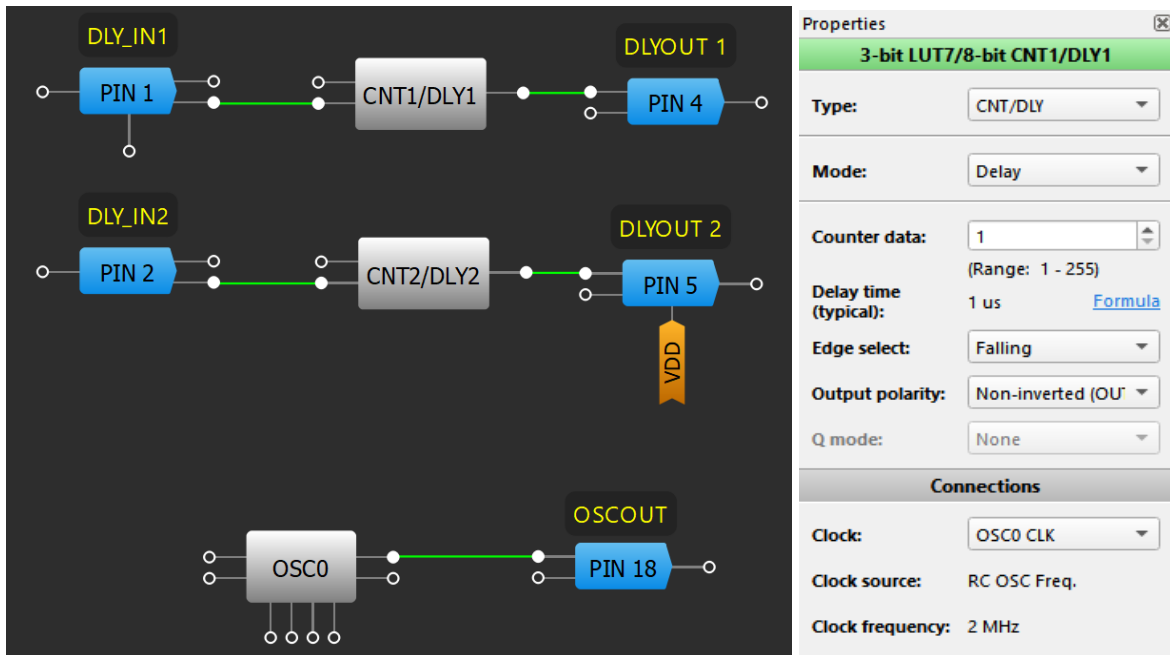
Figure 2: Test Circuit

- 25 kHz or 2 MHz OSC is in Auto Power On mode.
- DLYs are clocked by such OSC.
- Input to one more such DLY have glitches < 200 ns.
- OR of OSC trigger signals from all DLYs clocked by same OSC together form a long+short glitch pattern with precise (ns) timings as shown in Figure 1. The trigger signal generation per DLY is detailed in section **Error! Reference source not found.**
- During glitch period, no other DLY is active, meaning has already enabled OSC.

For this chip, the Auto Power On circuitry of the 25 kHz/2 MHz generators contains a circuit errata, which can potentially fail to power on the OSC for a specific pattern and timing of the OR of all related DLY trigger signals. The pattern is shown in Figure 1 (boxed in red) and consists of a relatively longer pulse (~145 ns) followed by a shorter (~5 ns) glitch of opposite polarity.

The error is difficult to capture as the timing must be exact within ns, and short (ns) pulses are difficult to generate glitch precise enough to induce the problem. GPIO naturally filter out ns pulses, so for purposes of errata capture, two simultaneous falling-edge DLY circuits (as shown in Figure 2) were used. By lining up two delays precisely at a particular timing relationship, we can use the internal Auto Power On (OR logic) to generate the glitch pattern necessary to cause the error.

1. Use signal conditioning circuits to prevent glitch on DLY inputs < 200 ns. Examples:
 - a. ACMP with Hysteresis
 - b. External RC in front of Digital Input with Schmitt Trigger
 - c. Filter cell.
2. Set OSC power mode to Force Power On mode instead of Auto Power On.
3. Use different oscillator, such as 25 MHz Ring OSC, which does not have Auto Power On issue.
