## SLG46583 Errata

### CE-GP-002

*This document contains the known errata for SLG46583 and the recommended workarounds.*

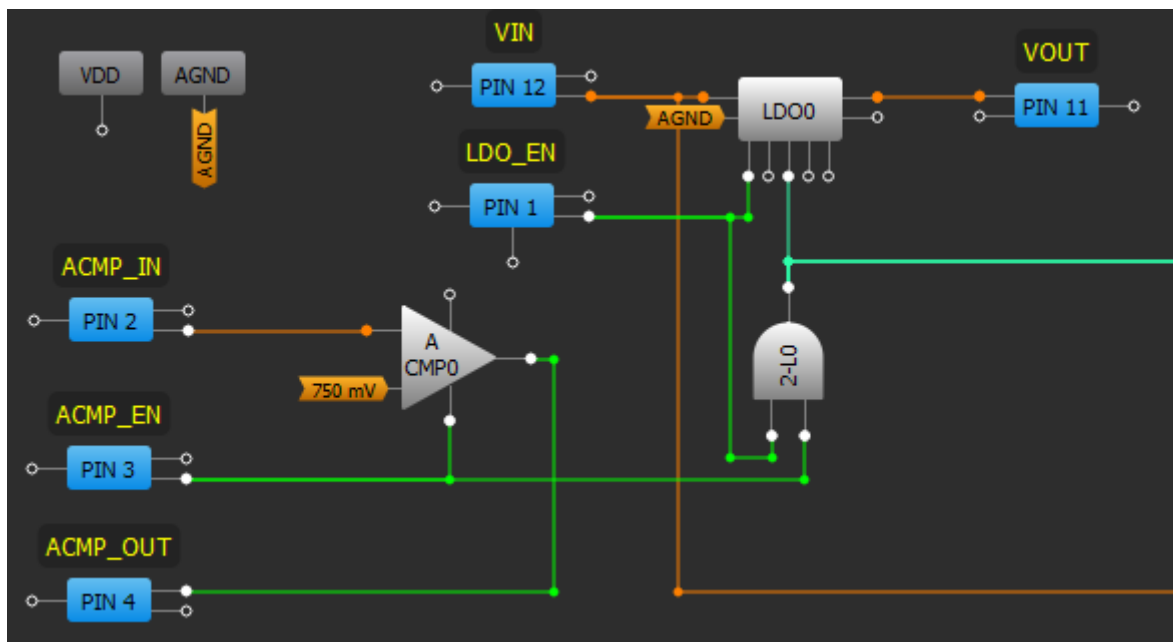
If an LDO's Low Power Mode is selected (for example tied to  $V_{DD}$ ) a glitch may appear on the ACMP's output after the first LDO is enabled. When the first LDO is turned on, the Low Power Mode switch causes a drop in the internal bandgap voltage that is used to derive the ACMP reference voltages.

3.3.3 Workaround

- Use both edge delay on the output to filter out the glitch.
- Use some logic to avoid turning on Low Power Mode before enabling LDO and powering up the ACMP. Example is shown below.
