SLG46585 Errata

CE-GP-002

This document contains the known errata for SLG46585 and the recommended workarounds.

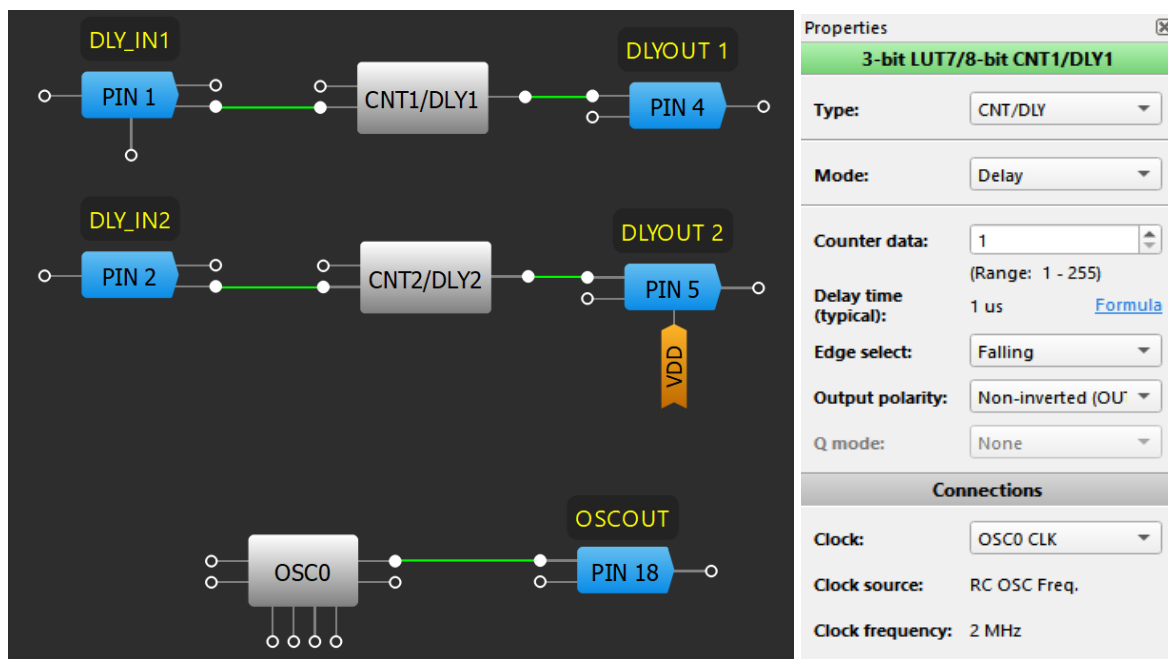
Figure 2: Test Circuit

The error is difficult to capture as the timing must be exact within ns, and short (ns) pulses are difficult to generate glitch precise enough to induce the problem. GPIO naturally filter out ns pulses, so for purposes of errata capture, two simultaneous falling-edge DLY circuits (as shown in Figure 2) were used. By lining up two delays precisely at a particular timing relationship, we can use the internal Auto Power On (OR logic) to generate the glitch pattern necessary to cause the error.

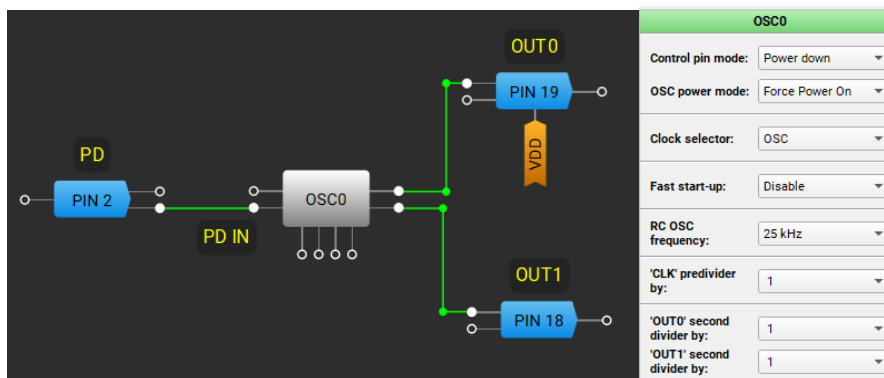
When a short pulse is applied to the PWR DOWN input, the oscillator exhibits a long start-up time.

Short pulse of less than ~40ns is applied to PWR DOWN OSC.

If a pulse with a duration of less than ~40 ns is applied to the PWR DOWN input of an oscillator, the oscillator outputs remain stuck for milliseconds.
