Errata

SLG46116

CE-GP-010

This document contains the known errata for SLG46116 and the recommended workarounds.

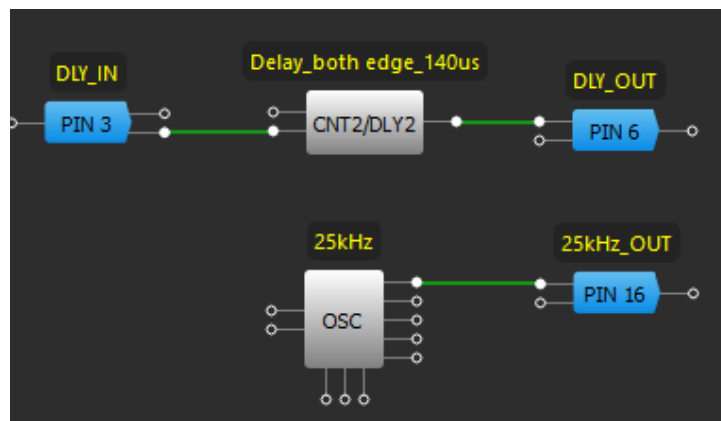
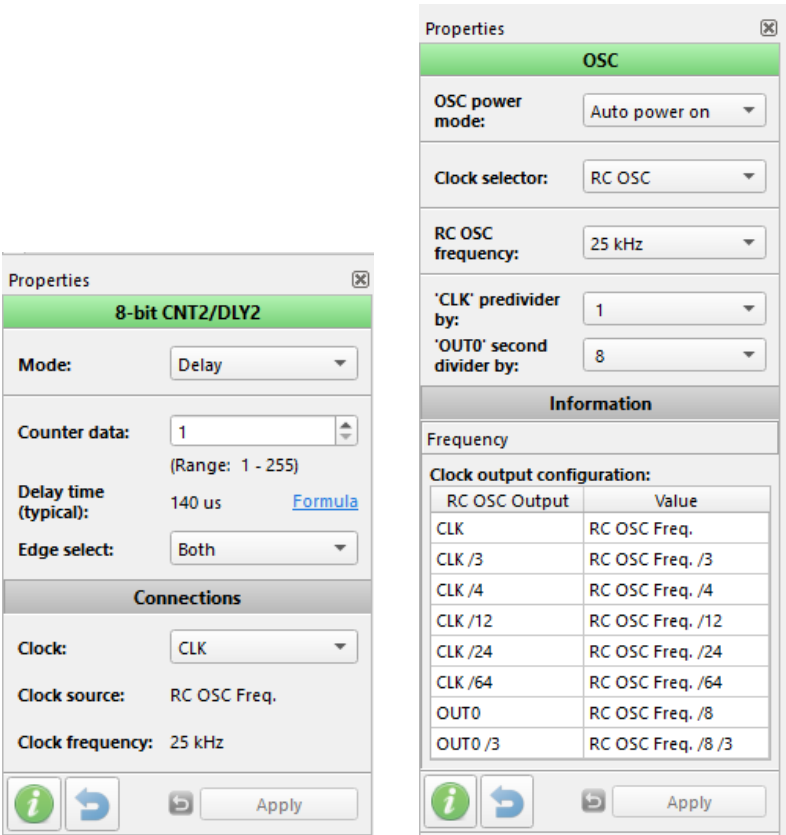
The first period of the RC OSC can be very short when OSC configured as 25 kHz with Auto Power On in the designs. This can be occurred when V_{DD} is above 4.0 V. Critical for CNT/DLY with a low counter data (less than 10) or if it is necessary to use the frequency of the OSC to clock external elements.

An example of such issue is in the following configuration:

3.6.4 Workaround

- Avoid V_{DD} higher than 4 V
- Force ON OSC

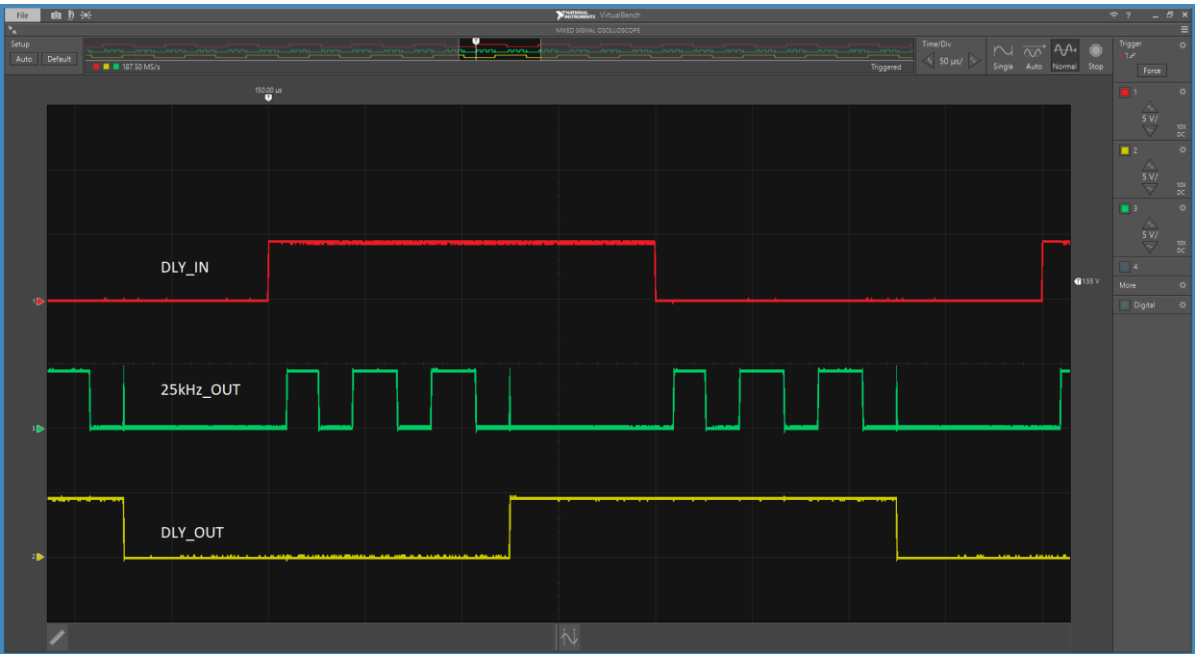
Normal oscillator behavior.

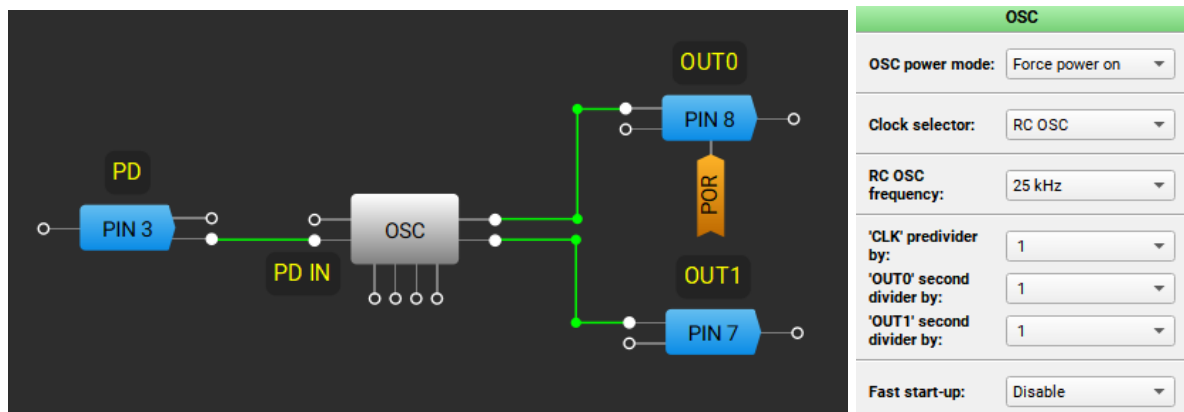
When a short pulse is applied to the PWR DOWN input, the oscillator exhibits a long start-up time.

When a short pulse of less than ~40 ns is applied to the PWR DOWN input.

If a pulse with a duration of less than ~40 ns is applied to the PWR DOWN input of the oscillator, the oscillator outputs remain stuck for milliseconds, as shown in figures below. This issue is observed for both 25 kHz and 2 MHz oscillators.
