Errata SLG46127 CE-GP-024

This document contains the known errata for SLG46127 and the recommended workarounds.

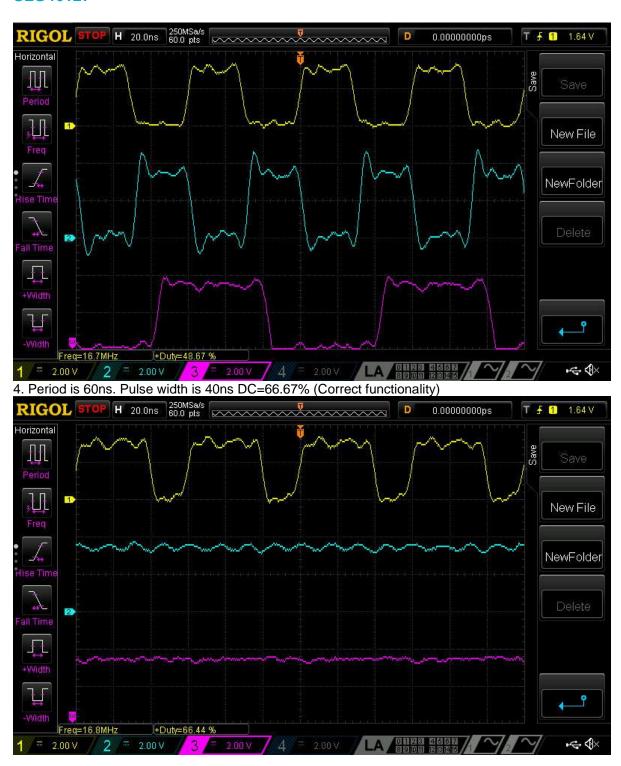
3. Period is 60ns. Pulse width is 30ns DC=50% (Incorrect functionality)

3.5.4 Workaround

Currently there is no workaround for this issue. Filter block is good at filtering short spontaneous glitches. It is intended to be used in series connection before the delay cell to avoid its latching (see issue #5).

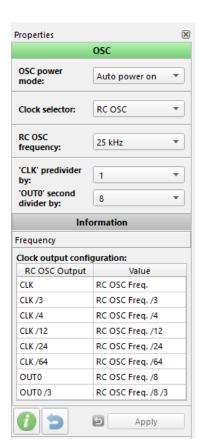
Normal oscillator behavior.
