# Errata

## SLG4653x

### CE-GP-002

*This document contains the known errata for SLG46533, SLG46534, SLG46535, SLG46536, SLG46537, SLG46538 and the recommended workarounds.*

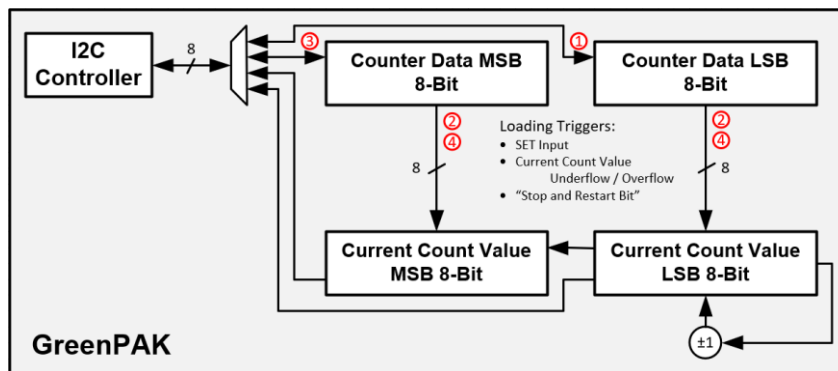
Figure 11: 16-Bit I2C Counter Block Diagram

As previously mentioned, the 16-bit value is loaded from the I2C buffers to the Counter Data registers in 8-bit chunks. Right at time “1”, the LSB byte (0x01) is loaded into the Counter Data registers. This makes the Counter Data value temporarily equal to 0x0001. At time “2” between the internal I2C load signals, the counter receives a rising edge on its clock input. This causes the Current Count Value to underflow and to be loaded with the Counter Data value which is 0x0001. At time “3”, the MSB byte (0x01) is loaded into the Counter Data registers setting the Counter Data value to 0x0101. At time “4”, the Current Count Value underflows again and is set to the Counter Data value of 0x0101.

This behavior results in two output pulses on OUT when only one pulse is expected. Observing this behavior depends upon the asynchronous timing between the counter’s clock and the I2C write command to the Counter Data registers. For some applications, the extra pulse on OUT can be ignored and the counter will self-correct after underflowing, overflowing, or being SET/RESET through the GreenPAK connection matrix.
