SLG46580

ISSUE 1: Long 2 MHz OSC Settling Time Functional Block Affected: OSC, Counter, Delay

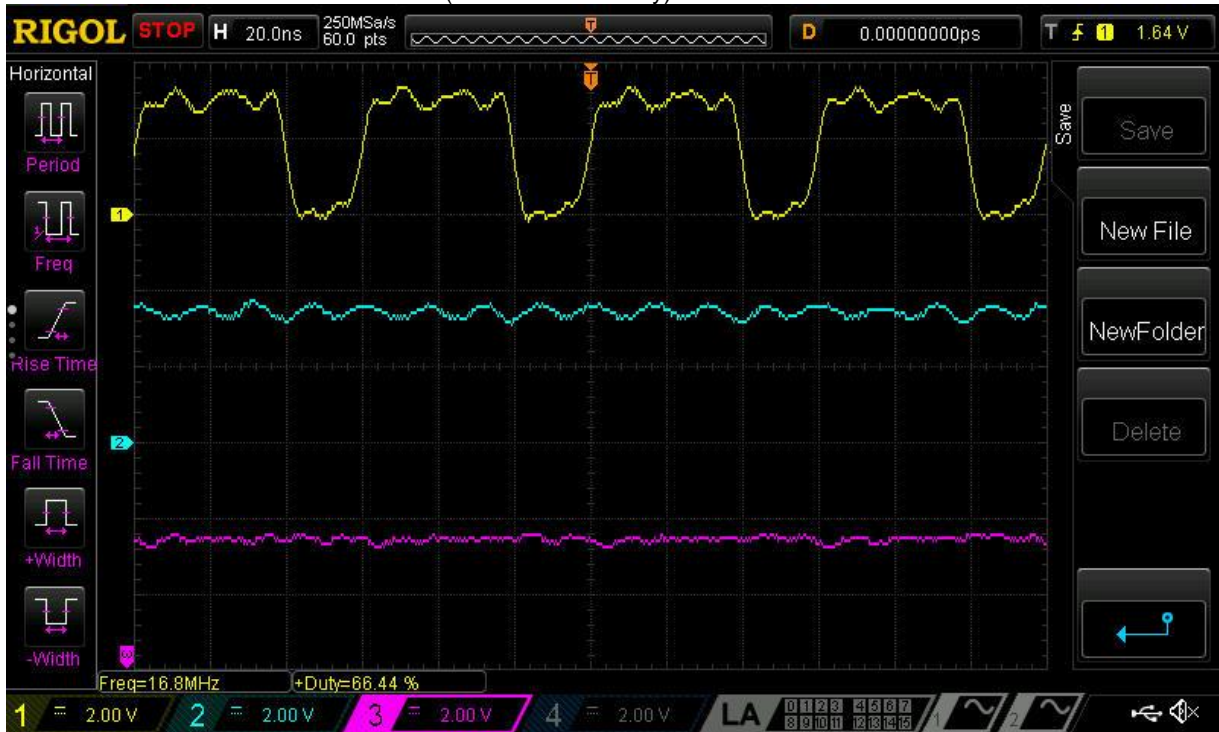
4. Period is 60ns. Pulse width is 40ns DC=66.67% (Correct functionality)

Currently, there is no workaround for this issue. The FILTER block correctly filters isolated glitches, but it shouldn't be used to filter repetitive, high frequency input signals.
