# Errata Sheet

## SLG46108

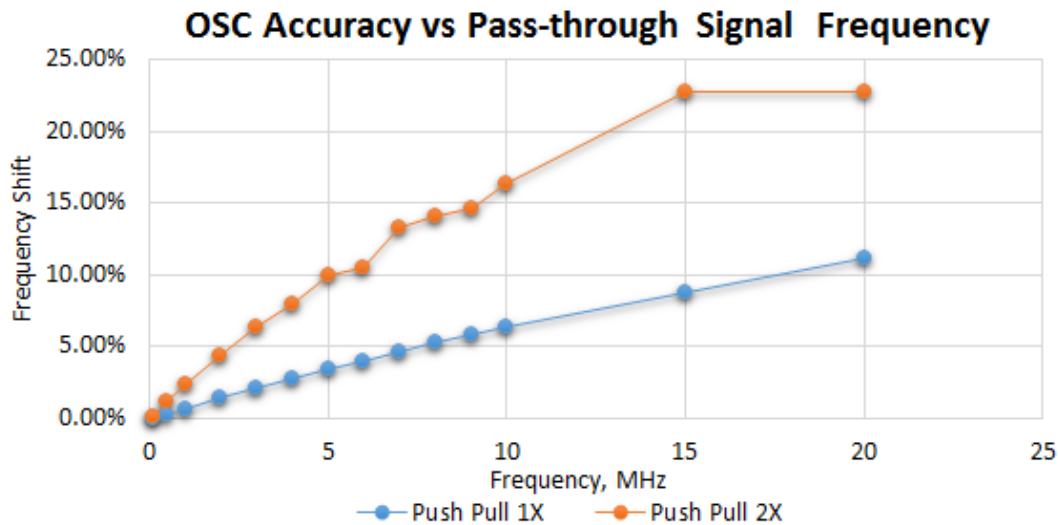
### OSC Accuracy vs VDD

While applying some high frequency noise to the VDD, OSC inaccuracy may increase. The same behavior is also present in cases where high frequency switches are outputted from the chip using the Push Pull type driver. See, test results below.

Additional frequency Shift by different PINs.

Currently there are no viable workarounds for this issue.
