Errata SLG46169 CE-GP-020

This document contains the known errata for SLG46169 and the recommended workarounds.

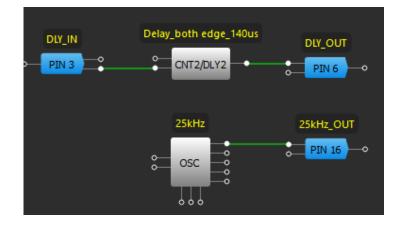
The first period of the RC OSC can be very short when OSC configured as 25 kHz with Auto Power On in the designs. This can occur when V_{DD} is above 4.0 V. Critical for CNT/DLY with a low counter data (less than 10) or if it is necessary to use the frequency of the OSC to clock external elements. An example of such issue is in the following configuration:
