SLG46580

ISSUE 1: Long 2 MHz OSC Settling Time Functional Blocks Affected: OSC, Counter, Delay

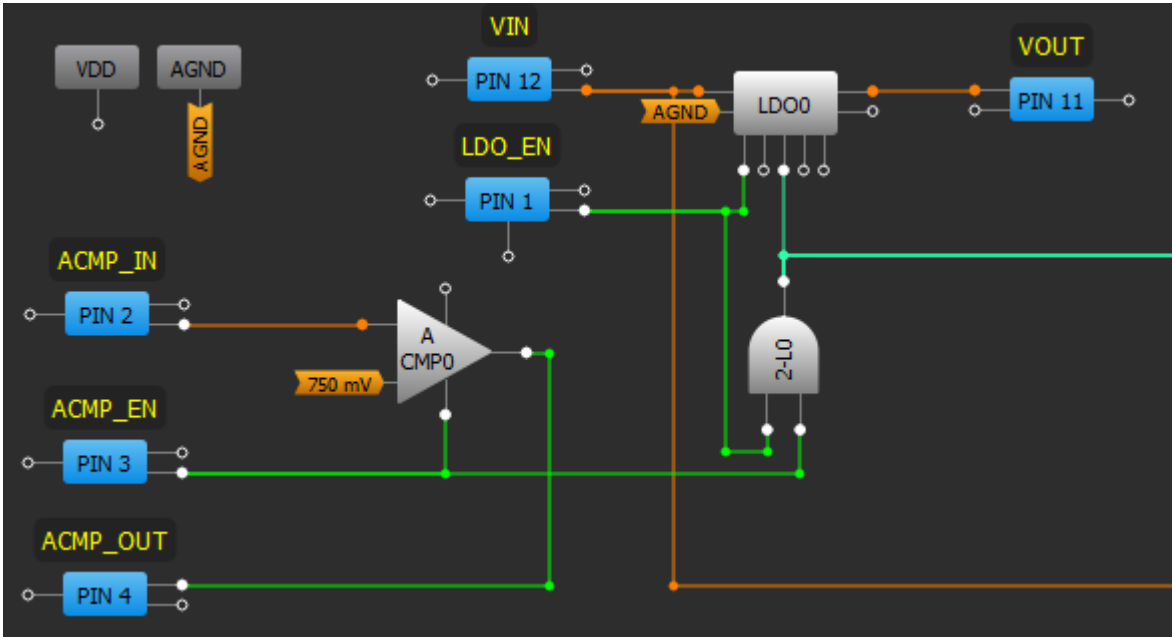
If an LDO's Low Power Mode is selected (for example tied to VDD) a glitch may appear on the ACMP's output after the first LDO is enabled. When the first LDO is turned on, the Low Power Mode switch causes a drop in the internal bandgap voltage that is used to derive the ACMP reference voltages.

- Use both edge delay on the output to filter out the glitch.
- Use some logic to avoid turning on Low Power Mode before enabling LDO and powering up the ACMP. Example is shown below.
