Errata

SLG46811

CE-GP-008

3.1 Incorrect 64 mV Hysteresis Operation while Using MS ACMP in Regular ACMP Mode

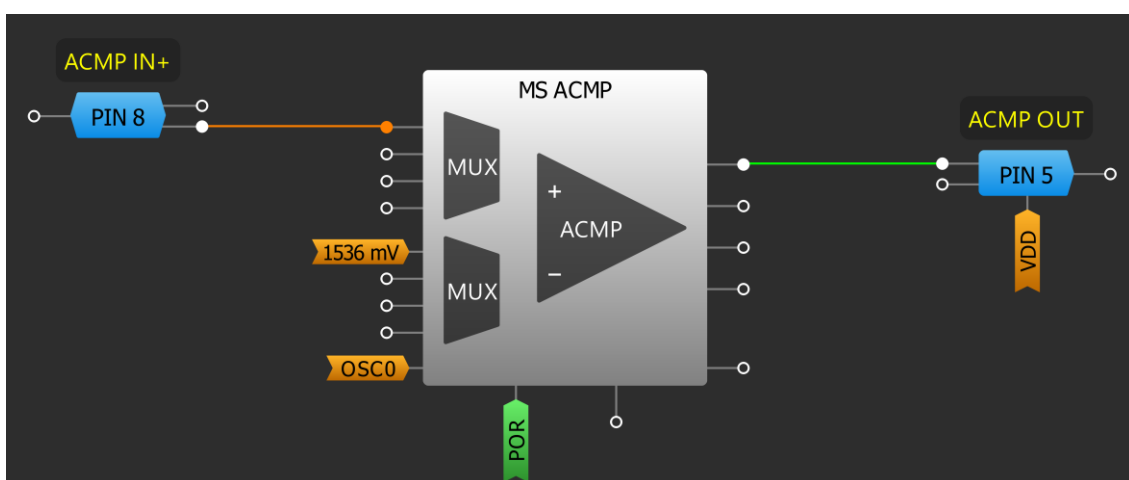
Figure 1: Testing Design

If using MS ACMP in Regular ACMP mode with 64 mV hysteresis, MS ACMP output could be glitching when MS ACMP positive input (IN+) close to the negative input (IN-). It can happen when $V_{DD} = 4.0$ V or higher and $V_{ref} = 1344$ mV or higher.

1. Use the deglitch filter connected to the MS ACMP output.
2. Decrease the reference (below 1344 mV) at $IN-$ and add the $IN+$ gain to keep the needed threshold.
3. Use MS ACMP in multichannel mode.
