RENESAS TECHNICAL UPDATE

Product Category	MPU/MCU		Document No.	TN-RZ*-A0082A/E	Rev.	1.00
Title	Initialization setting issue of CRU MIPI CSI2 Link Registers		Information Category	Technical Notification		
Applicable Product	RZ/G2L Group RZ/G2LC Group RZ/V2L Group	Lot No.	Reference Document	RZ/G2L Group, RZ/G2LC Group User's Manual: Hardware Rev.1.00 (R01UH0914EJ0100) RZ/V2L Group User's Manual: Hardware Rev.1.00 (R01UH0936EJ0100)		
		All lots

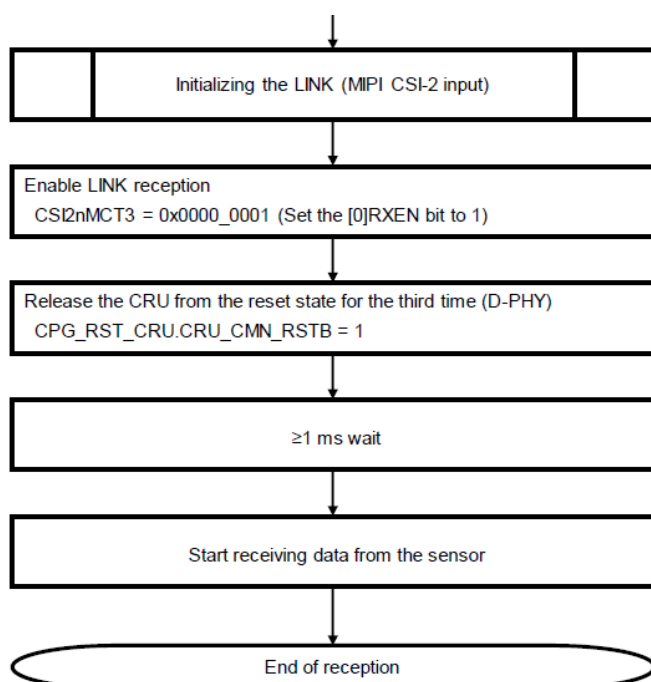
<Before>

At the time of initial setting, the following MIPI-CSI2 Link register setting may not be reflected correctly.

Additional operations are added to "35.3.1, Figure 35.33 Reception Start Flow for the MIPI CSI-2 Input" to avoid this issue.
