Microcontroller Technical Information

QB-78K0RKX3 In-Circuit Emulator for 78K0R/KE3, 78K0R/KF3, 78K0R/KG3, 78K0R/KH3, 78K0R/KJ3 Usage Restrictions	Document No.	ZBG-CD-08-0022	1/2								
	Date issued	June 5, 2008									
	Issued by	Development Tool Solution Group Multipurpose Microcomputer Systems Division Microcomputer Operations Unit NEC Electronics Corporation									
Related documents	QB-78K0RKX3 User's Manual: U17866EJ4V0UM00 QB-78K0RKX3 (Control Code: E, F, G, H, J, K, L, M) Operating Precautions: ZUD-CD-08-0072	Notification classification

Operating Precautions for QB-78K0RKX3

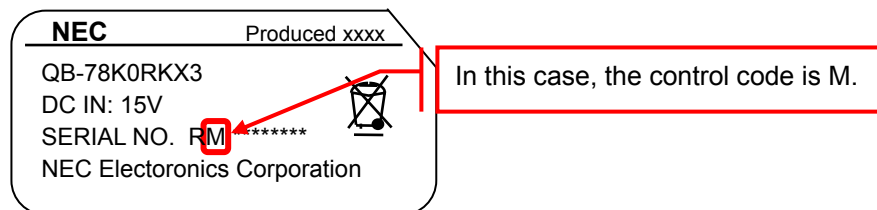
Figure 1. Checking Control Code (Label on QB-78K0RKX3)

The product versions of NEC Electronics in-circuit emulators are indicated by a control code. The control code is the second digit from the left in the 10-digit serial number. If the product has been upgraded, the control code can be checked by selecting [About] from the [Help] menu while the ID78K0R-QB is running. "X" in version information "IECUBE **** X F/W: V*.**" is the control code.
