# HITACHI SEMICONDUCTOR TECHNICAL UPDATE

| Classification of Production | MPU | | No | TN-SH7-412A/E | Rev | 1 |
| THEME | SH7615/SH7616 limitation of DACKn output timing. | | Classification of Information | 1. Spec change<br>2. Supplement of Documents<br>③ Limitation of Use<br>4. Change of Mask<br>5. Change of Production Line | | |
| PRODUCT NAME | HD6417615ARF<br>HD6417616RF | Lot No. | Reference Documents | SH7615 Hardware Manual<br>ADE-602-198 Rev.1.0<br>SH7616 Hardware Manual<br>ADE-602-243 Rev.1.0 | Effective Date | |

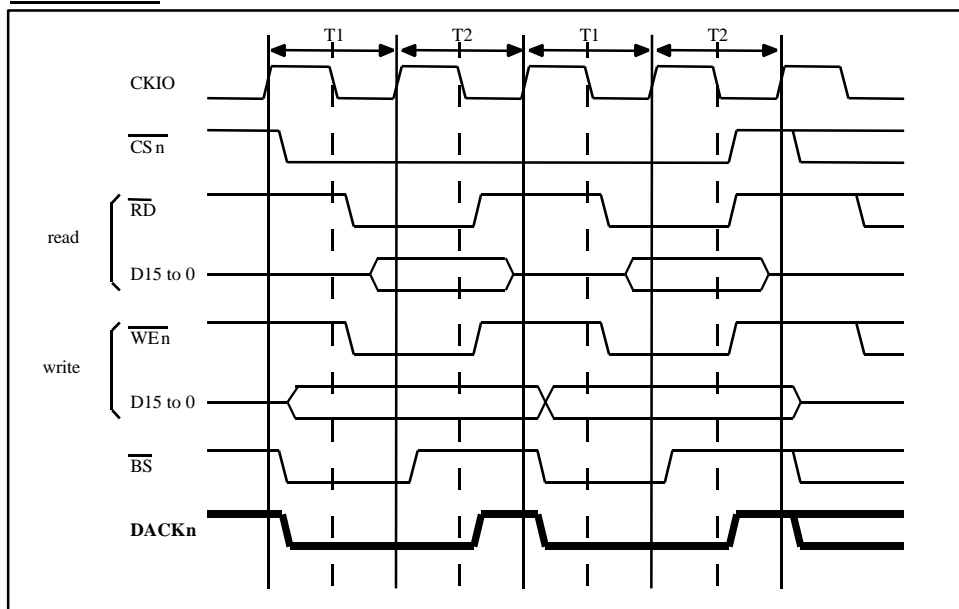
Correct timing

When all following conditions are met, SH7615/SH7616 DACKn(n=0,1) outputs with "Error timing".

- (1) I<sub>0</sub>:E<sub>0</sub>=1:1.
- (2) DMA transfer to Ordinary space or Burst ROM.
- (3) 16-byte/Long word DMA transfer on 16-bit bus width or 16-byte/Long word/Word DMA transfer on 8-bit bus width.
