# Microcontroller Technical Information

| | | Document No. | ZBG-CD-07-0062 | | 1/2 |
| QB-78K0KX2<br>In-Circuit Emulator for 78K0/KB2, 78K0/KC2,<br>78K0/KD2, 78K0/KE2, 78K0/KF2<br><br>Usage Restrictions | | Date issued | September 6, 2007 | | |
| | | Issued by | Development Tool Solution Group<br>Multipurpose Microcomputer Systems Division<br>Microcomputer Operations Unit<br>NEC Electronics Corporation | | |

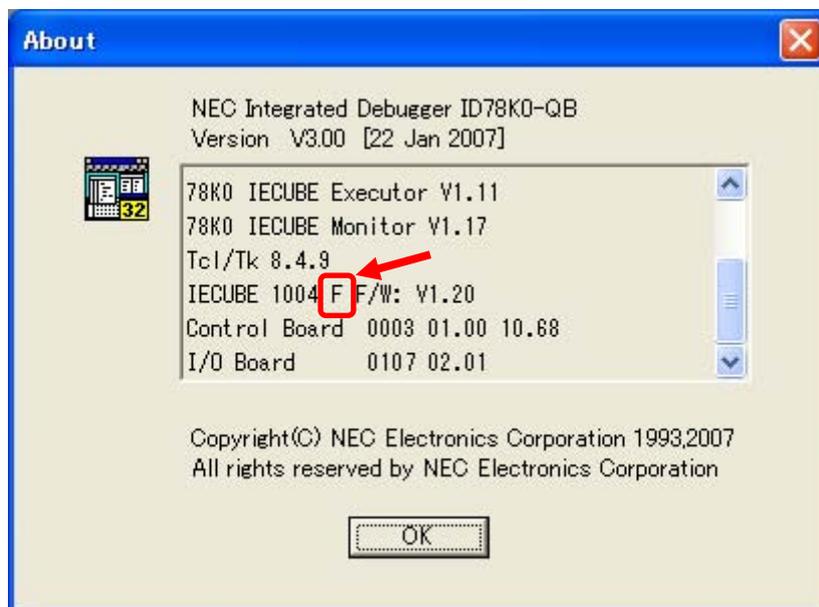
If the product has been upgraded, the control code can be checked by selecting [About] from the [Help] menu while the ID78K0-QB is running.

"X" in version information "IECUBE **** X F/W: V*.**" is the control code.

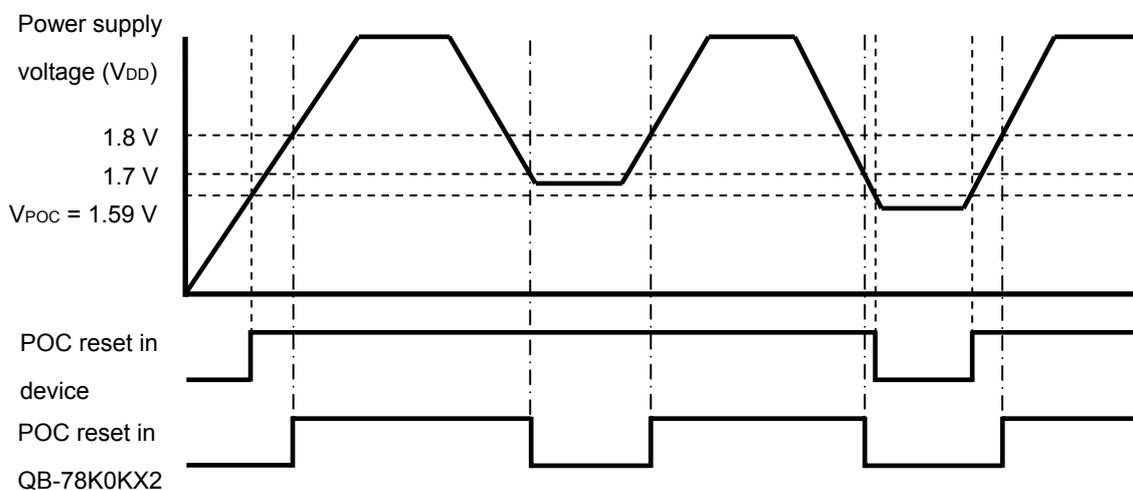
(1) In 1.59 V POC mode (option byte: POCMODE = 0)

The POC detection voltage differs between the QB-78K0KX2 and the device.

• Device:          An internal reset signal is generated at power application, and the reset state is released when the power supply voltage ($V_{DD}$) exceeds the detection voltage ($V_{POC}$ = 1.59 V ±0.15 V).

The power supply voltage ($V_{DD}$) and detection voltage ($V_{POC}$ = 1.59 V ±0.15 V) are compared, an internal reset signal is generated when $V_{DD}$ drops lower than $V_{POC}$ ($V_{DD} < V_{POC}$), and the reset state is released when $V_{DD}$ becomes $V_{POC}$ or higher ($V_{DD} \geq V_{POC}$).

• QB-78K0KX2:  An internal reset signal is generated at power application, and the reset state is released when the power supply voltage ($V_{DD}$) exceeds 1.80 V.

An internal reset signal is generated when $V_{DD}$ drops lower than 1.70 V ($V_{DD} < 1.70$ V), and the reset state is released when $V_{DD}$ becomes 1.80 V or higher ($V_{DD} \geq 1.80$ V).

There is no workaround. Regard this issue as a permanent restriction.

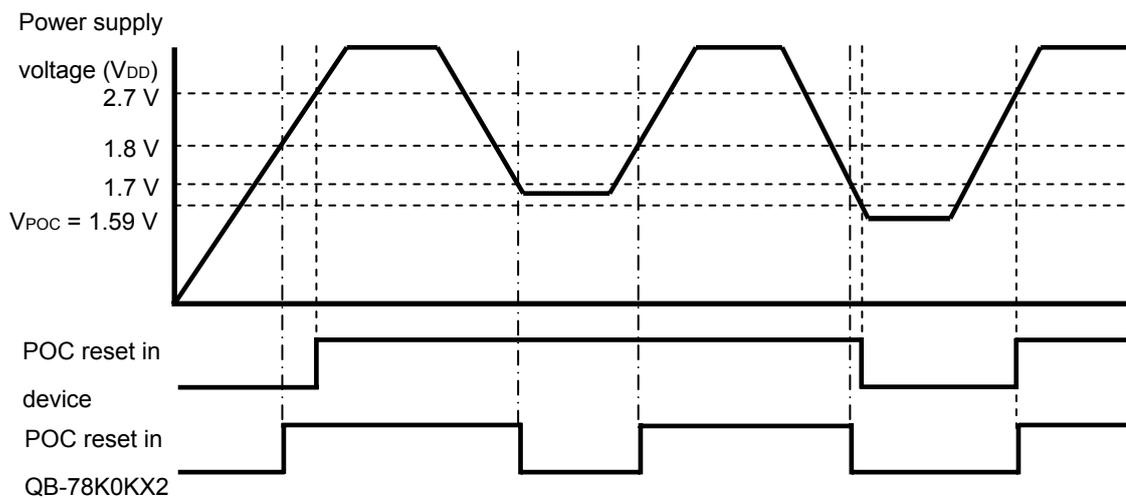
(2) In 2.7 V/1.59 V POC mode (option byte: POCMODE = 1)

• Device:          An internal reset signal is generated at power application, and the reset state is released when the power supply voltage ($V_{DD}$) exceeds $V_{POC}$ (power detection voltage at power application; $V_{POC}$ = 2.7 V ±0.2V).

The power supply voltage ($V_{DD}$) and detection voltage ($V_{POC}$ = 1.59 V ±0.15 V) are compared, an internal reset signal is generated when $V_{DD}$ drops lower than $V_{POC}$ ($V_{DD} < V_{POC}$), and the reset state is released when $V_{DD}$ becomes 2.7 V or higher ($V_{DD} \geq 2.7$ V).

- QB-78K0KX2: An internal reset signal is generated at power application, and the reset state is released when the power supply voltage ($V_{DD}$) exceeds 1.80 V.

An internal reset signal is generated when the detection voltage ($V_{POC}$ = 1.59 V $\pm$0.15 V) < $V_{DD}$ < 1.70 V, and the reset state is released when $V_{DD}$ becomes 1.80 V or higher ($V_{DD} \geq$ 1.80 V).

If the power supply voltage ($V_{DD}$) drops to a level of the detection voltage ($V_{POC}$ = 1.59 V $\pm$0.15 V), the reset state is released the next time the power supply voltage ($V_{DD}$) exceeds $V_{POC}$ (power detection voltage at power application; $V_{POC}$ = 2.7 V $\pm$0.2 V).

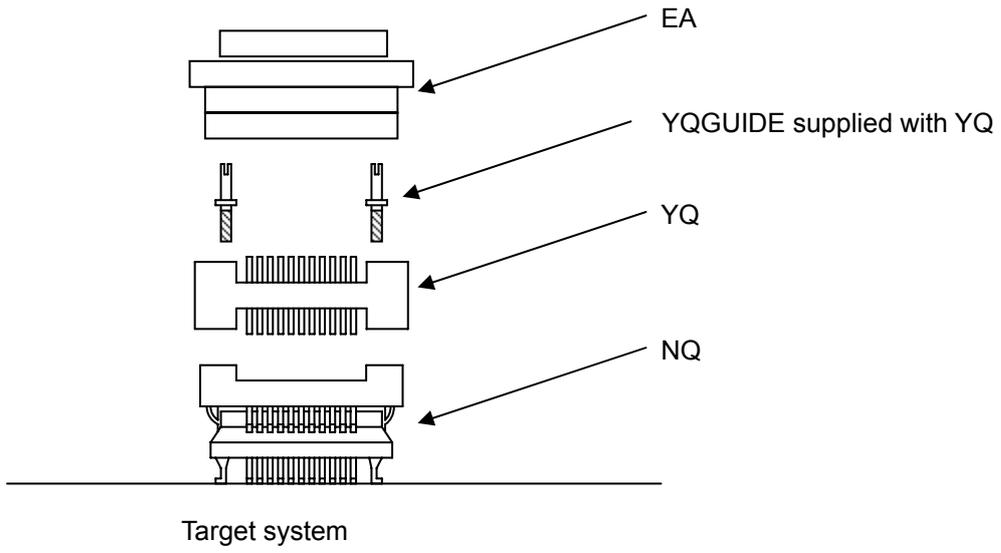
(1)  After confirming that there are no broken or bent YQ contact pins, fit YQ in NQ and fasten it using the supplied YQGUIDE (for the fastening method, see the next step, (2)).  If repeatedly inserting and removing, be sure to inspect the YQ pins before fitting.  If pins are bent, correct them using something thin and flat such as the edge of a knife.

(2)  Fasten YQ to NQ on the target system using the supplied YQGUIDE.  Fasten the screws equally in the four corners using the supplied flat-blade screwdriver or a torque driver.  The tightening torque of YQGUIDE is 0.054 Nm (MAX.).  Too great tightening causes bad connections.
Four screws for fitting to the MA (M2 $\times$ 10 mm / 4 units) are included with YQ.
