Errata

SLG46117

CE-GP-012

This document contains the known errata for SLG46117 and the recommended workarounds.

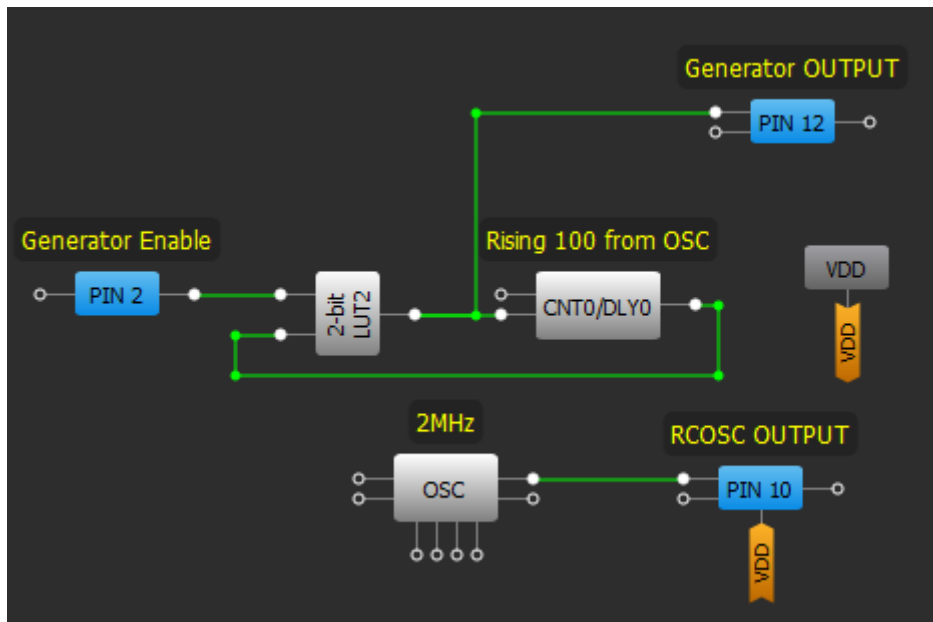
An example of such issue is in the following configuration:

The RC OSC has a longer settling time when configured as 2 MHz with Auto Power On in the designs that have very short RC OSC disable time.

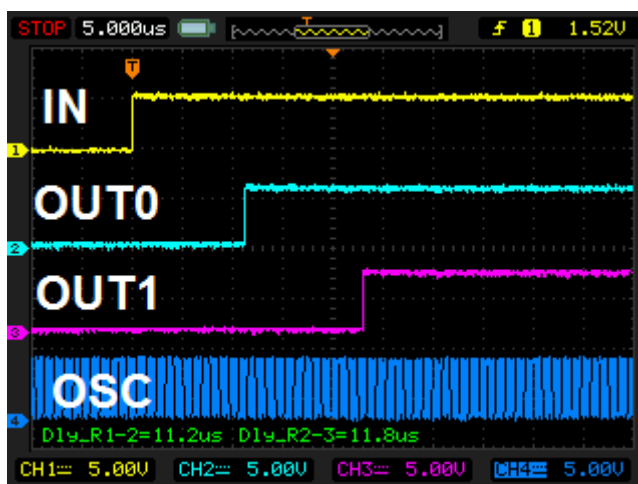
The configuration shown above generates a periodical signal with a frequency defined by the Delay cell and started by a HIGH signal on PIN2. The issue becomes apparent in a longer settling time when the scheme generates short pulses (Delay is configured as a rising edge delay only). See waveform below.

Channel 1 – 2-bit LUT0 output; Channel 2 – RC OSC output

Such behavior will lead to substantial error in period calculations if the delay time is relatively small.

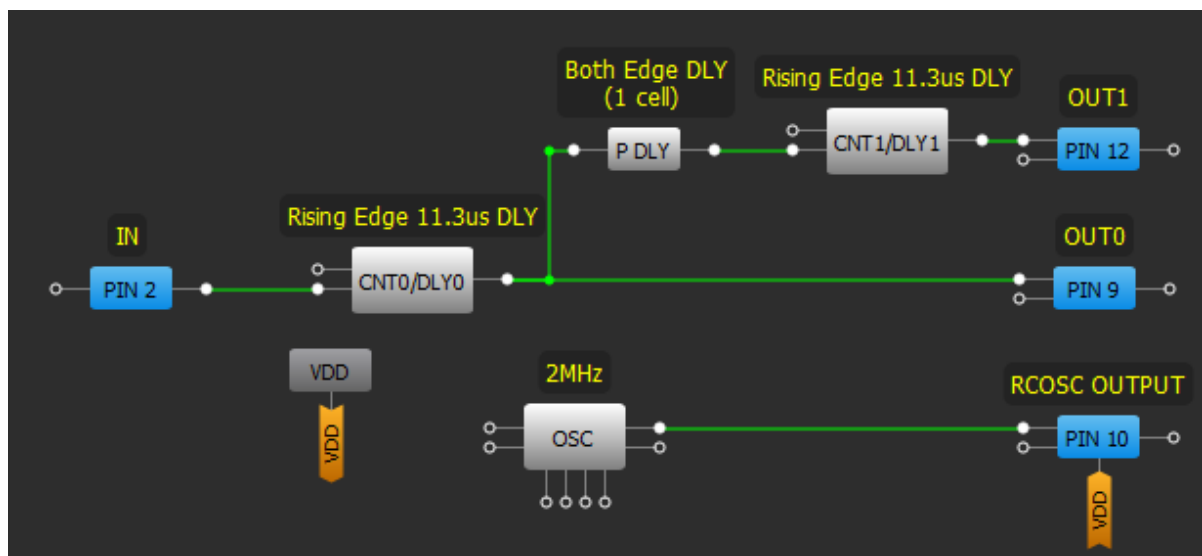
Channel 1 – 2-bit LUT0 output; Channel 2 – RC OSC output

- In first case use block with longer propagation time.

- using two delays in series (except for a pair "Rising edge DLY – Falling edge DLY") use one Filter cell or P DLY between delay blocks. Using LUTs won`t help in this case.

- use the "Force power on" RC OSC power control option to make the RC OSC operate at all times.

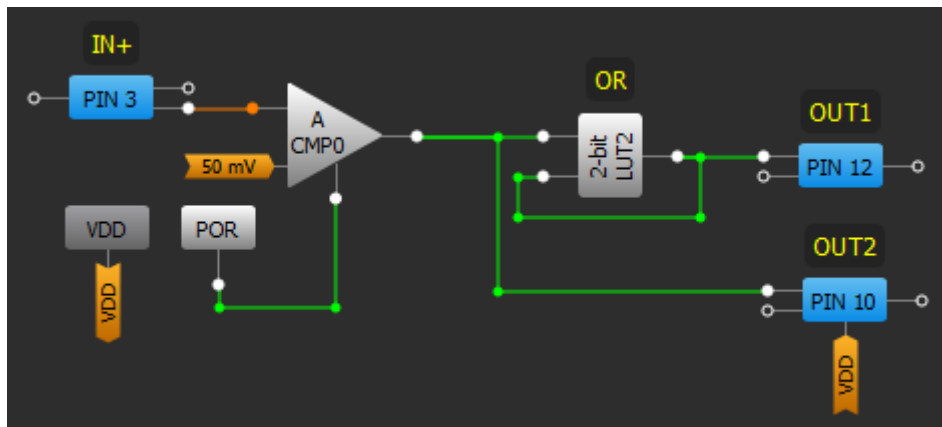
In some cases, ACMP may have short high-level glitches on its output (even if IN+ voltage is less than IN- voltage) after GreenPAK chip being powered up. Such cases may appear when using ACMP with Low Bandwidth mode enabled and Power Up is connected directly to the V_{DD}.

In order to detect such glitches, scheme with additional LUT was used. This LUT detects high level on ACMP output and stays high until chip powers down.

ACMP IN+ is connected to the Ground.

Use POR block, connected to the ACMP`s Power Up pin. However, in this case ACMP will start working with low level output and will be able to go high only after POR goes high + ACMP power on time.

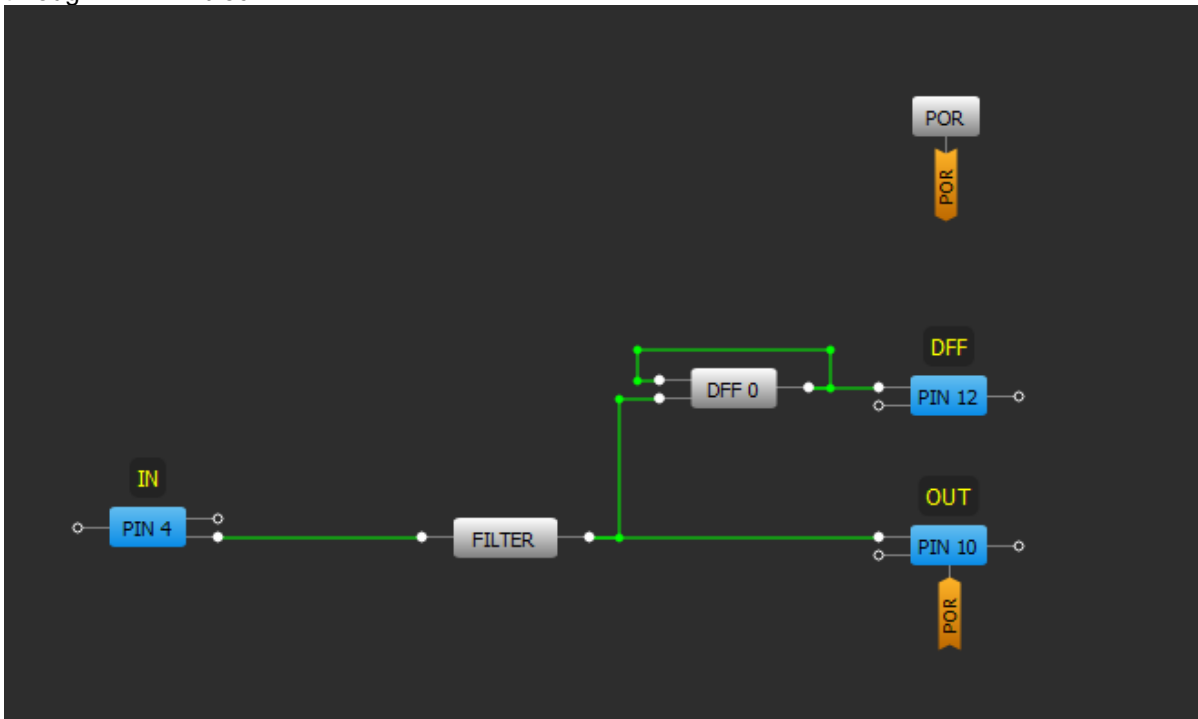
If clock type high frequency input comes in, the FILTER cell may not filter out it. There are several factors like input frequency, duty cycle and LOW duration in such signal that may lead to its passing through FILTER block.

Channel 1 (yellow/top line) – PIN#4 (IN)
Channel 2 (light blue/2nd line) – PIN#10 (OUT)
Channel 3 (magenta /3rd line) – PIN#12 (DFF)

1. Period is 60ns. Pulse width is 10ns DC=16.7% (Correct functionality)

2. Period is 60ns. Pulse width is 20ns DC = 33.3% (Incorrect functionality)

3. Period is 60ns. Pulse width is 30ns DC=50% (Incorrect functionality)

4. Period is 60ns. Pulse width is 40ns DC=66.67% (Correct functionality)

Currently there is no workaround for this issue. Filter block is good at filtering short spontaneous glitches. It is intended to be used in series connection before the delay cell to avoid its latching (see issue #5).

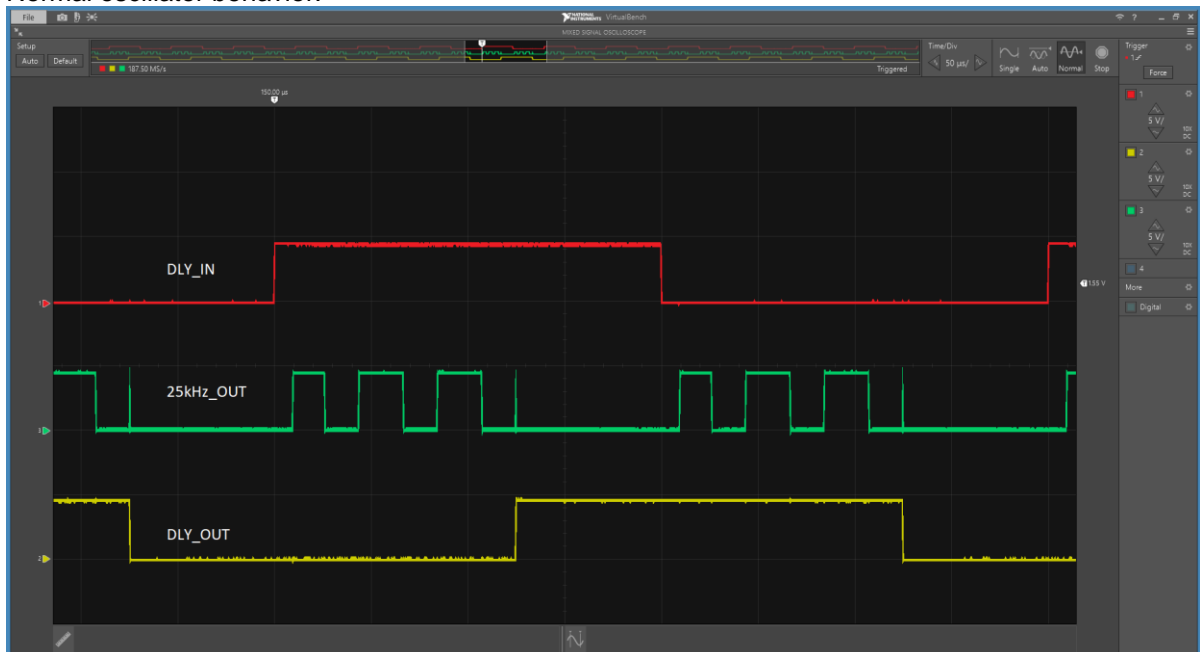
Abnormal oscillator behavior.

- Avoid V_{DD} higher than 4 V
- Force ON OSC
