Errata

SLG46826

CE-GP-015

This document contains the known errata for SLG46826 and the recommended workarounds.

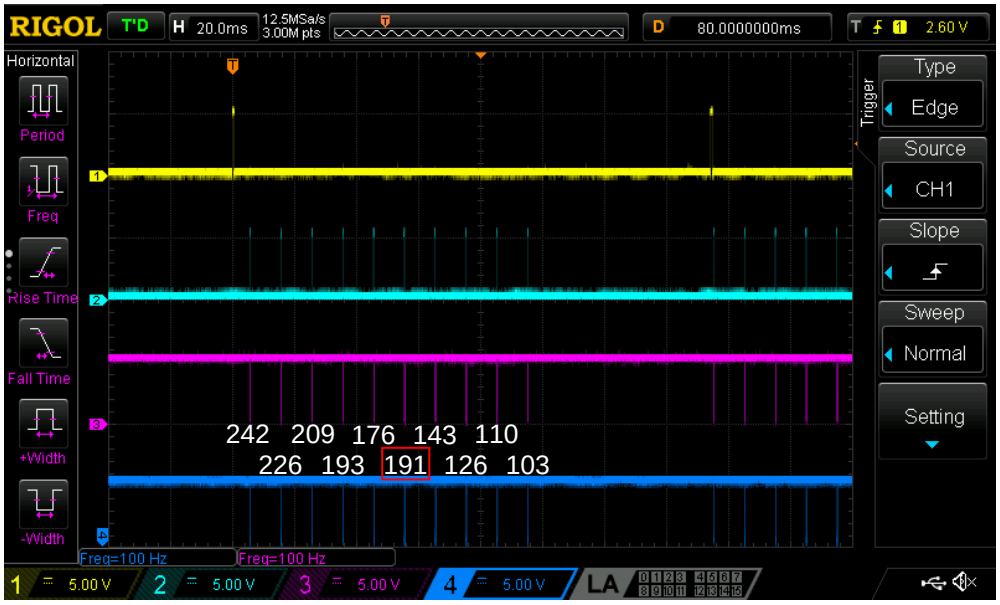
Figure 1: Example Data

Asynchronous interaction between the CNT/DLY clock input and the I²C latch signal (generated by an I²C read command of the CNT/DLY block's count value) can result in an incorrect I²C data read. The CNT/DLY block will count accurately, but the count value transferred into the block's I²C read register might be loaded incompletely if the I²C latch signal and the clock input occur at about the same time.

The example data capture below shows ten periodic I²C reads of CNT2/DLY2 configured to count down at about 16 clocks per read. The sixth read sample erroneously shows a value greater than that of the fifth. The seventh sample reads as if the previous I²C error never occurred - the difference from the fifth sample (176) to the seventh (143) is 33 clocks or 16 clocks + 17 clocks as expected.

If the possibility of incorrect I²C data reads can't be accommodated for by external software checks, one can guarantee proper operation by stopping the CNT/DLY block's clock during I²C reads through one of the following methods: by disabling the oscillator block, by reconfiguring the CNT/DLY block's clock source, or by gating an external clock using a LUT (Look Up Table) in the signal matrix. After disabling the CNT/DLY block's clock, the count registers can be read without error. Please note that this workaround will add the I²C read and processing time to the counter's overall clock period.

The best workaround depends on the resource constraints of the application. If the oscillator block doesn't clock other logic elements within the design, a matrix output can be used to manually power down the oscillators for the I²C read. When the CNT/DLY block's clock source is routed internally from the oscillator block, I²C commands can temporarily reconfigure the CNT/DLY block's clock source registers to select "Ext. CLK. (From Matrix)." This action will disable the clock by connecting it to ground. If the CNT/DLY block is clocked from the signal matrix, the LUT can be used to gate the clock during the I²C read.

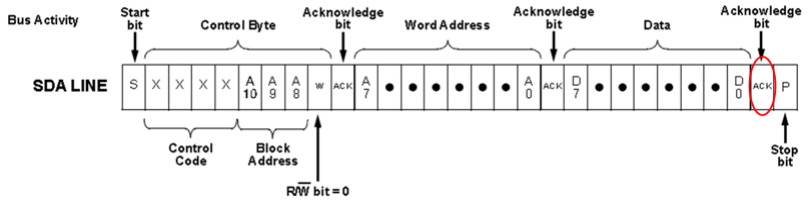
Figure 2: GreenPAK I²C Write Frame for Page Erase

To erase the NVM and the EEPROM, one must perform an I²C write to the "Page Erase Byte" located at 0xE3. The ACK bit which follows the "Data" portion of Figure 2 won't comply with standard I²C specifications. Please see the ACK bit circled in RED below.

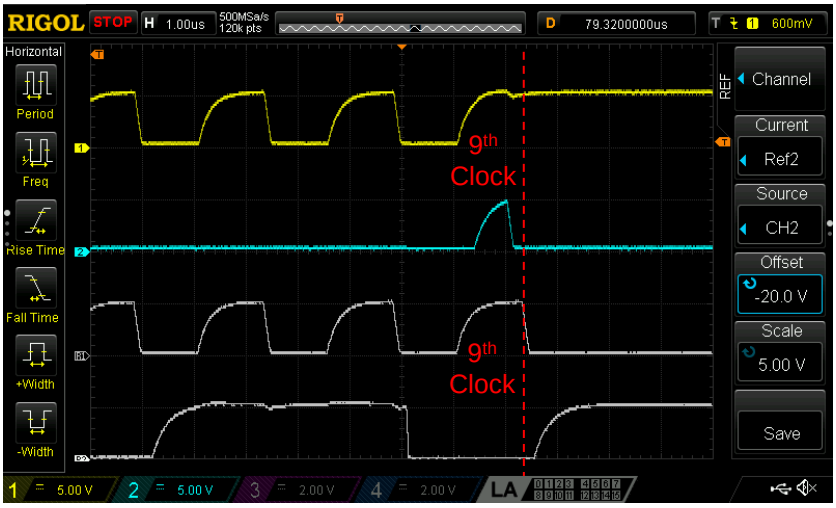
Figure 3: Non-I²C Compliant Behavior Oscillogram

The following waveform compares the regular I²C ACK behavior (Ref 1 - SCL and Ref 2 - SDA) with the non-compliant ACK behavior (Channel 1 - SCL and Channel 2 - SDA) generated by an I²C write to the “Page Erase Byte.” During the 9th clock cycle, the SLG46826 does not adhere to the “data hold time” specification by releasing SDA (Channel 2) before the falling edge of the clock pulse on SCL (Channel 1).

Note 1 It should be noted that the NVM and EEPROM erases will execute properly inside the GreenPAK device despite a potential I²C NACK. In addition, this behavior only applies to the “Page Erase Byte.” All other I²C writes won’t exhibit this behavior.

On a system level, other I²C devices might interpret this non-compliant ACK as an additional STOP and START condition. By definition, a START condition occurs when SCL is HIGH and SDA transitions from HIGH to LOW. A STOP condition occurs when SCL is HIGH and SDA goes from LOW to HIGH. After the 9th clock cycle, the MCU should generate the final STOP condition to indicate the end of transmission to all I²C slaves on the bus.

No workaround is required for the GreenPAK device as the NVM and EEPROM erase operations will execute properly. For verification, one can perform an I²C read of the erased pages. Excluding protected pages, all erased NVM and EEPROM registers should be cleared.

Adjust the MCU’s I²C firmware to catch and ignore a “NACK” from the GreenPAK device when the “Page Erase Byte” is addressed. In light of the additional STOP and START conditions, the behavior of other I²C slaves on the same bus should be evaluated.

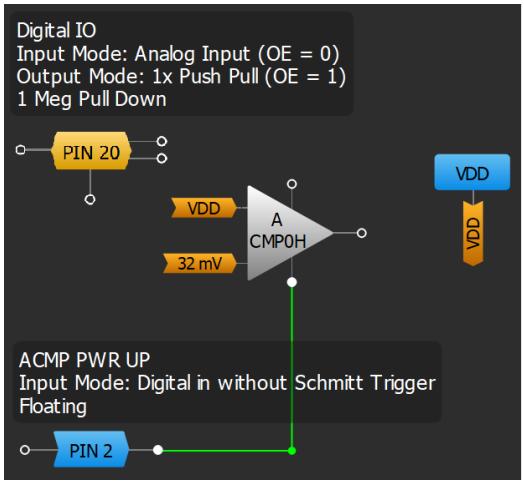
Figure 4: GreenPAK Input Structure Test Schematic

Figure 4 shows the GreenPAK configured with IO14 as a Digital IO with a 1 MΩ pull-down resistor. Since the OE pin is connected to 0 V, this pin is acting as an “Analog IO.” As seen in Table 2, IO14 and V_{DD} are both input options for ACMP0H. In this example, IO0 is being used as a digital input to enable and disable the ACMP.

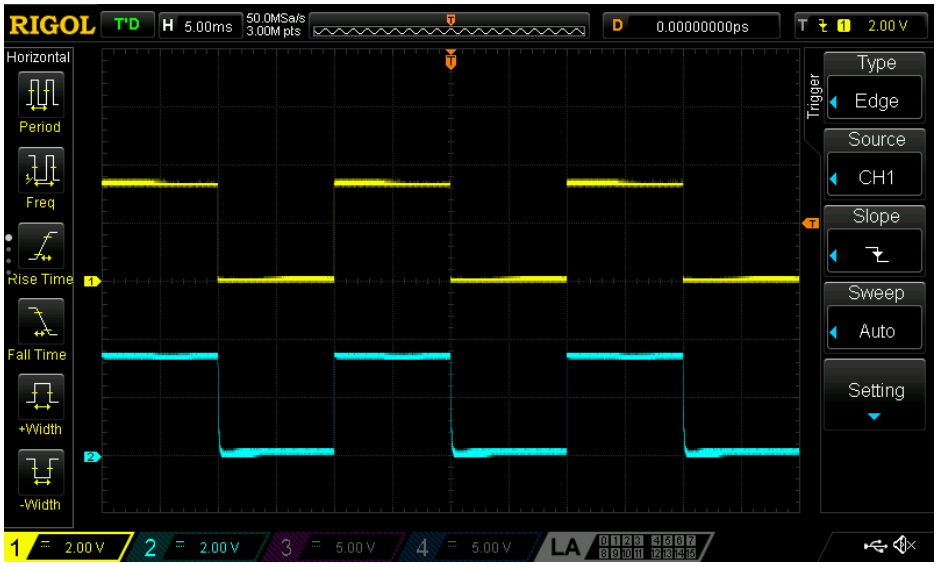
Figure 5: ACMP Input Structure Behavior

Figure 5 shows that IO14 in analog input mode is pulled HIGH by the V_{DD} signal whenever the ACMP is enabled despite having an internal pull-down resistor. This behavior is caused by an internal connection between V_{DD} and IO14. Similar behavior can be reproduced when one ACMP’s IN+ port is connected to another ACMP’s IN+ port.

If an ACMP is disabled, the IO associated with that ACMP will operate as expected under any configuration. Please reference Table 2 for more information regarding which IOs are associated with which ACMPs.

There is no workaround for this behavior. With this in mind, the IOs should not be used as digital IOs (with "Input mode" set to Analog input) or as digital outputs (with "Output mode" set to 1/2/4x 3-State Output) if the respective ACMP is enabled and connected to another input source.

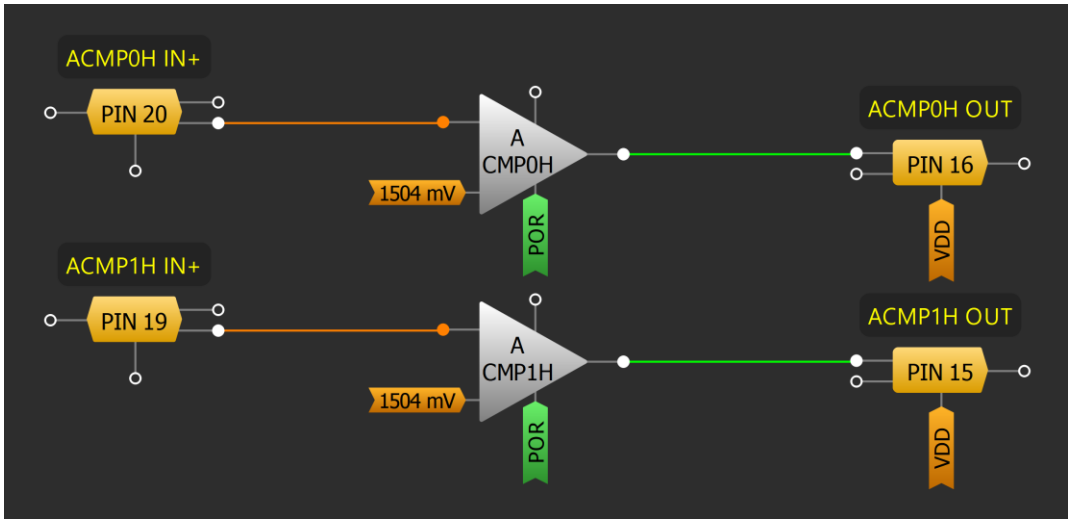
Figure 6: Testing Design

If using ACMPxH with 32 mV hysteresis, ACMPxH output could be glitching when ACMPxH positive input (IN+) is close to the negative input (IN-). It can happen when V_{DD} = 4.0 V or higher and Vref ranges from 0.832 V to 1.024 V, and 1.312 V to 1.44 V.

1. Use the deglitch filter connected to the ACMPxH output.
2. Avoid conditions described in paragraph 3.4.2.

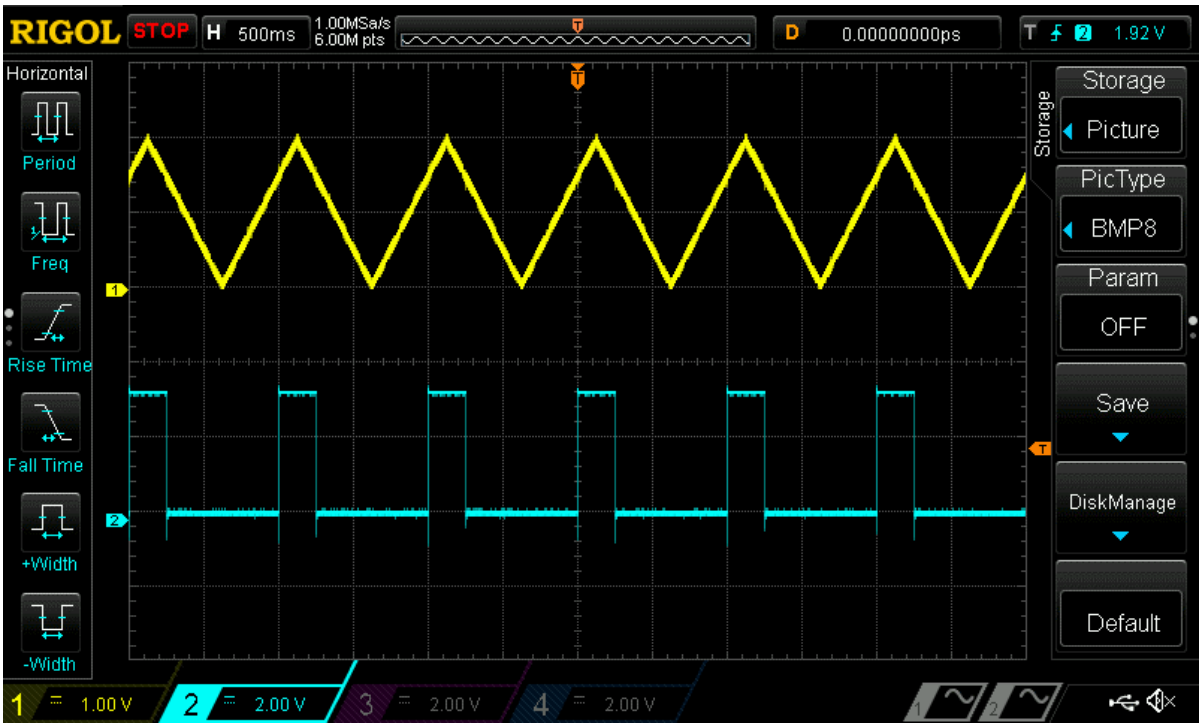
Figure 7: ACMP Output during Glitching

1. Waveform at Vref = 1504 mV, hysteresis is equal to 32 mV.

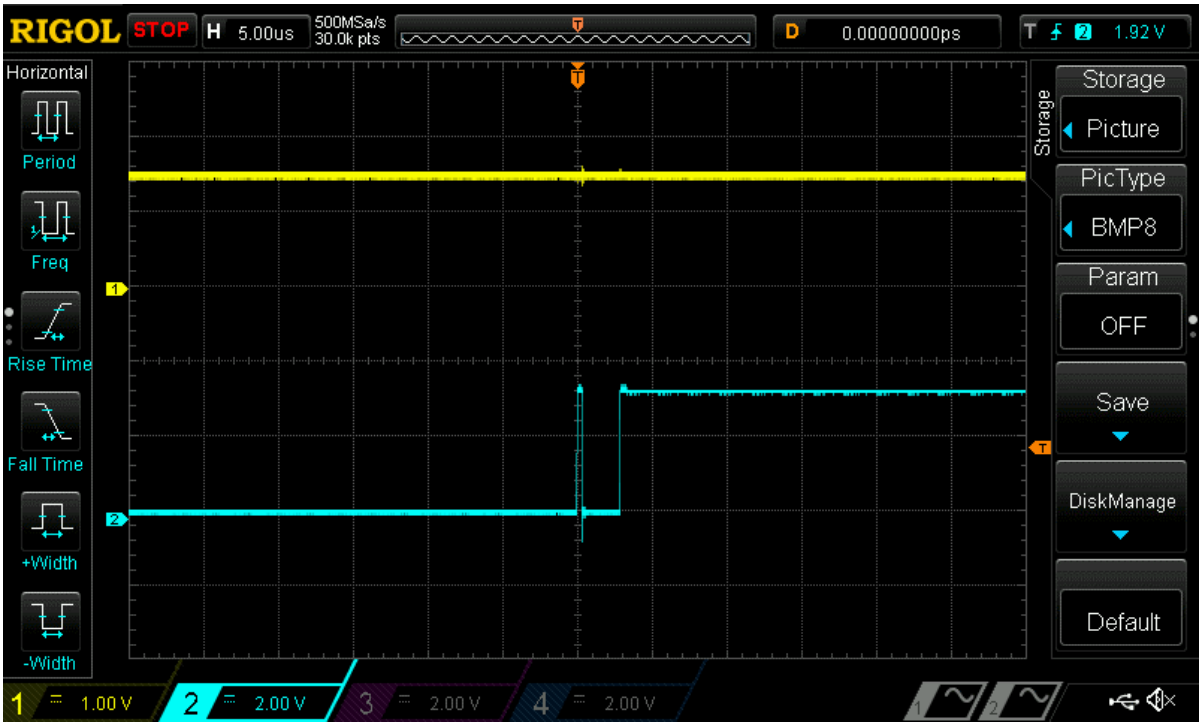
Figure 8: Zoomed ACMP Output during Glitching

2. Waveform at Vref = 1504 mV, hysteresis is equal to 32 mV (zoomed rising edge).

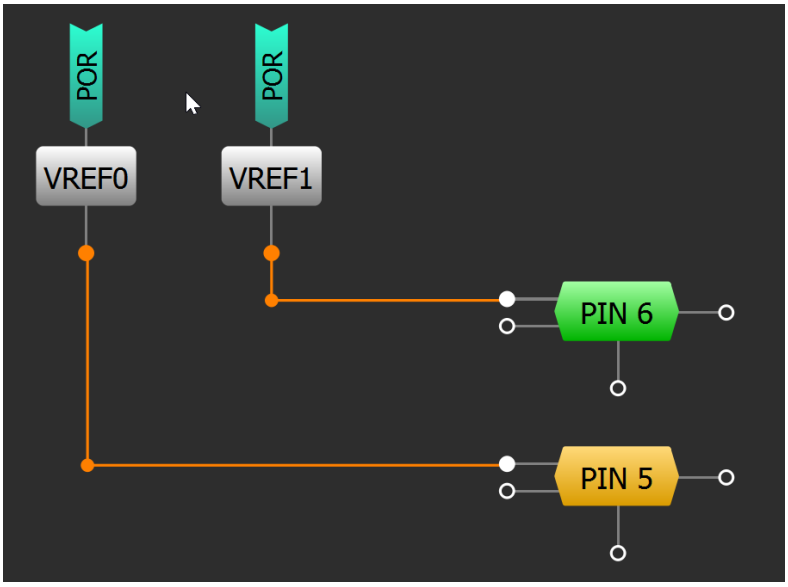
Figure 9: Testing Design

If using Vref output in the range of 32 mV to 192 mV connected to the analog input/output PIN, the Vref accuracy is very low due to the built-in buffer's offset.
