Customer Notification

Flash Programmer

PG-FP4-E

Operating Precautions

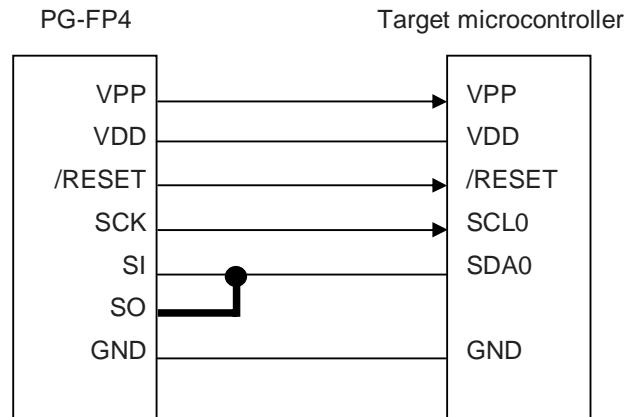
Connection example

When using IIC communication mode with PG-FP4 control code B, short the SI and SO pins in the PG-FP4.

The IIC communication mode adapter board is included in products with control code C (firmware: V1.17, GUI: V2.00) and later. Use the IIC communication mode adapter board for IIC communication.

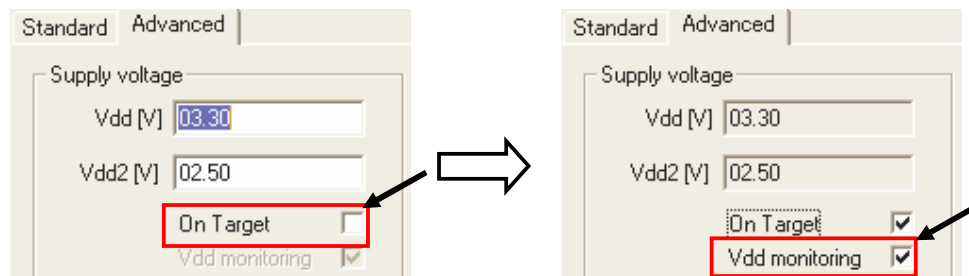
[Description]

Caution When this function is disabled, the product can be used even if the VDD pin of the target system and that of the PG-FP4 are not connected, as long as the VDD generated in the target system and the VDD of the output signal generated by the PG-FP4 match.

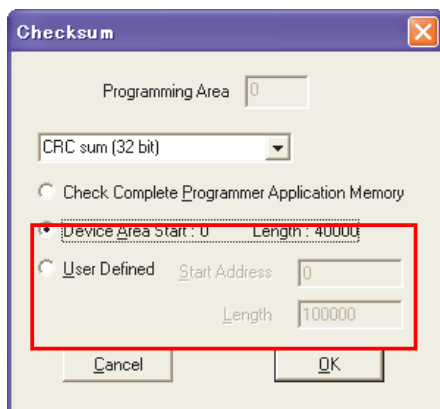
<When a parameter file that does not support the data flash area is downloaded>

When [Checksum] in the [File] menu is executed, the window display varies depending on whether or not the downloaded parameter file supports the data flash area.

After clicking the OK button, the following information will be displayed in the File Checksum area of the programmer parameter window.

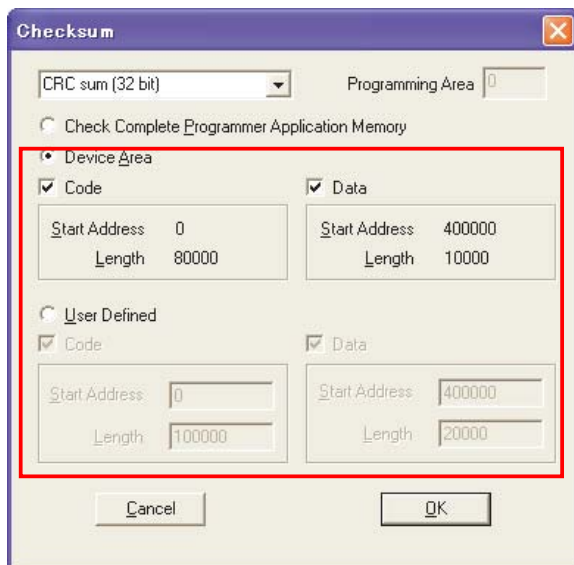
<When a parameter file that supports the data flash area is downloaded>

After clicking the OK button, the following information will be displayed in the File Checksum area of the programmer parameter window.

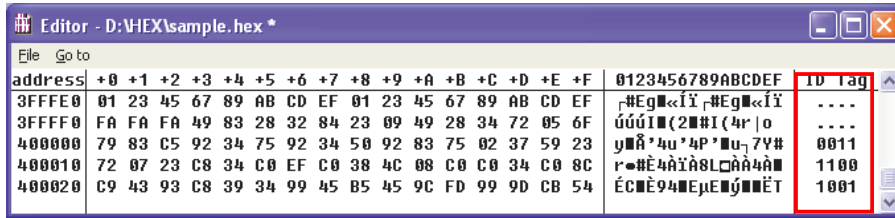
An ID Tag row has been added to the [HEX Editor] in the [File] menu. The ID Tag row is used in microcontrollers that support the data flash area. Only the values at addresses 400000h and beyond can be edited in the ID Tag row.

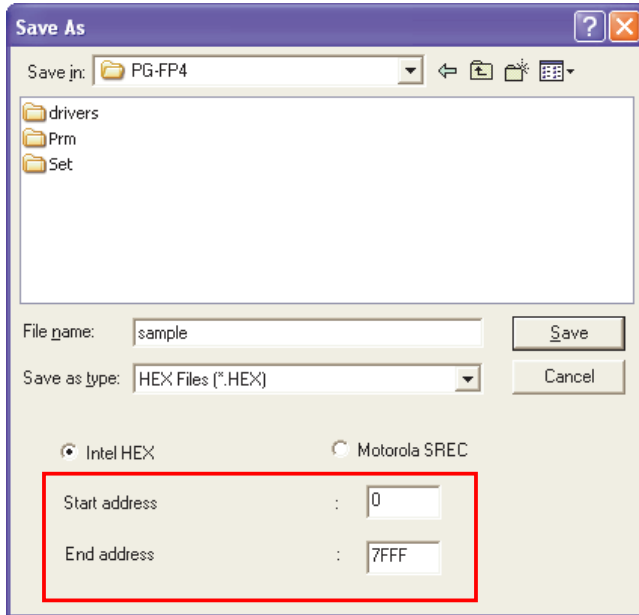
<When a parameter file that does not support the data flash area is downloaded>

When a parameter file is downloaded using the [HEX Editor] and the file is saved as, the available options in the [Save As] window vary depending on whether or not the downloaded file supports the data flash area.

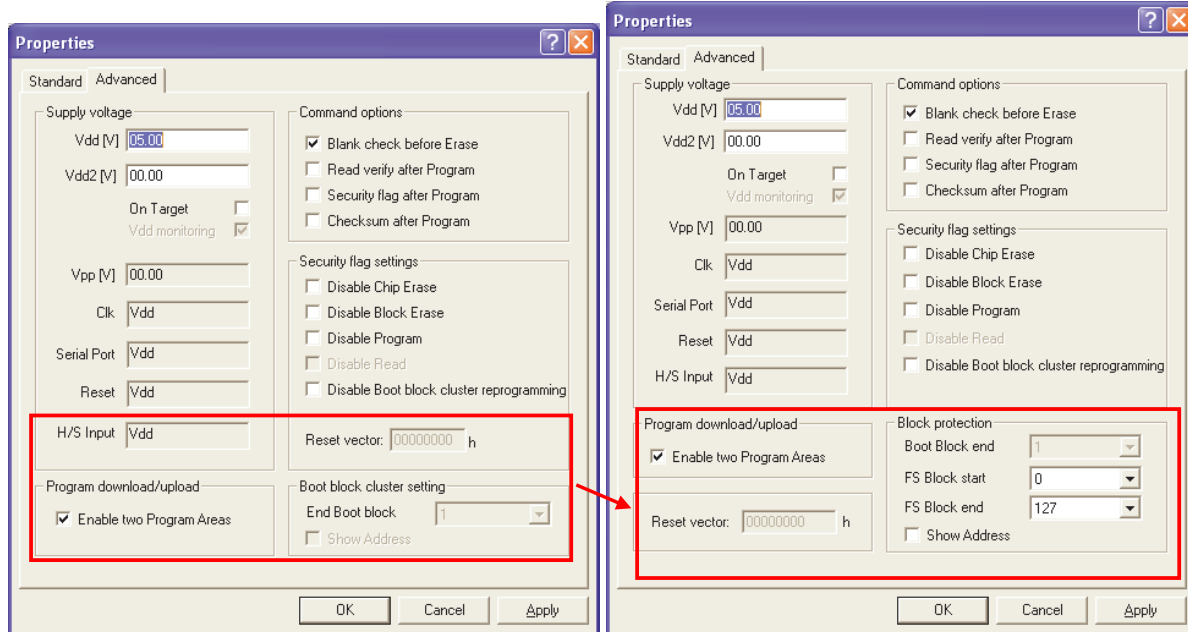
GUI V2.17 and later

[Reset vector] text box

When the [Security] command is executed with an arbitrary address value specified in this text box, the reset vector will be changed to the specified address. This setting is cleared when the [Erase] command is executed with the "Chip" option specified in the Operation Mode area on the Standard tab. The initial value is 00000000h.
