Renesas RA Family

Standard Boot Firmware for the RA family MCUs Based on Arm® Cortex®-M33

Introduction

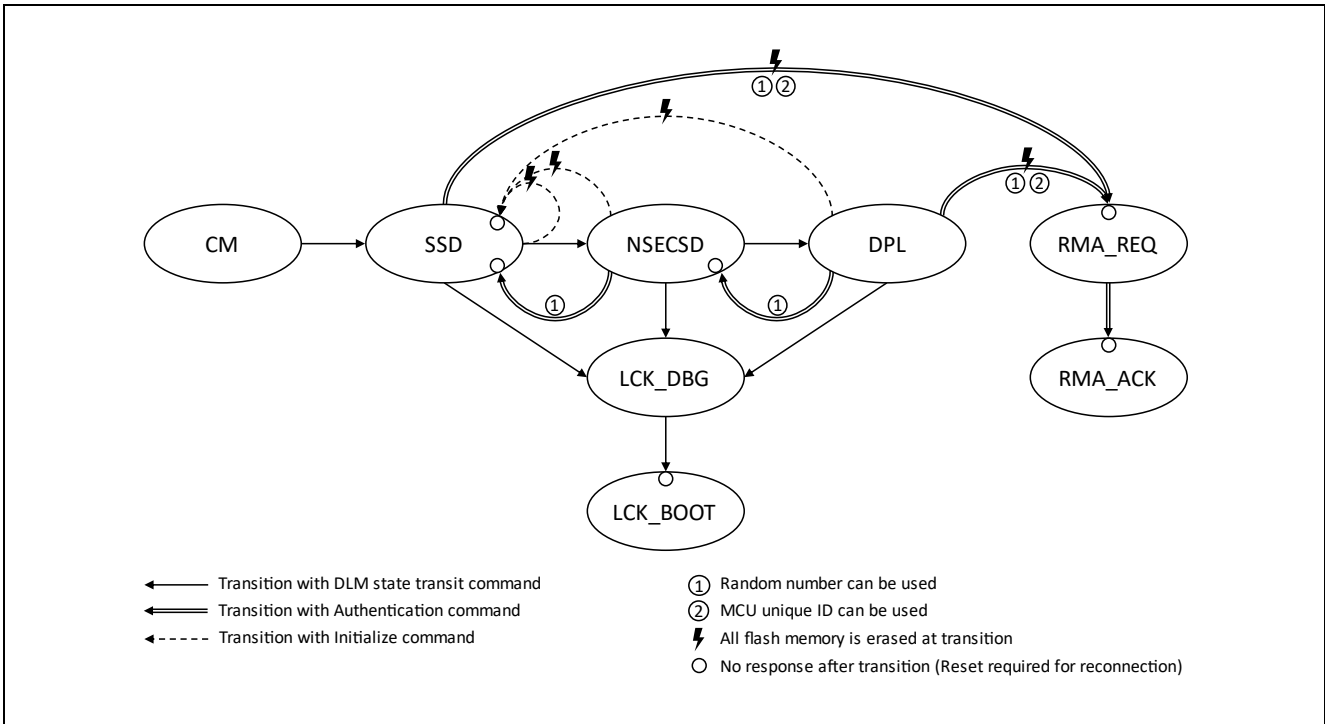
6.1 Device Lifecycle Management (GrpA, GrpB, and GrpC)

The following DLM state transitions can be triggered by each command:

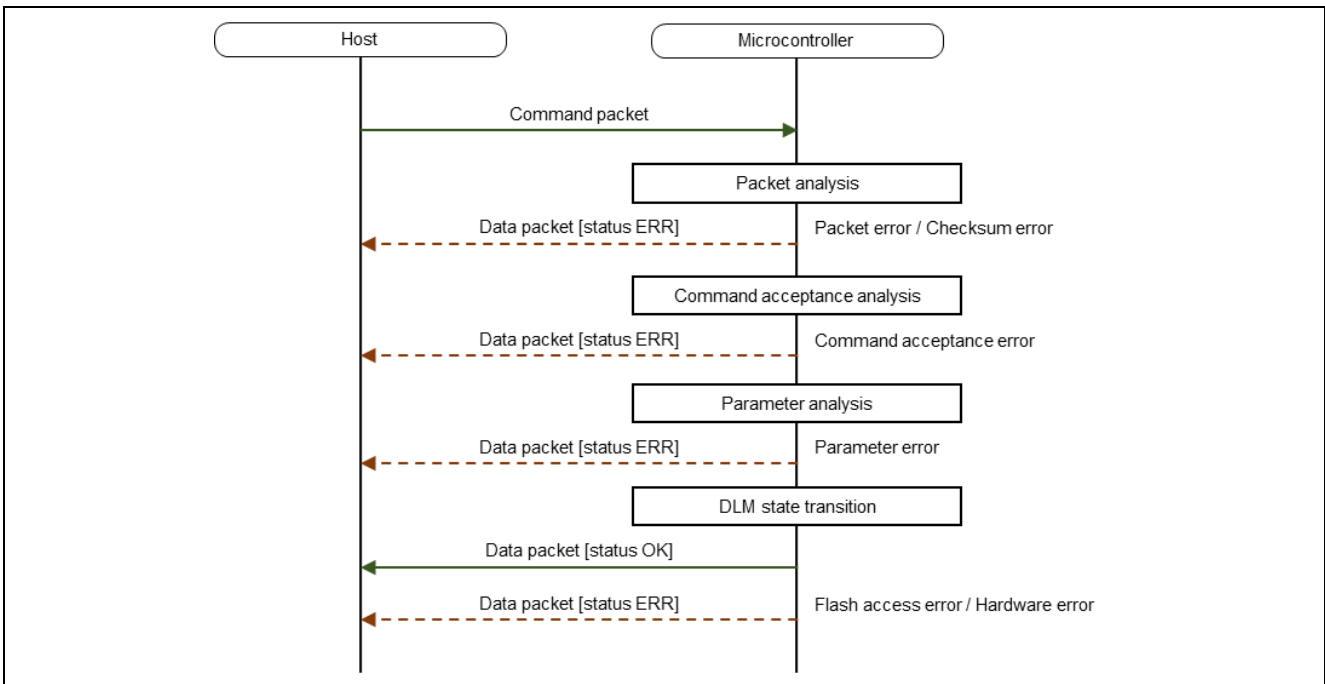
6.2.1 Sequence diagram

This command transitions the DLM state without authentication. The boot firmware is hung when the DLM state transitions to LCK_BOOT.

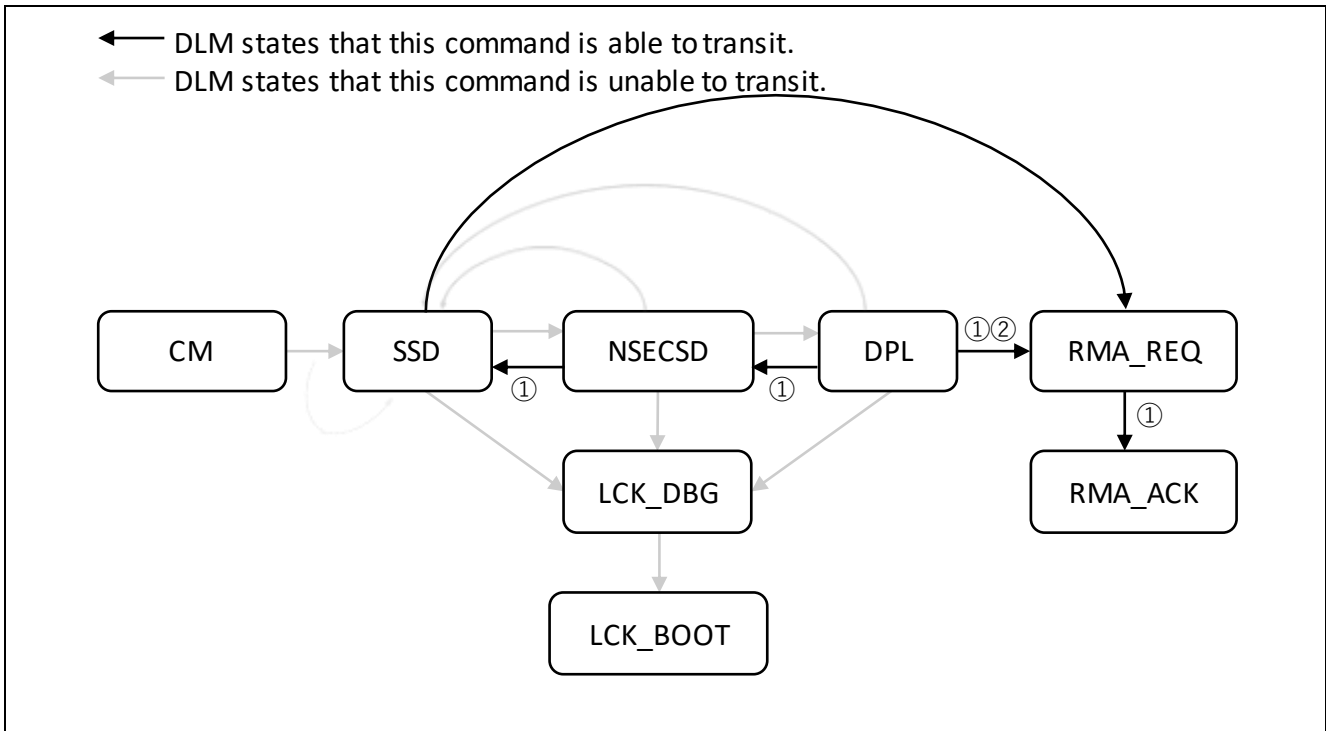
6.3.6 DLM state transition for GrpA, GrpB, and GrpC

The following diagram shows the DLM state that can be transit by this command.

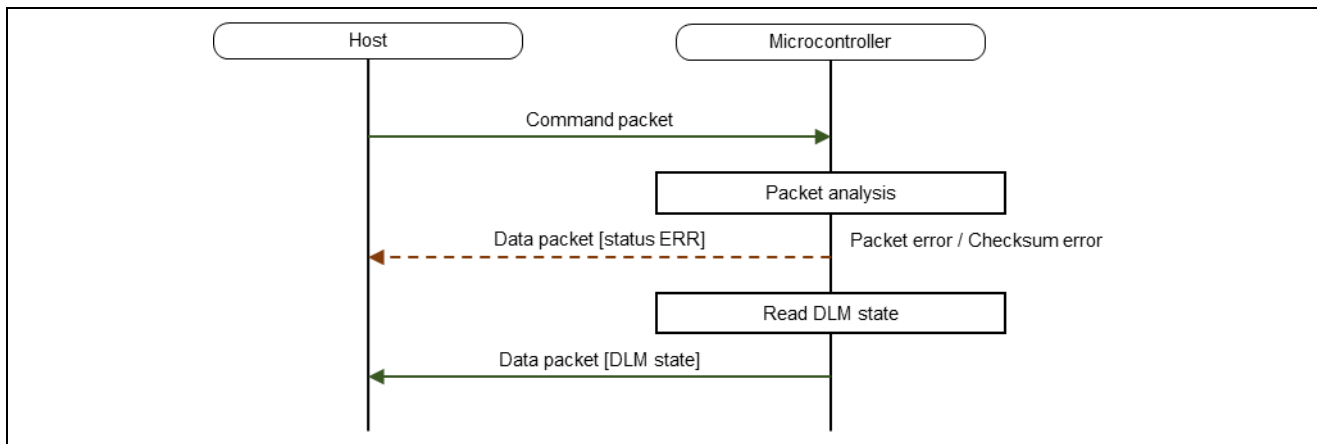
6.9.1 Sequence diagram

This command is used to get the current DLM state.
