Thank you for purchasing the PG-FP5 flash memory programmer.

This document describes specifications that have been added or changed, restrictions, and cautions on using the PG-FP5. Also see the user's manual of the PG-FP5 for terminology and points for caution on using the PG-FP5.

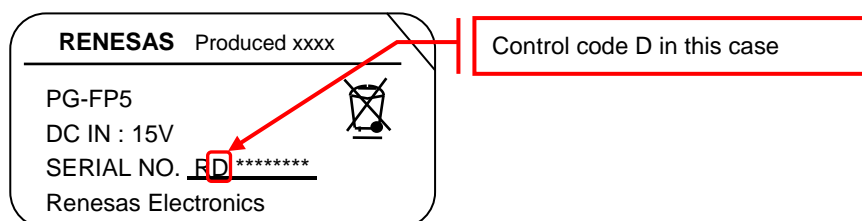
Notes 1. The control code is the second digit from the left in the 10-digit serial number. If the product has been upgraded, a label indicating the new version is attached to the product and the x in **V-UP x** on this label indicates the control code.

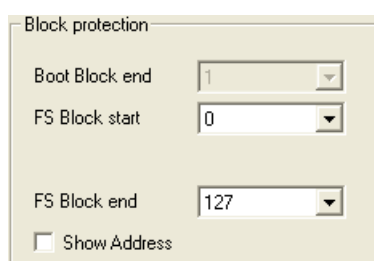
Before change

Description: The layout in the **Block protection** area has been changed.

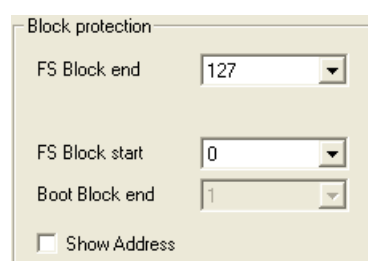
After change

Implementation: This item has been implemented in products with control code A (firmware: V2.02, FPGA: V2, GUI: V2.02).
