This document outlines the device support, new features added in 4.2.0, fixed issues and open issues in e² studio 4.2.0.

4. What is new in 4.2.0?

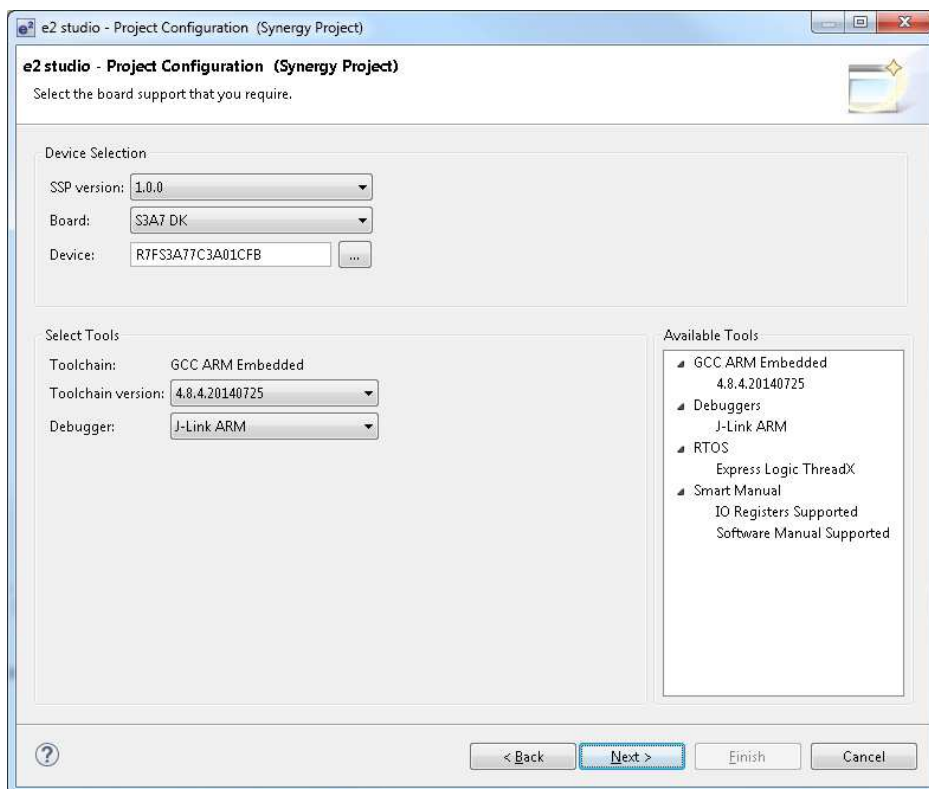
Component	Description
Synergy Support	<p>e² studio 4.2 will be the first version of the product to support the new Renesas Synergy Family. This will have a lot of specific functionality to support the ARM Cortex M series devices. Initially supporting the S3A7 and S7G2 group of devices on the ARM Cortex M4.</p> <p>The functionality provided will create ARM Launchpad GCC and IAR ARM toolchain Synergy projects which can create, configure and debug projects using SSP (Synergy Software Platform) components. Note, you can download the ARM Launchpad GCC using the web based e² studio installer.</p> <p>The SSP is a driver model which delivers both HAL drivers and framework drivers providing higher level services for customers to use in their end applications. These framework drivers are built on top of the ThreadX RTOS.</p> <p>Before you try and use the Synergy project generator you need to ensure you have a valid license and the latest version of the SSP.</p> <p>To download the latest version of the SSP please go to The Synergy gallery website to register and download: https://synergygallery.renesas.com</p> <p>The Synergy project generator is available via [File->New->Synergy Project].</p> <p>To use the system you need to browse to a license file which can be downloaded from the gallery.</p> <p>Once the project is created and editor is displayed which allows the configuration of the Synergy project and SSP code.</p> <p>Project generation</p> <p>A fully featured project generator will be implemented to create Synergy projects for GCC and IAR. This allows selection of the device, board, toolchain version and debugger. This project generator is launched via the [File->New->Synergy Project] menu item.</p>

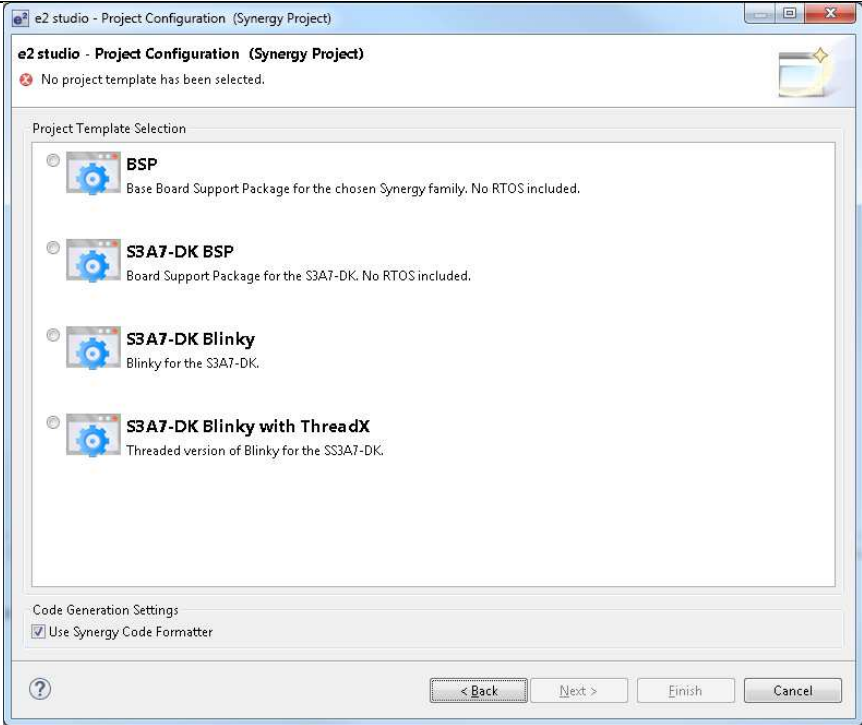
Once these are selected a project templates page is shown that allows you to choose a suitable template to start building your project from.

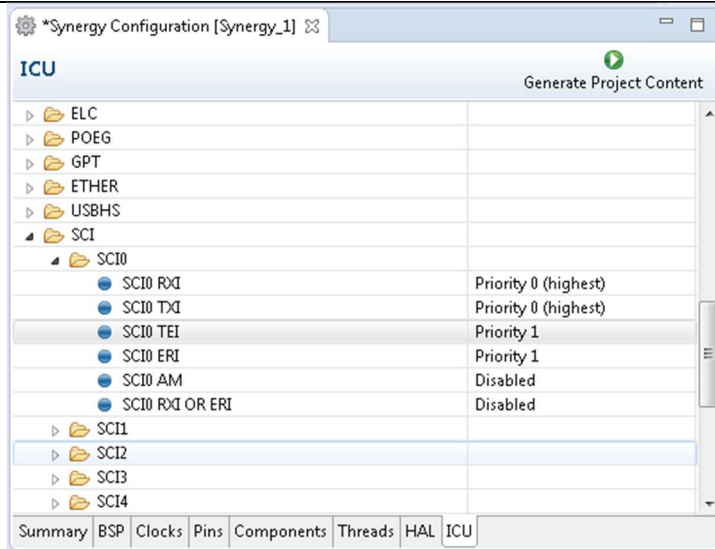
ICU

This tab allows you to configure the interrupts in their project. All interrupts in the system are listed. Selecting an interrupt allows the user to enable and specify the priority of the interrupt.

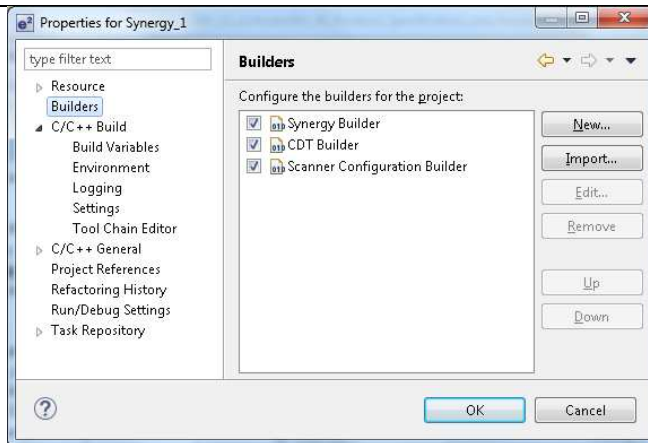
Generating and building code

There are two methods for the code to be generated. There is a generate code button within the editor, there is also a builder implementation. This builder regenerates the editor source files when the settings have been modified on a standard Synergy build operation.
