# RENESAS TECHNICAL UPDATE

Product Category	MPU/MCU		Document No.	TN-RZ*-A0087A/E	Rev.	1.00
Title	RZ/G2M V1.3 Additional Explanation for Ethernet AVB-IF		Information Category	Technical Notification		
Applicable Product	RZ/G Series, 2nd Generation RZ/G2M V1.3	Lot No.	Reference Document	RZ/G Series, 2nd Generation User's Manual: Hardware Rev.1.10 (R01UH0808EJ0110)		
		All lots

Additional Explanation for "RZ/G Series, 2nd Generation User's Manual: Hardware Rev.1.10".

Section 46. EthernetAVB-IF

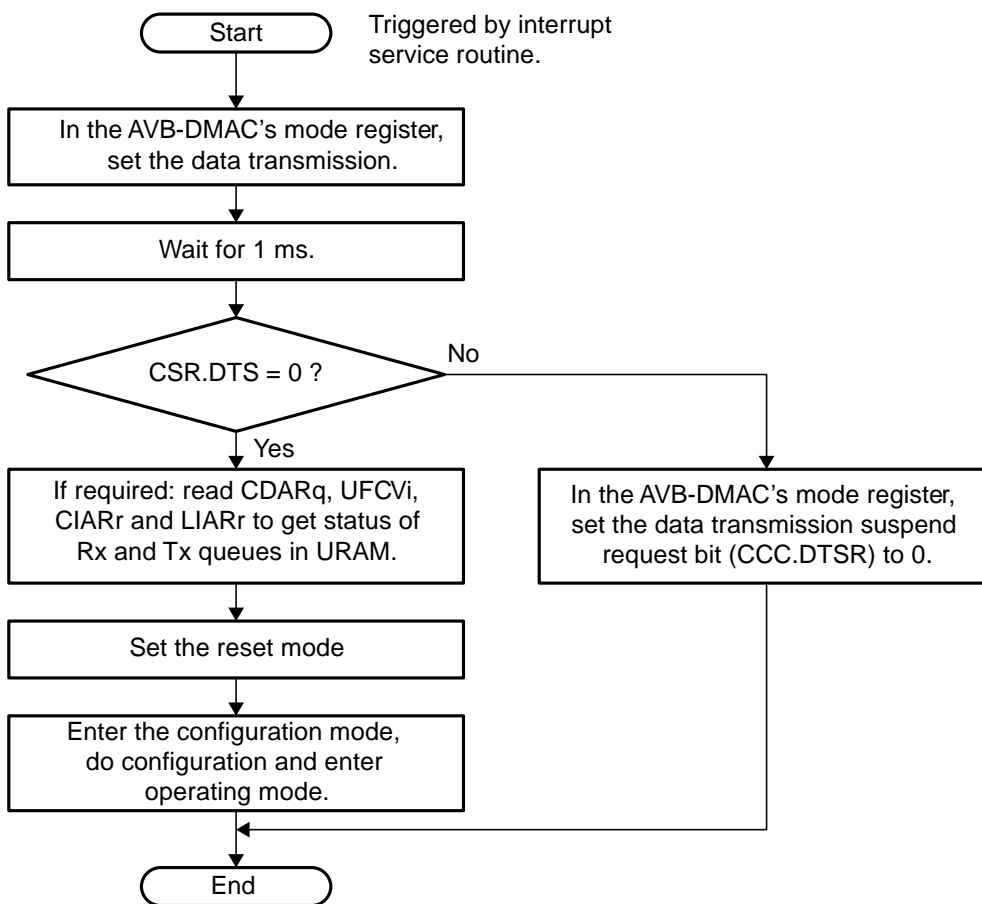
Figure 46.91 Data Transfer Function Stop Flow2 after Read Access Error

Current (from):

- Section 46. EthernetAVB-IF, Page 46-334, 46.4.4 Register Description, (d) Display Plane Register Configuration, Alpha blending related registers are added.

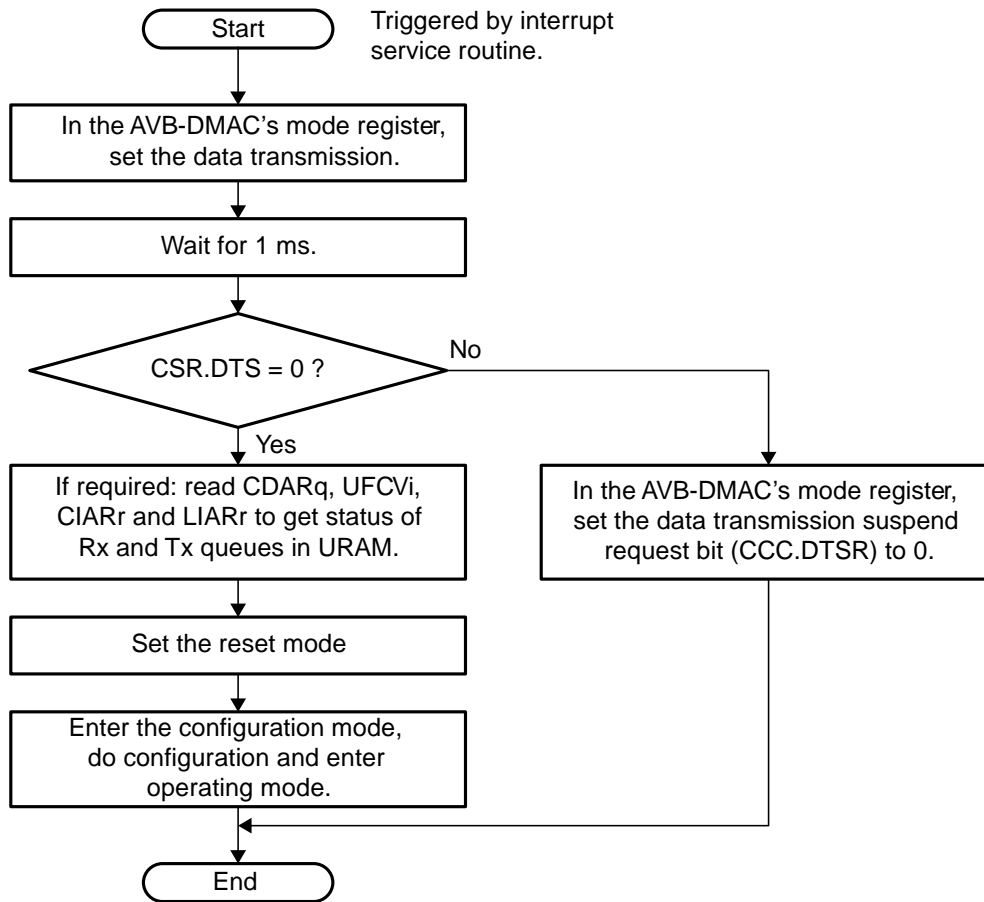
Figure 46.91 Data Transfer Function Stop Flow2 after Read Access Error

Correction (to):
