## Abstract

The design of a daisy chain battery system, while fairly straightforward, has a number of design elements that can become obstacles to implementation. This case study provides a glimpse into the questions and responses in the development of one daisy chain system.

The ISL78600 and ISL78610 are Li-ion battery manager ICs that supervise up to 12 series connected cells. The parts perform accurate monitoring, cell balancing and extensive system diagnostics functions. The devices communicate to a host microcontroller via an SPI interface and to other ISL78600, ISL78610 devices using a robust, proprietary, 2-wire daisy chain system.

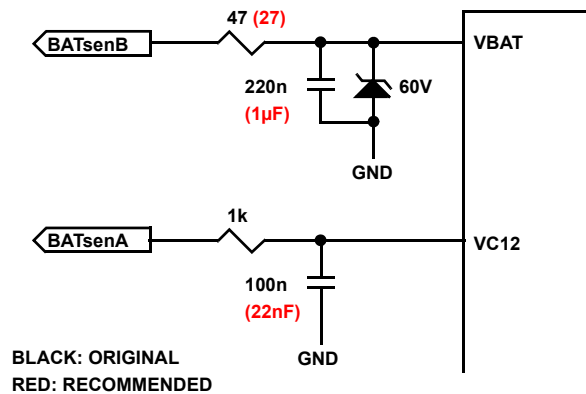
FIGURE 1. INITIAL VBAT CONNECTION

The VBAT input resistor was not damaged. Attached is a schematic of the VBAT connection.

Normally, we recommend a 27Ω resistor. While a 47Ω resistor may be OK, what happens is that the voltage at the VBAT pin drops when there is higher current, like during SPI or daisy chain communications. If the voltage drops too much, then there is not enough headroom on the front end analog circuits and there can be measurement errors. So, if the input resistor is not damaged then try a 27Ω resistor to see if this makes a difference.

If a smaller resistor value does not make a difference, then check that there is no large voltage differential across the VBAT series resistor. There should be a small drop in voltage (up to about 80mV), however, if there is more than this, check the diode. If the diode is OK and there is still a voltage drop across the resistor, then the part may be damaged.

Another recommendation we make on the input filters is that the time constants on all inputs be the same (or about the same). In this case, the cell input time constant is about 16 times the VBAT time constant. If there are high voltage transients on the pack voltage, the differential time constants will result in high voltage differentials on the IC input pins. To minimize this, we recommend different filter values, as shown in RED in [Figure 1 on page 2](#).

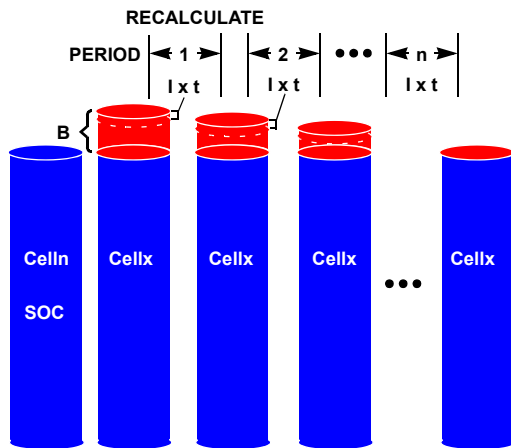
FIGURE 3. ILLUSTRATION OF AUTO BALANCE

- Determine amount of excess capacity in CELLx than in CELLn
- Remove part of the excess capacity in each cycle
- Continue until the excess capacity is removed

The Balance Value is calculated for each cell to be balanced. The ISL78600 then balances each cell, subtracting the measured cell voltage from the Balance Value at the end of each Balance Time interval, until the Balance Value is zero. See [Figures 3 and 4](#).

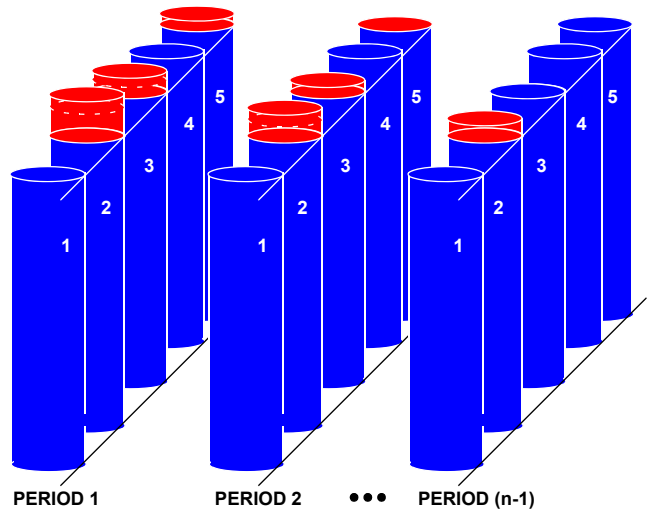
FIGURE 4. ILLUSTRATION OF AUTO BALANCE (MULTIPLE CELLS)

- Each period capacity is removed from cells
- When all capacity is removed from a cell, balance for that cell ends
- Balance continues on remaining cells until excess capacity is removed from all cells.

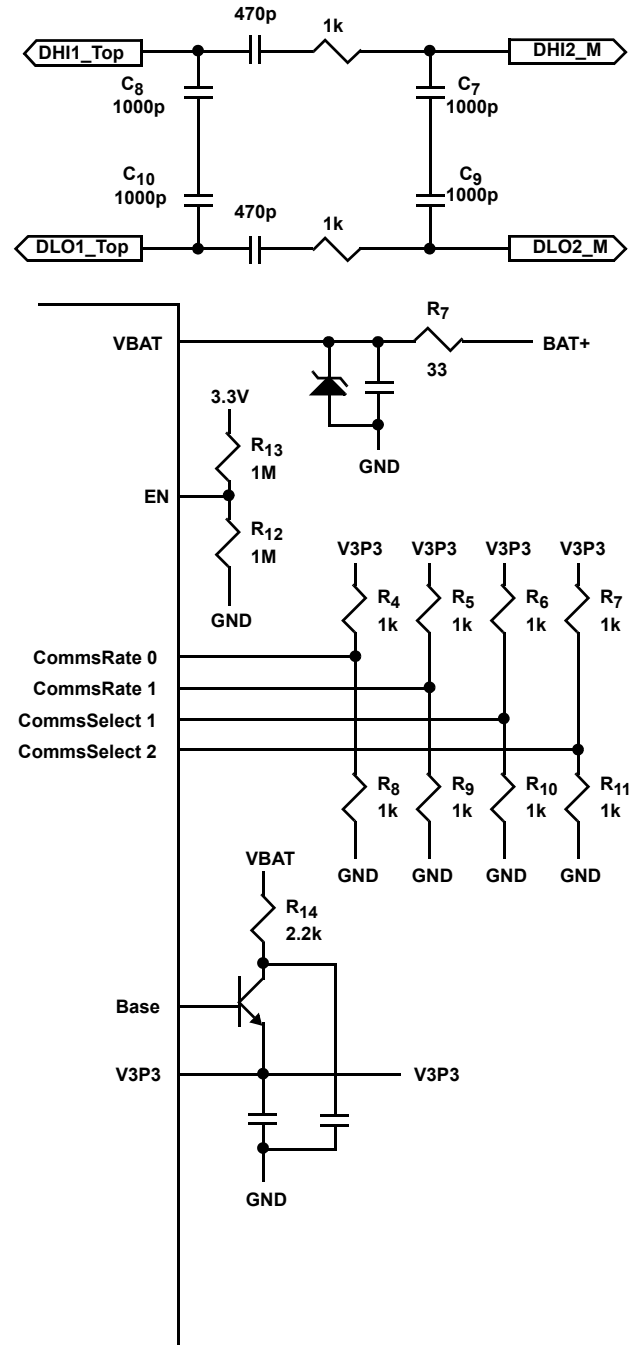
FIGURE 6. CUSTOMER ORIGINAL DAISY CHAIN CONTROL CONNECTIONS

Below (Figure 6) is a schematic of the ISL78600 daisy chain and control circuits in my battery management system.

Resistor  $R_{12}$  is not loaded and the Comms pull-up/pull-down resistors are loaded according to the configuration settings above. I measured the voltage across the resistor,  $R_7$ , in the schematic. The master bottom device is currently reading 11.9mV (360 $\mu$ A) and the top device is currently reading 2.4mV (72 $\mu$ A). Neither of these currents are popping off the datasheet to tell me what is going on.

The first thing to notice on the schematic is that the center point of the capacitors C<sub>8</sub> and C<sub>10</sub> (and C<sub>7</sub> and C<sub>9</sub>) should be at the respective IC GND (see [Figure 7](#)).

1. Resistor R<sub>14</sub> is probably too big. This will work OK for stand-alone, however, because of higher currents in the Daisy Chain mode, it might cause the 3.3V supply to drop out during communications. In our designs, we use a 100 $\Omega$  resistor.
2. On the V3P3 regulator, the collector resistor R<sub>14</sub> is shown to connect to VBAT. This should connect to BAT+, otherwise the V3P3 current will also flow through R<sub>7</sub>, reducing the VBAT voltage.

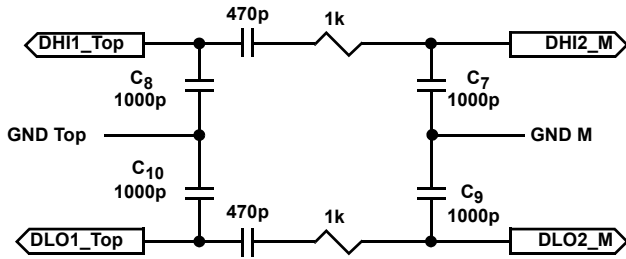
**FIGURE 7. PROPER DAISY CHAIN CIRCUIT FOR SINGLE BOARD CONNECTIONS**

If there is a cable between the two devices, then there should be a different arrangement of isolation components, though it will still work this way. The extra components are to protect the system in case of a cable short to chassis and to provide higher ESD immunity.

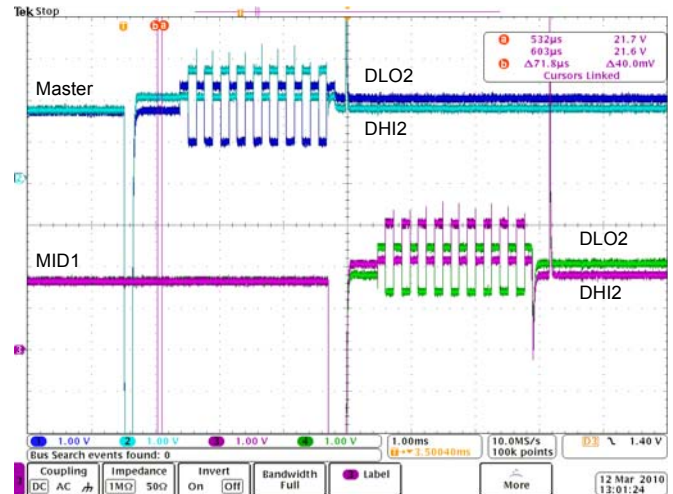
FIGURE 9. WAKE-UP DAISY CHAIN SIGNALS

Figure 9 shows the wake-up signals for multiple cascaded devices. Notice that before the device wakes up, the DHI2 and DLO2 signals are at about the same level. However, once awake, the DLO2 signal is slightly higher than the DHI2 signal.

What does the scope shot of the DHI2/DLO2 look like when sending the wake-up? It should look something like the signals in Figure 9.

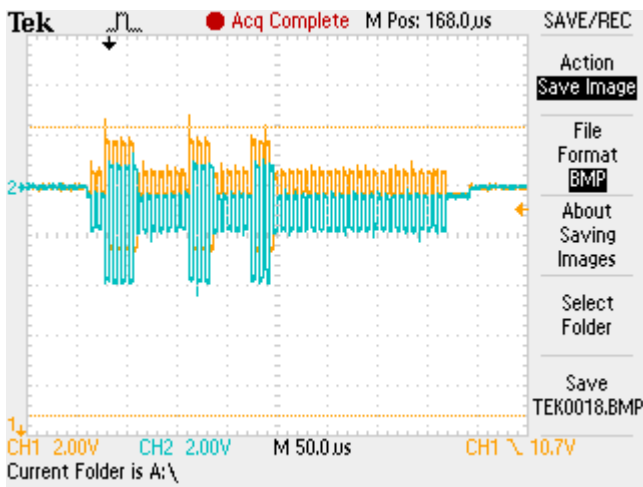
FIGURE 10. CUSTOMER DHI/DLO TRACES

So, that looks good. [Figure 10](#) is the scope waveform for the master/bottom device's DHI2 and DLO2 lines, which actually look correct now while the daisy chain interface isn't connected. DLO2 is blue and DHI2 is orange.

**A:** The waveform in [Figure 10](#) looks almost correct for daisy chain communications, however, it is still not what you want to see. When the boards properly connect, you should see that the waveforms are more symmetrical vertically; and before and after the signals there should be an offset between the two traces (while here they appear to be the same voltage).

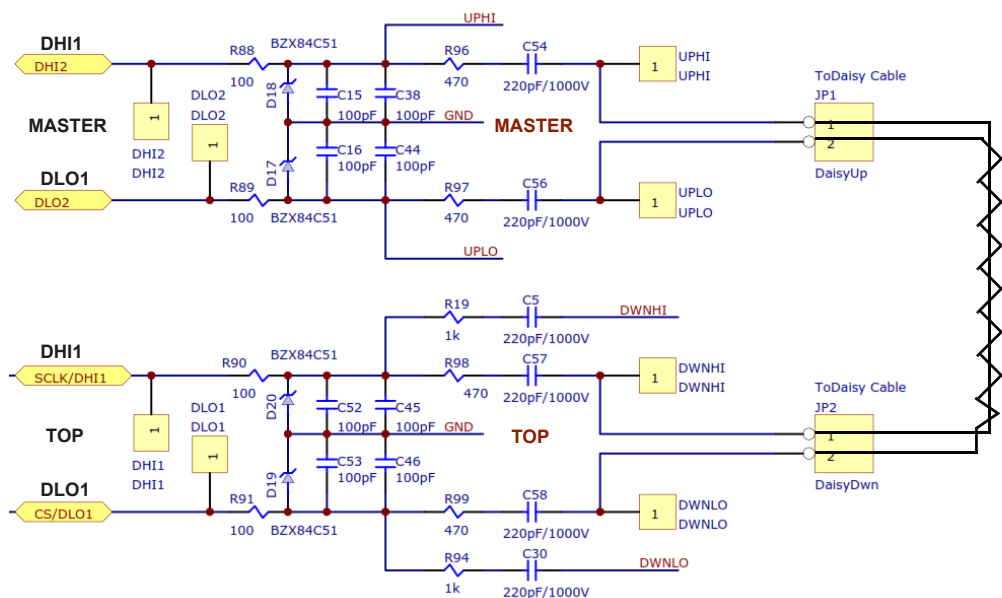
FIGURE 11. RECOMMENDED DAISY CONNECTIONS BETWEEN SEPARATE PCBs (COMPONENTS SELECTED FOR 500kHz DATA RATE)

One other recommendation, if you have two boards connected by a cable, we normally recommend a daisy chain connection as shown in [Figure 11](#). This has components for faster daisy chain, however, what you might notice is that the up and down circuits are the same. This arrangement splits all of the components for symmetry, so if there is a break in the cable, the pins are isolated on both sides of the break. Even with a direct connection, this arrangement means that you do not need to bring the ground on the high side capacitors through the connector.

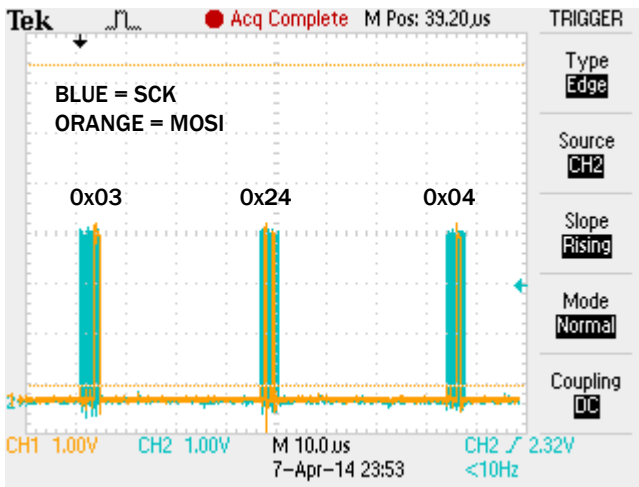
FIGURE 13. CUSTOMER BASE ID COMMAND (SPI)

The 'base id command' waveform (Figure 13) shows the transmission of 0x03 24 04 from the Host MCU to the bottom/master device, specifically, the timing between SPI bytes in the overall transmission of this command. The timing shows that this command meets the 100 $\mu$ s maximum requirement defined as the  $\overline{CS}$  high time (the time between bytes). Please let me know if you see any concerns with the timing of my command transmission.

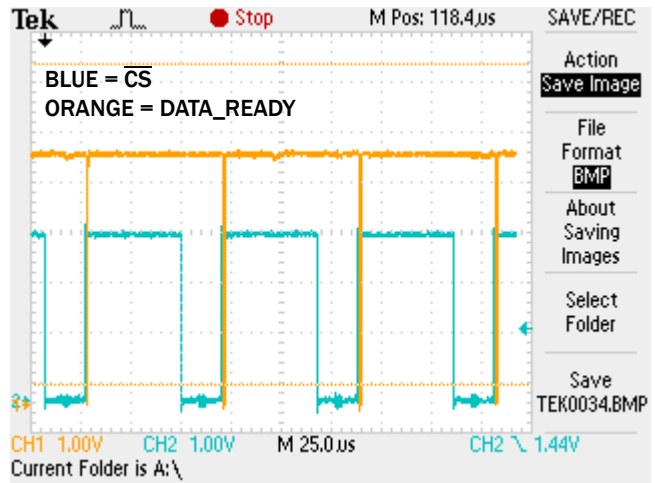
FIGURE 14. CUSTOMER DATA READY RESPONSE HANDLING TIMING

Also, the 'data\_ready response handling' waveform (Figure 14), shows the timing on servicing the  $\overline{DATA\_READY}$  line. Please note that I have a level shifter that inverts  $\overline{DATA\_READY}$  from the ISL78600. As shown in the waveform, the  $\overline{DATA\_READY}$  signal goes HIGH when a byte is available in the ISL78600 buffer. The time that  $\overline{CS}$  is low is the time it takes for me to read a SPI byte (~25 $\mu$ s). At the completion of each read with the rising edge of  $\overline{CS}$ , you can see  $\overline{DATA\_READY}$  dip low briefly and return HIGH, indicating another byte is available. The time from the rising edge of  $\overline{DATA\_READY}$  to  $\overline{CS}$  going low again is the time it takes for me to respond to the  $\overline{DATA\_READY}$  signal (~45-50 $\mu$ s). Do you think this is too long?

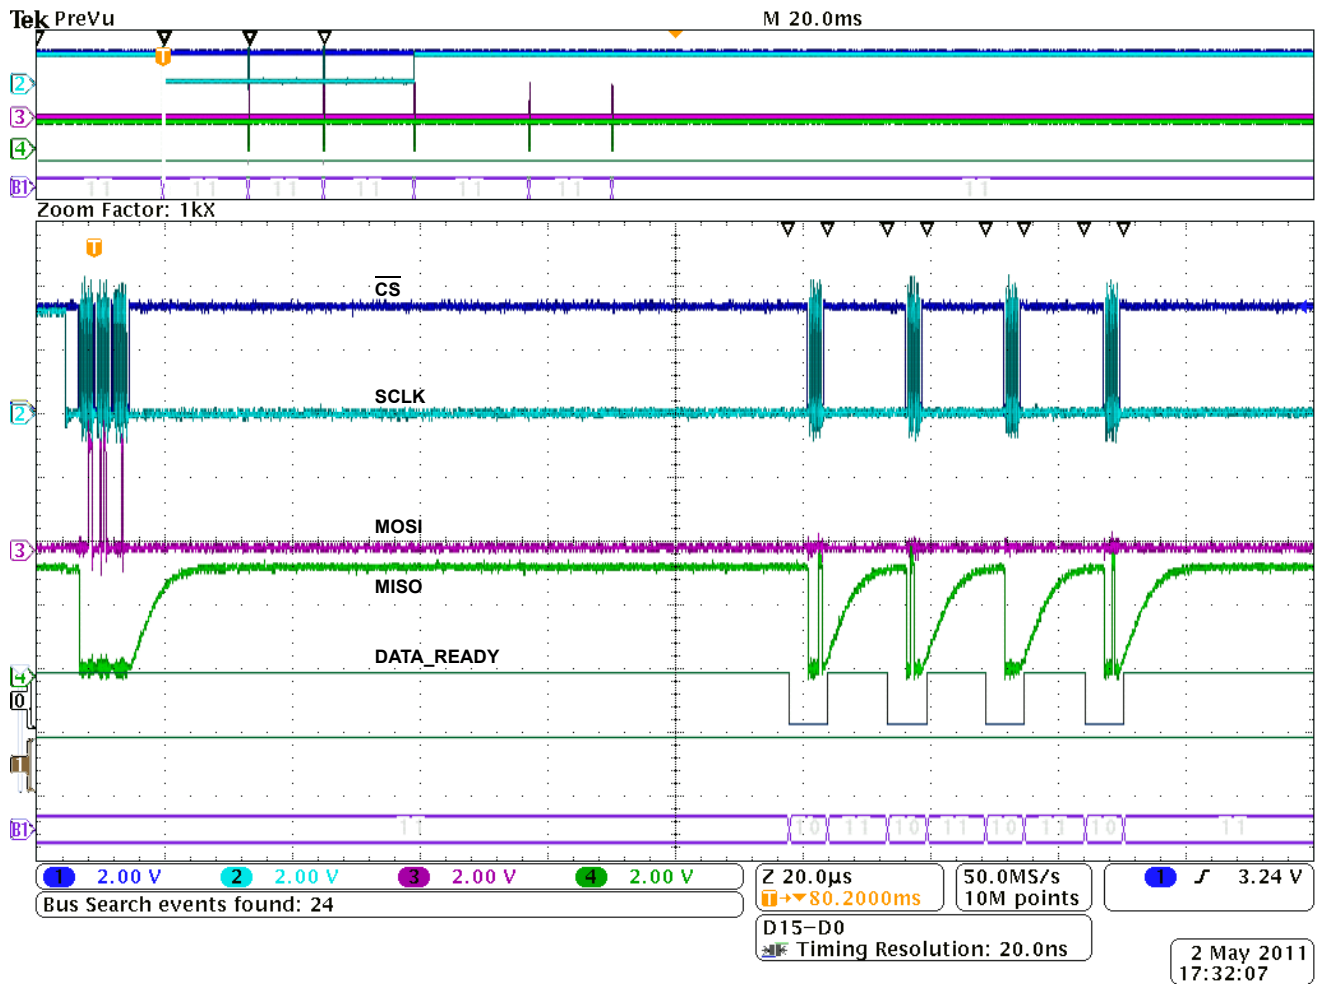
**FIGURE 15. EXAMPLE IDENTIFICATION SEQUENCE FROM INTERSIL (GOOD RESPONSES)**

I went through some timing diagrams from tests I did a while ago and found a scope shot of an identify sequence from our board. See [Figure 15](#). You can see that our response to data ready (the "0" trace) is much faster than yours and is about 3-4 $\mu$ s delay from falling edge of data ready to the start of SPI communication.

shows up on the IDENTIFY command, not on any other command. Simulations show that there can be data corruption in the IDENTIFY response if the  $\overline{CS}$  to SCLK time exceeds 50 $\mu$ s. We will be changing the datasheet to include a comment suggesting a maximum of 30 $\mu$ s (to cover corner conditions) between these two signal edges.
